**REPORT#: 25KY032 REPORT DATE: 05/01/2026**

## Electrician Trainee Fatally Electrocuted at Commercial Job Site

### SUMMARY

On May 19, 2025, a 23-year-old white, non-Hispanic electrician trainee (victim) was attempting to install new electrical wire in a commercial building renovation project. While doing so, the victim was electrocuted by an energized wire. As a result, the victim succumbed to the injuries he sustained. [Read Full Report>](#)

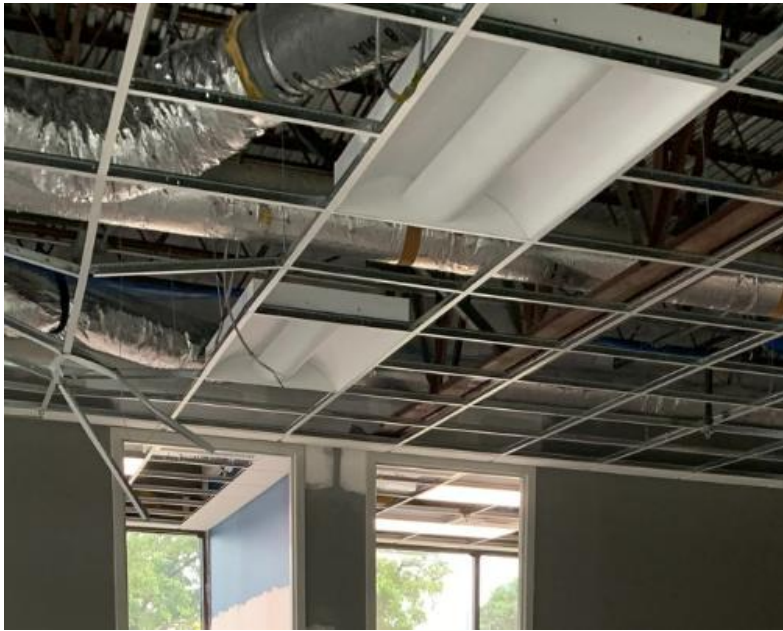
As a part of the multi-day renovation project, the victim's job on the day the incident occurred was to install and route new wiring (type mc cable) for the troffer style light fixtures (photo 2) that were installed by the involved company just three days earlier, on May 16, 2025. Once the wiring was routed, the victim's job was to connect the new wire to the newly installed, unenergized lighting fixtures. To perform the task, the victim was required to work on a 6-foot fiberglass ladder to access the ceiling mounted light fixtures and utilize LED work lights and a head lamp to aid with visibility while performing work.

Photo 2: Troffer style lights in the incident. Photo obtained via open records request.

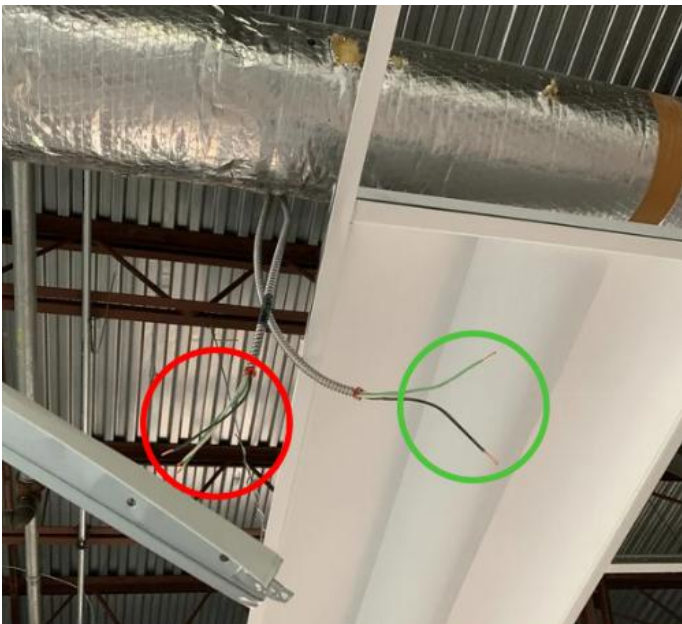
Photo 3: Unenergized wire (green circle) installed by the victim and energized wire contacted by the victim (red circle), which resulted in the fatal injuries. Photo obtained via open records request.

In this incident, an unlicensed electrician trainee (victim), also referred to by OSHA as an “unqualified person” was working to install wiring for newly installed troffer style lights. The lights themselves were de-energized. However, a lighting whip that was connected to existing lights was energized, within the vicinity of the victim and controlled by a wall mounted switch. The victim, in error, removed a wire nut and made contact with the 277-volt energized wire.

program; however, procedures were not followed or implemented at the job site. A wiring whip in the vicinity of the victim's work area, though protected with wire nuts, was not guarded and locked out, nor was the wall-mounted switch that controlled the flow of electricity to the whip de-energized or locked out at the time the incident occurred.

A lockout/tagout program could be beneficial in removing the risk of electrical shock in similar scenarios. Even if lockout is not possible, a tagging system (photo 6) can warn employees of electrical shock risk, helping the employee mitigate the exposure.

To help prevent similar incidents, Kentucky FACE investigators suggest that employers implement, train, and adhere to a formal energy-control program, which includes lockout/tagout procedures.

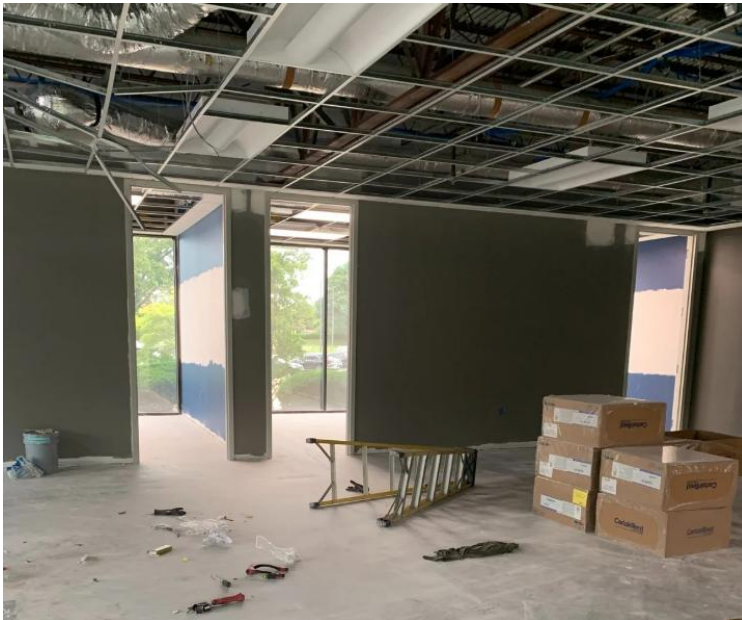
The incident occurred inside a 134,000-square-foot, four-story commercial office building (photo 4). The building, which was erected in 1989, is constructed of brick and hosts multiple business suites on each floor. The incident took place in a suite that was being renovated (photo 5). The victim and his supervisor were working within the same room; however they did not have a clear line of sight due to the L-shaped design of the room. The victim was working around a corner, on the shorter side of the L-shaped room, while the supervisor was on the opposite end completing a task when the incident occurred.

Photo 5: The scene of the incident. Photo obtained via open records request.
