## 38 Year-Old Construction Laborer Dies When Trench Walls Collapse Incident Number: 03KY107

# Kentucky Fatality Assessment and Control Evaluation (FACE) ProgramIncident Number:03KY107Incident Date:November 3, 2003Release Date:November 5, 2004Subject:38 Year-Old Construction Laborer Dies When Trench Collapses

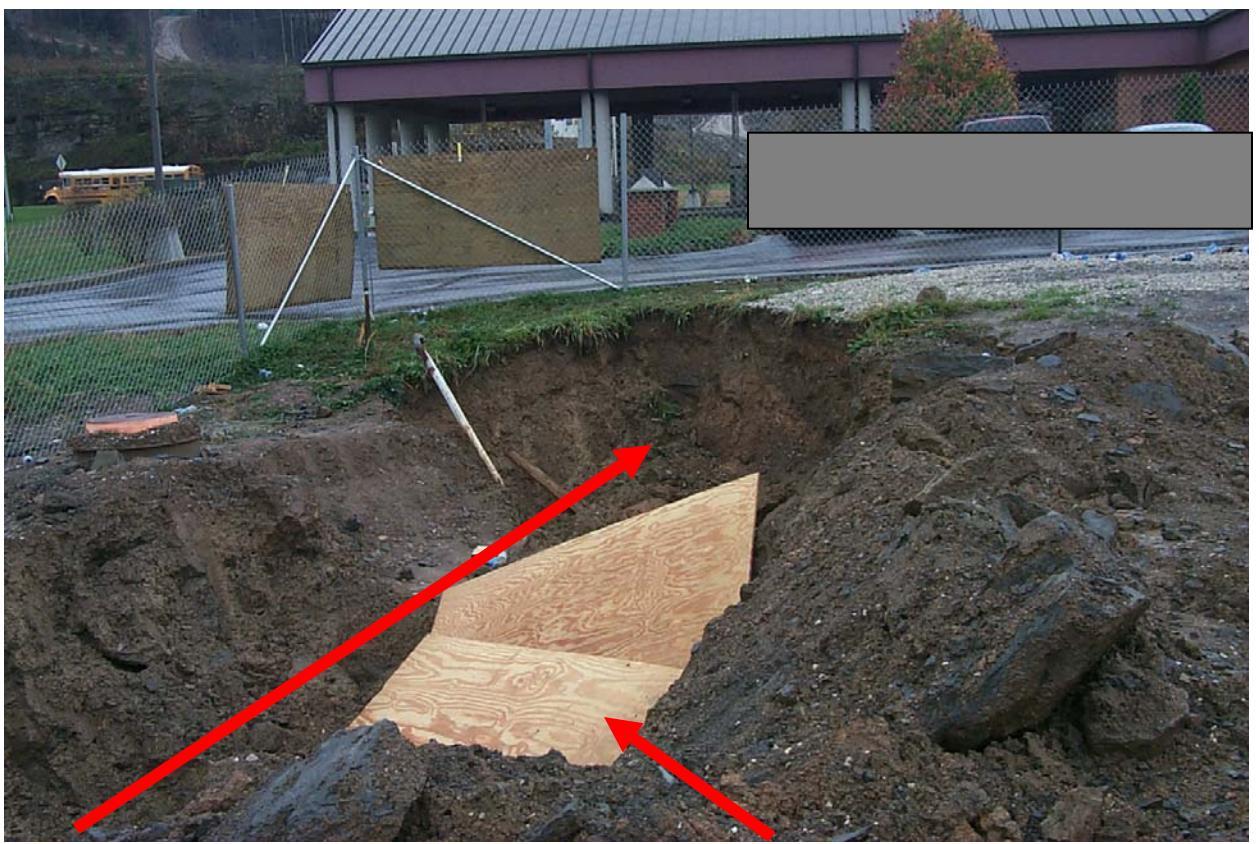
Location of victim in trench when sides collapsed. Plywood used by emergency response personnel.

On November 3, 2003, a 38-year-old male construction laborer died when the unprotected 8-foot high walls of the trench he was working in collapsed. The decedent was working for a subcontractor who was contracted by a construction company to remove old gas, storm and sanitary sewer lines and install similar new lines. The old abandoned 6-inch diameter gas line was a high pressure, 300 - 320 psi gas line in 10-inch steel casing and was 600 feet long. There were five employees at the job site employed by the subcontractor; a foreman who was a certified competent person, a lab technician who was a certified competent person, and 3 laborers (one of which was the decedent). The foreman had dug an 8-foot deep trench with a track hoe to expose the abandoned gas line. After the gas line was exposed, the 38-year-old laborer climbed into the trench with a saw to cut through the gas pipe and its casing. The sides of the trench were not shored or benched. As the laborer began sawing, the sides of the trench collapsed, burying him. He was declared dead at the scene by the local coroner.

Recommendation No. 1: Employers and employees should not take shortcuts.

According to one person interviewed, the decedent's job of cutting the exposed gas line pipe and casing with a saw should have only taken a few minutes to accomplish. Taking the time to shore the sides of the trench would have taken longer than sawing the pipe and casing. Instead, it was decided to take a shortcut and not protect the laborer from the possibility of the trench sides collapsing.

Recommendation No. 2: Employers should train employees on safe work practices and how to recognize and avoid unsafe work conditions.

Recommendation No. 3: Employers should train employees working in excavations on use of appropriate protective equipment.

Employers are required by OSHA Standard 29 CFR 1926.652(a)(1) to protect employees from cave-ins while performing excavation work. This regulation also stipulates configurations for sloping sides of trenches and appropriate materials to be used in shoring walls of excavation sites. Any trench 5 feet or more in depth must have an adequate protection system before being used by employees.

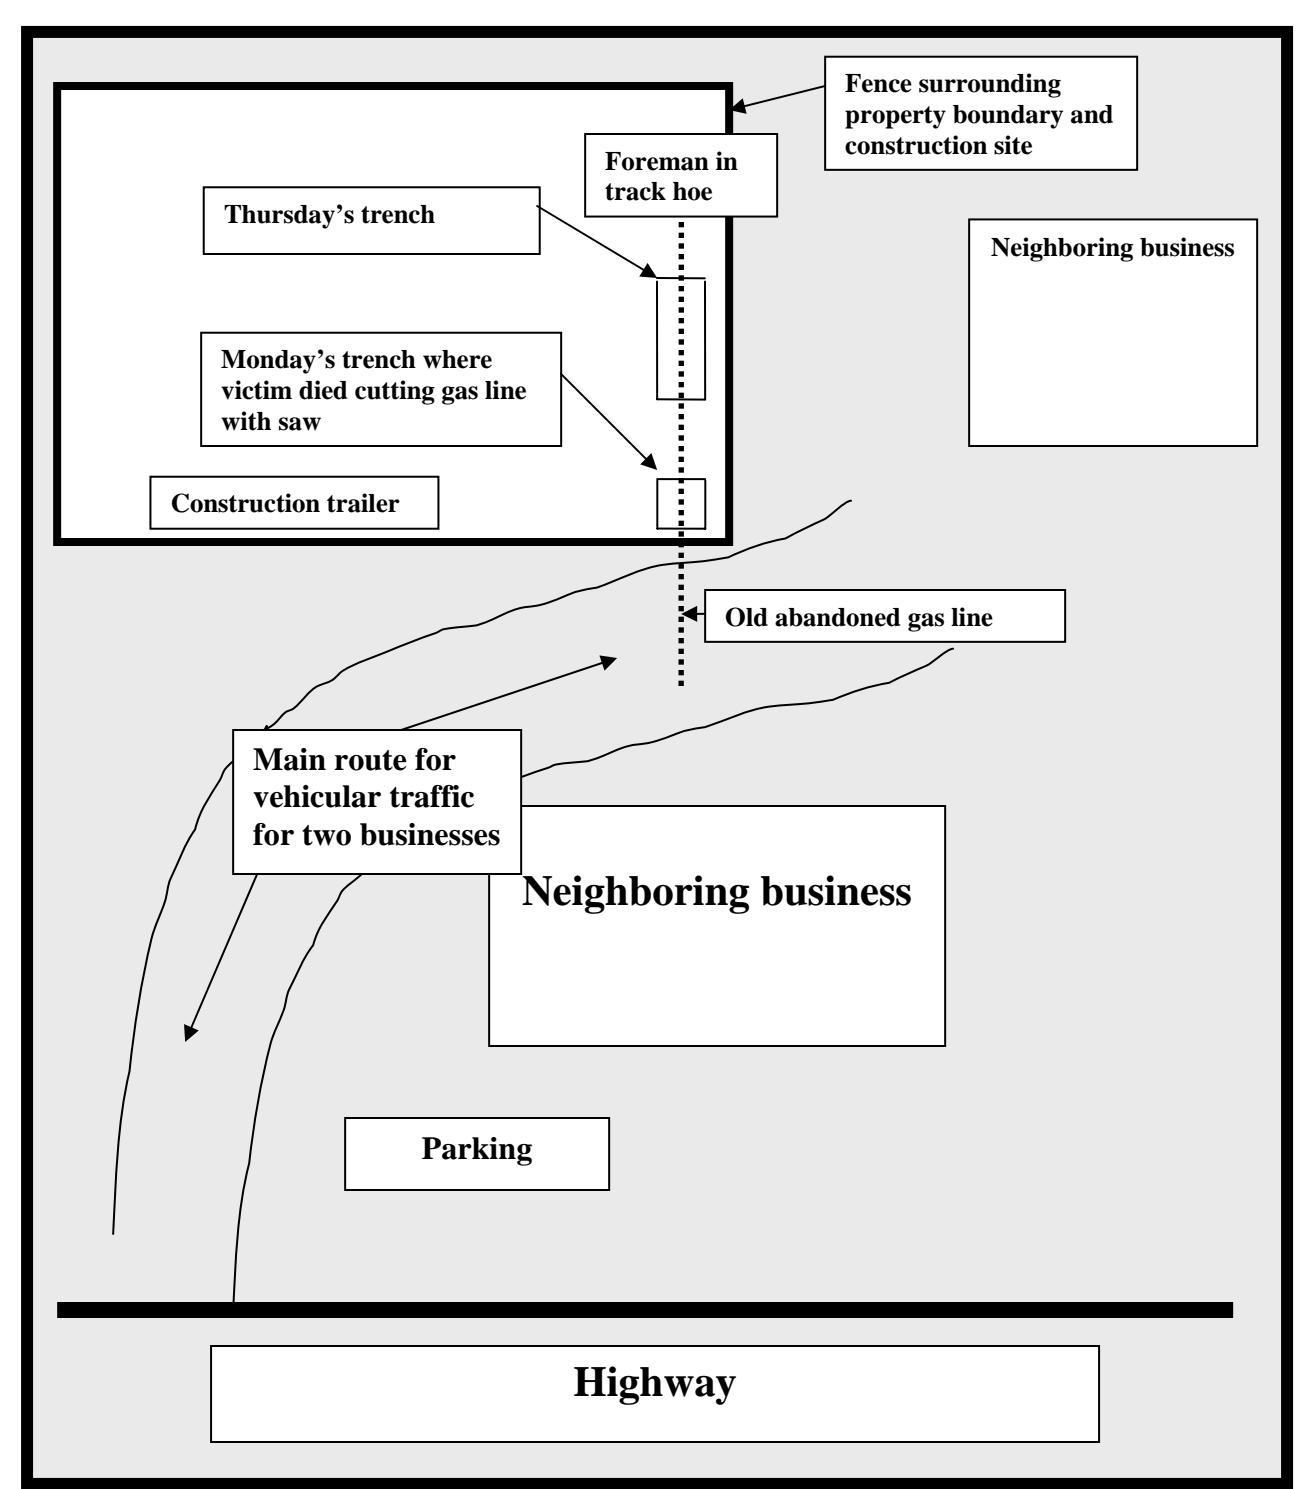
Diagram of construction site and neighboring businesses, driveway and parking lots

The job site was in a commercial area located behind and to the left of existing businesses (see diagram) and was surrounded by chain link fencing. The work was to be performed in a corner where the three properties came together. The two existing businesses shared a driveway which passed from the highway between the business in front and the construction site, around the corner and to the other existing parking lot. Heavy traffic traveled in front of the work site to and from the existing businesses and within 10 feet of the trench where the fatality occurred.
