Cleaner Falls 35 Feet to His Death Through Temporary Roof Opening

Incident Number: 04KY011

Kentucky FatalityAssessment and Control Evaluation (FACE) ProgramIncident Number:04KY011Incident Date:February 28, 2004Release Date:September 12, 2005Subject:Cleaner Falls 35 Feet to His Death Through
Temporary Roof Opening

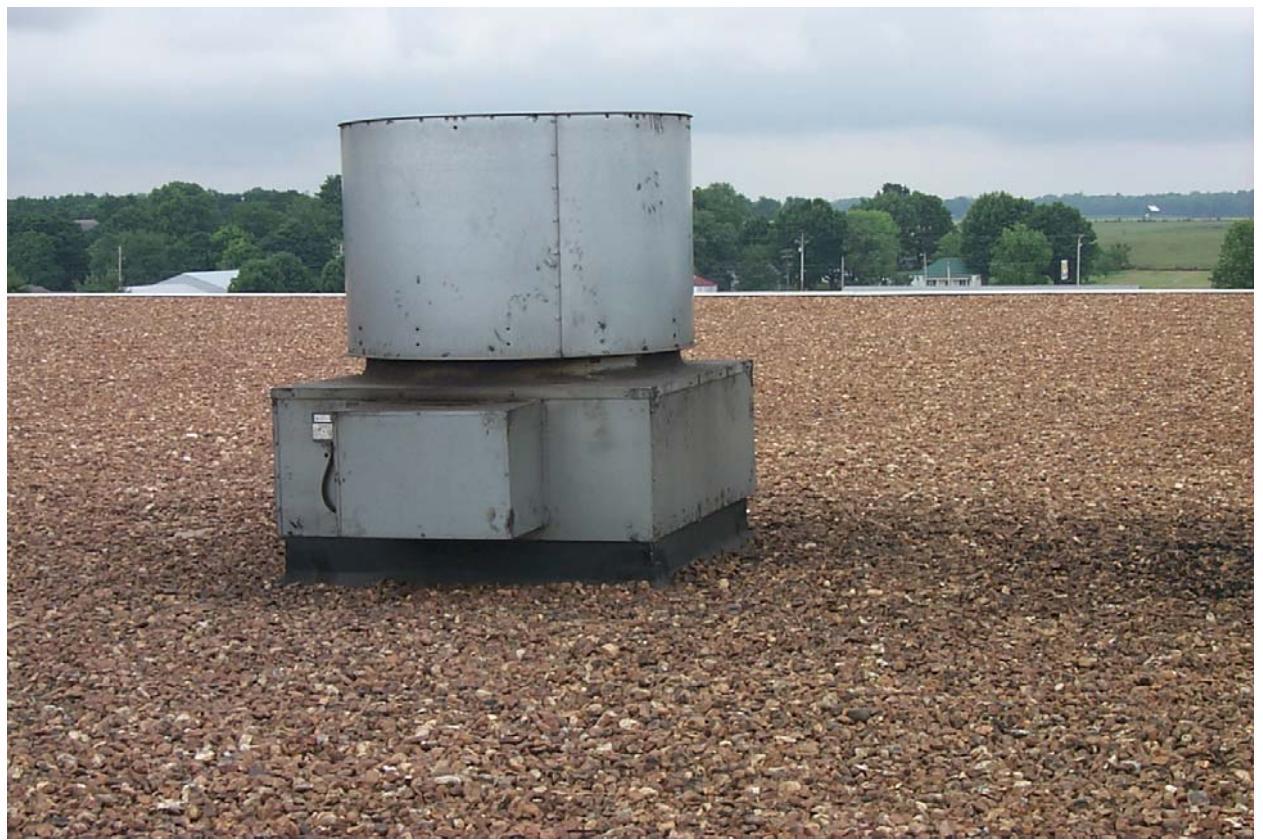
Exhaust fan had been removed for cleaning, creating a temporary opening where cleaner fell approximately 35 feet onto a piece of machinery in the factory.

Recommendation No. 1: When removing fixtures for cleaning on roof tops, temporary roof openings should be covered or barricaded.

Kentucky Occupational Safety and Health standards state that employees shall be protected from falling through holes by use of personal fall protection, covers, or guardrail systems CFR 1926.501(b)(4). After this incident occurred, the company constructed covers of 2 x 4s and plywood nailed together to be placed over the temporary holes in the roof while the fans were removed. The employer stated that the factory initially did not want the holes covered up when the fans were removed because it would keep air from flowing out of the factory. In these circumstances, if a guardrail is used, it should meet CFR 1926.502(b)(1) requirements of the top rail to be a minimum of 42 inches high, plus or minus three inches. Also, according to CFR 1926.502(b)(3) the guardrail system must be able to withstand a minimum of 200 pounds of force on the top two inches of the guard rail. CFR 1926.502(b)(11) states that if guardrails are used, they must be installed on all sides of the opening.

Along with a roof covering, a moveable four-wall, five foot high barricade could have been constructed for the roof openings. This would have allowed the factory air to exhaust through the roof openings while the fans were being cleaned.

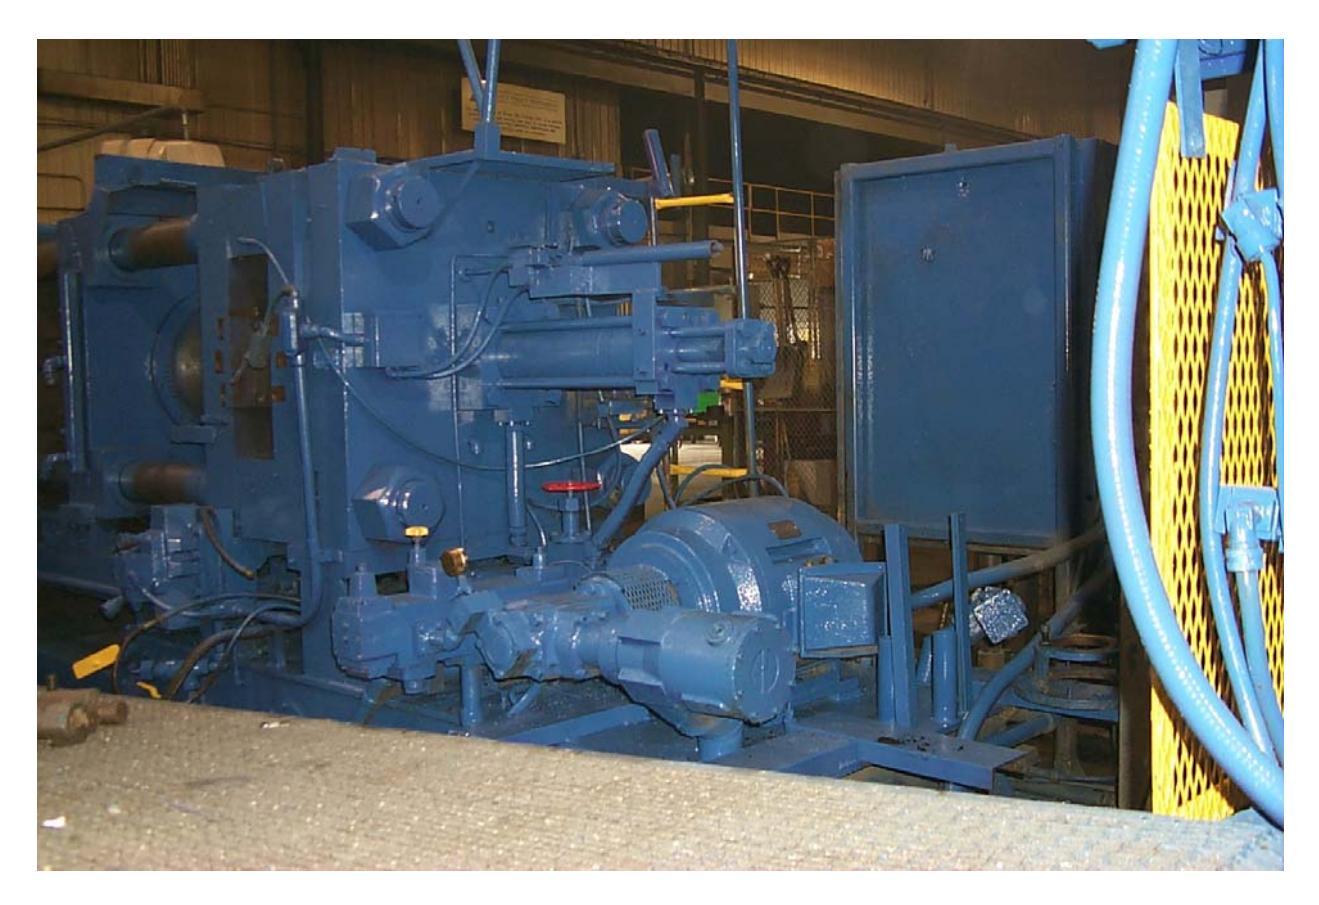
Machinery onto which the cleaner fell.

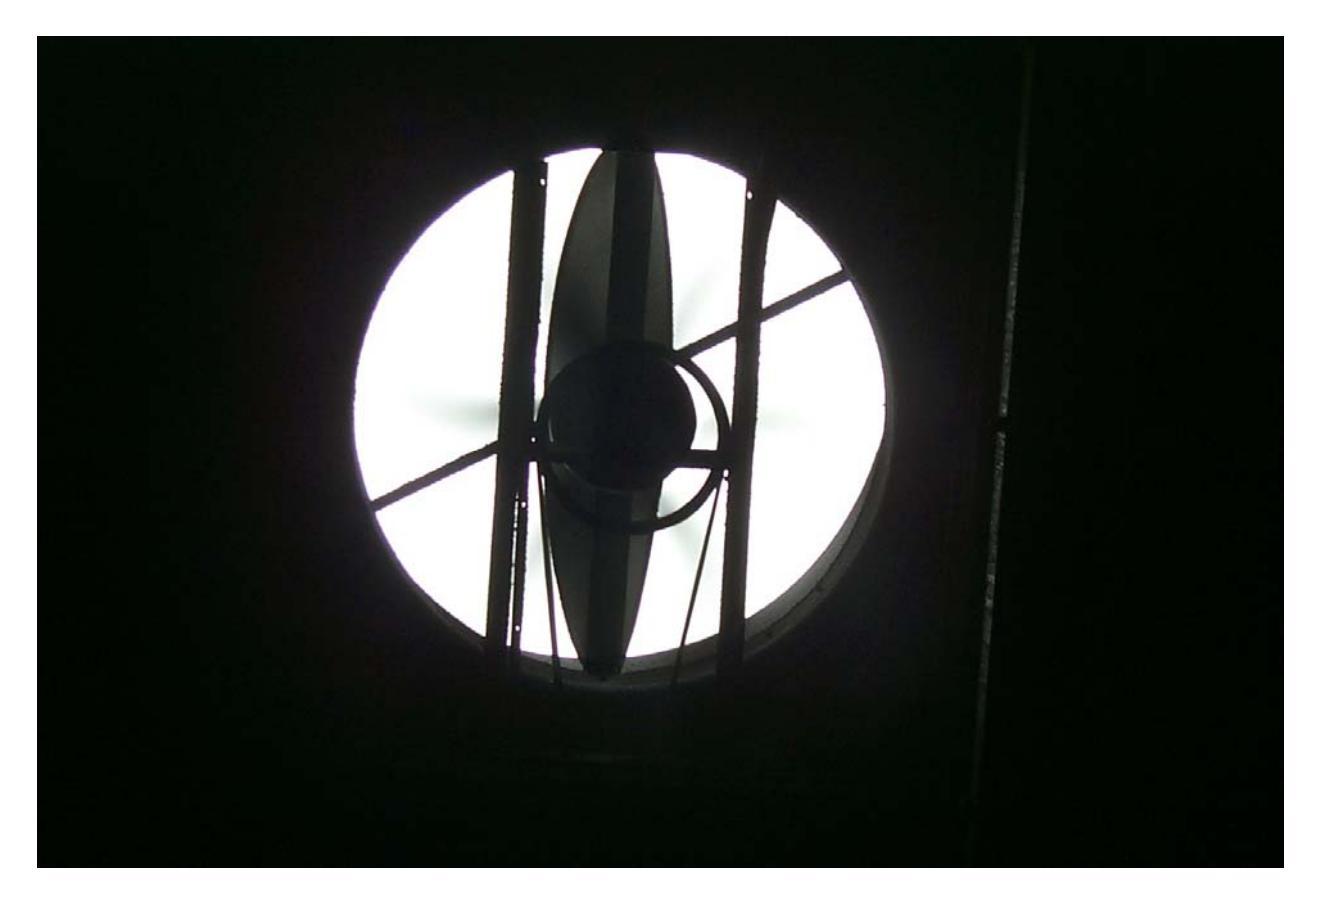
Exhaust fan above machinery on factory floor where fatal incident occurred. Picture was taken from factory floor.
