Kentucky Fatality Assessment and Control Evaluation (FACE) Program Incident Number: 15KY001 Release Date: February 3, 2016

Semi-Truck Driver Fatally Struck by Falling Flatbed Cage Door

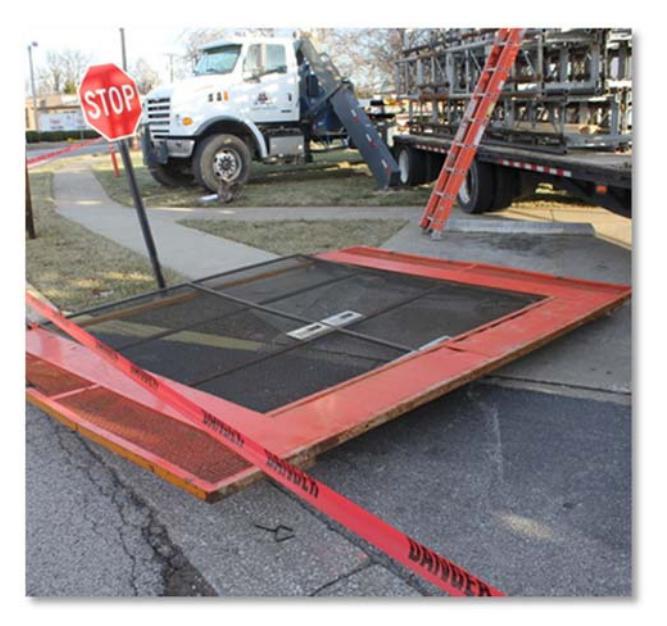
Figure 1. The cage door that fell from the flatbed trailer onto the victim.

- Employers should implement a safety policy where employees should not place themselves in a possible fall shadow zone while flatbeds are being loaded, or unloaded.
- Employers should establish work place safety guidelines for securing loads while loading and unloading.
- Employers should implement a comprehensive safety and health program and provide training which includes hazard recognition and avoidance of unsafe conditions, such as the hazards associated with loading and unloading equipment worksites.

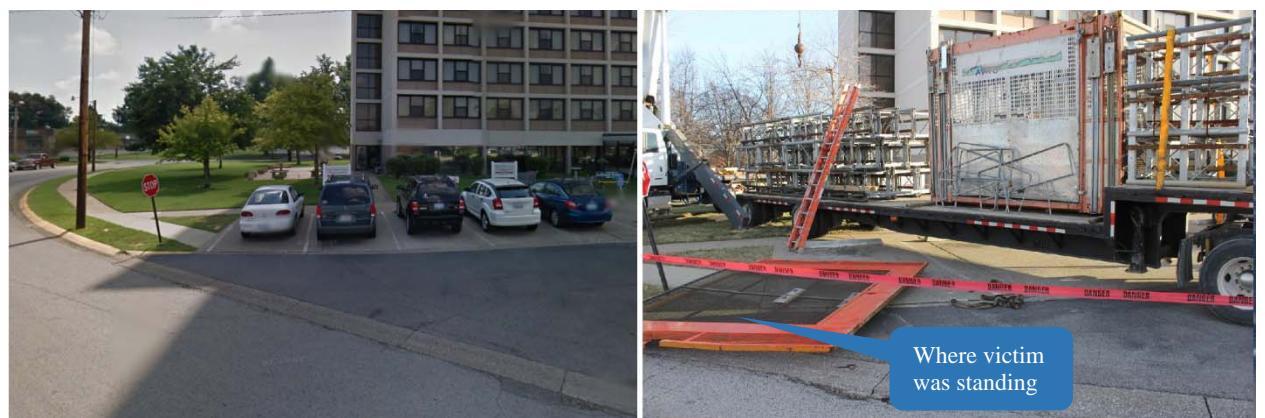
Figure 2. Parking lot where the incident occurred. The building in the background can be used as a reference point between the two photos as to where the flatbed trailer was positioned.

The incident scene was a concrete parking lot where a building was under construction. The employees were located on the north wall of the building. The victim had backed the flatbed truck into the parking lot and parked, with the end of the flatbed resting on the grass adjacent to the parking lot and the front of the truck at the entryway of the parking lot (see figure 2). The truck was parked on a slight incline.

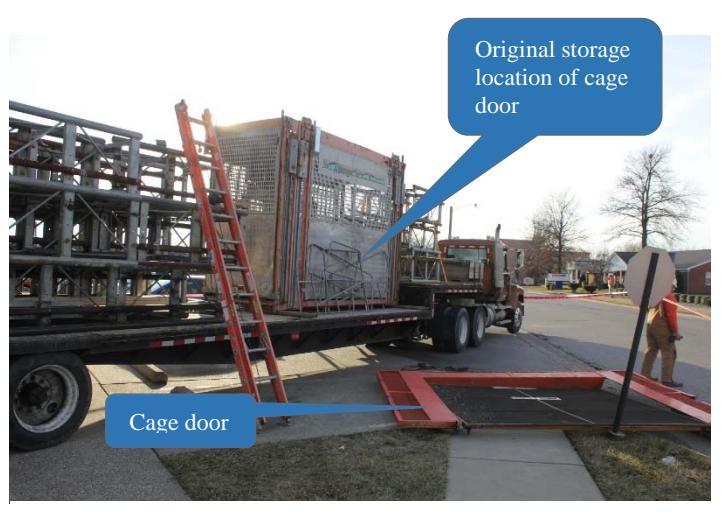
Figure 3. The cage door that fell on the victim and its original storing location.

warn him. When the crane operator was approximately 8 feet from the victim, the cage door fell off the trailer striking the victim (see figure 3). The employee called for assistance. The crane operator, a third employee and a bystander who witnessed the incident removed the door and called 911.

- Employee was in the fall shadow zone as equipment was being unloaded
- There was no one spotting the unloading of equipment to ensure safety

Loading and unloading semi-trucks can be a dangerous job. Falling loads, being struck by falling loads or even being struck by another vehicle are some of the risks involved in offloading cargo. Employers should only have one section at a time unsecured and only after a crane has been rigged to the load or a forklift is under the load. The person un-securing the load should move

out of the fall zone before releasing the load. A spotter to ensure employees are out of the fall zone is safe practice.

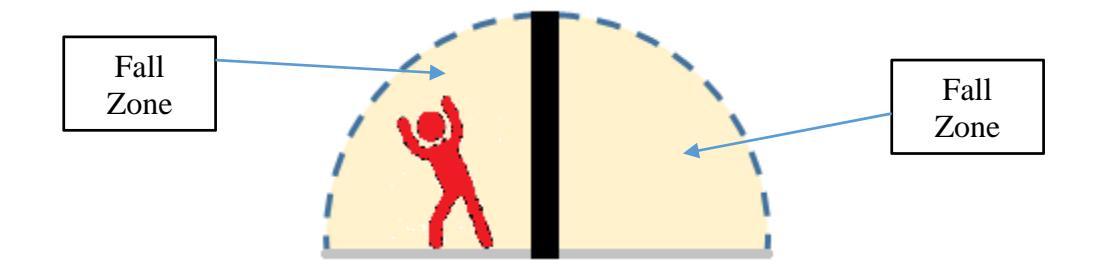
OSHA defines the fall shadow zone as the area on both sides of the trailer where the equipment could fall. The higher the equipment is lifted from the ground, the larger the fall zone. Standing outside of the fall shadow at either side of the trailer is the best practice to prevent being crushed or stuck by falling loads.

Recommendation No.1: Employers should implement a safety policy where employees should not place themselves in a possible fall shadow zone while flatbeds are being loaded, or unloaded.¹
