Kentucky Fatality Assessment and Control Evaluation (FACE) Program Incident Number: 15KY011 Release Date: February 15, 2016

Maintenance Technician is Struck by Crane, Falls 10 feet to Conveyor and Dies

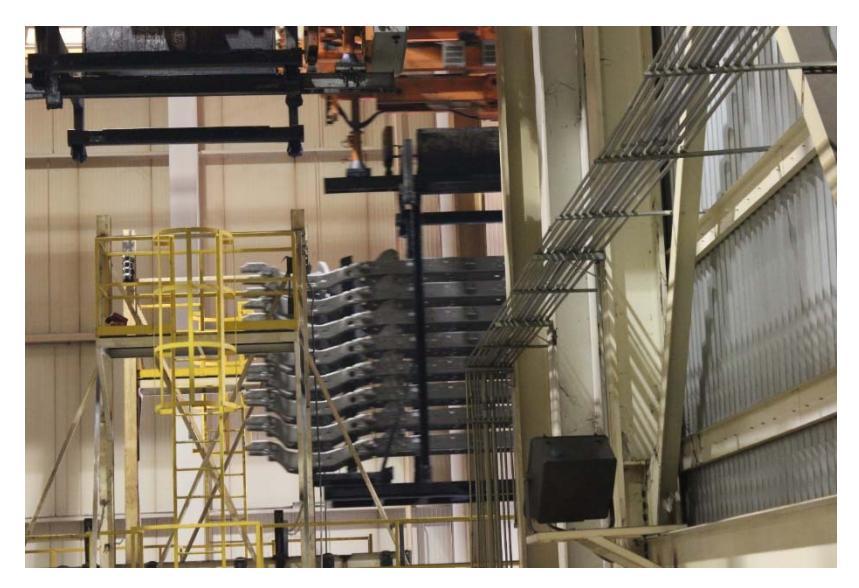
Figure 2. Crow's nest where the worker was standing.

The incident scene was inside a manufacturing facility, on an E-Coat conveyor system located 20 feet from the floor. The victim had been working from an upper level crow's nest which was located 10 feet above the conveyor system. A crane assembly system passed less than 6 ft above the crow's nest walking surface.

The catwalk along the upper conveyor system did not have end railings on the north end of the catwalk. OSHA regulation 29 CFR 1910.23 states that all walking-working surfaces must be guarded by standard railings on all exposed sides. Guard railings would prevent an employee from being exposed to a fall hazard.

Recommendation No. 3: Employers should ensure that all walk areas four feet or higher are guarded by railings on all sides.³

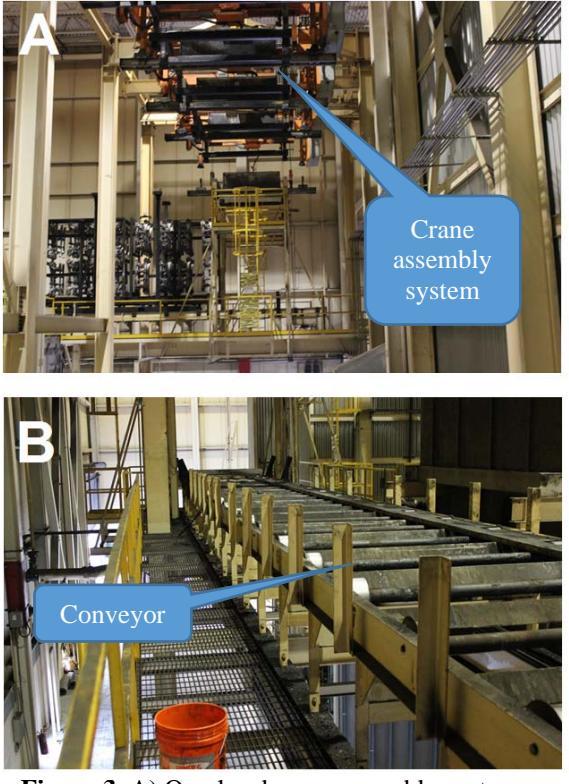
On Monday, January 26, 2015, a second shift maintenance technician climbed up the attached metal ladder to the crow's nest, that was situated 10 feet above a conveyor system (see figure 2). The conveyor system was located 20 feet above the ground level (see figure 3B). Just 6 feet above the crow's nest was a crane assembly system which had not been disengaged (see 3A). It was typical for the maintenance technicians to access this area more than four times per shift to clear jams in the production pathway or make repairs as needed. It is believed the victim was leaning over the railing of the crow's nest to change out a micro switch while holding onto the I-beam with his right hand (see figure 4A). While the victim worked on the switch, the overhead crane system which was still running came into contact with his right hand, causing him to lose his balance and fall 10 feet landing on the conveyor below (see figure 4B).

Figure 3. A) Overhead crane assembly system. B) Conveyor that was beneath the crow's nest.

Recommendation No. 1: Employers should ensure that employees are following lockout/ tag out policies at all times.¹

OSHA standard 29 CFR 1910.147 addresses the practices and procedures necessary to disable equipment or machinery, preventing the release of hazardous energy while employees perform maintenance work. By locking-out the equipment, there is no possibility of accidental engagement of equipment while maintenance activities are performed

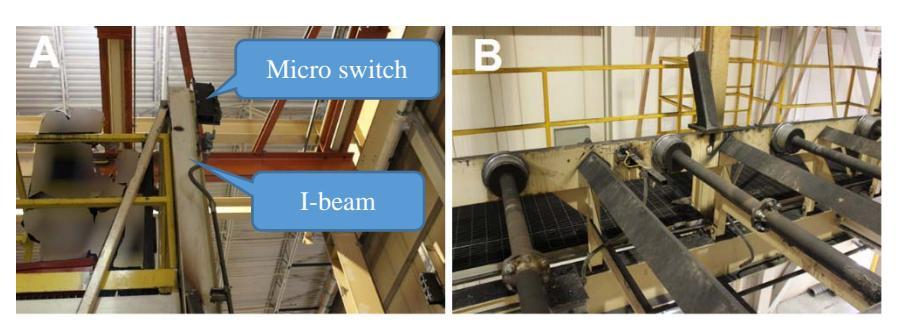
Figure 4. A) Micro switch being repaired and I-beam victim was holding on to. B) Area of conveyor belt where victim fell.

The investigation revealed the company had a written lock-out/tag-out program. During interviews with the maintenance technicians, they stated they never locked-out or tagged-out to perform the task the victim was performing. The standard procedure was to fix the jam or replace the part while the crane was operating. Occasionally a request was made to stop the crane and conveyor, but it was not locked-out or tagged-out.

Recommendation No. 2: Employers should ensure that fall protection is worn when working at heights on equipment.²
