REPORT#: 22KY096

Roofing Contractor Dies after Falling through Skylight

Kentucky FACE Program

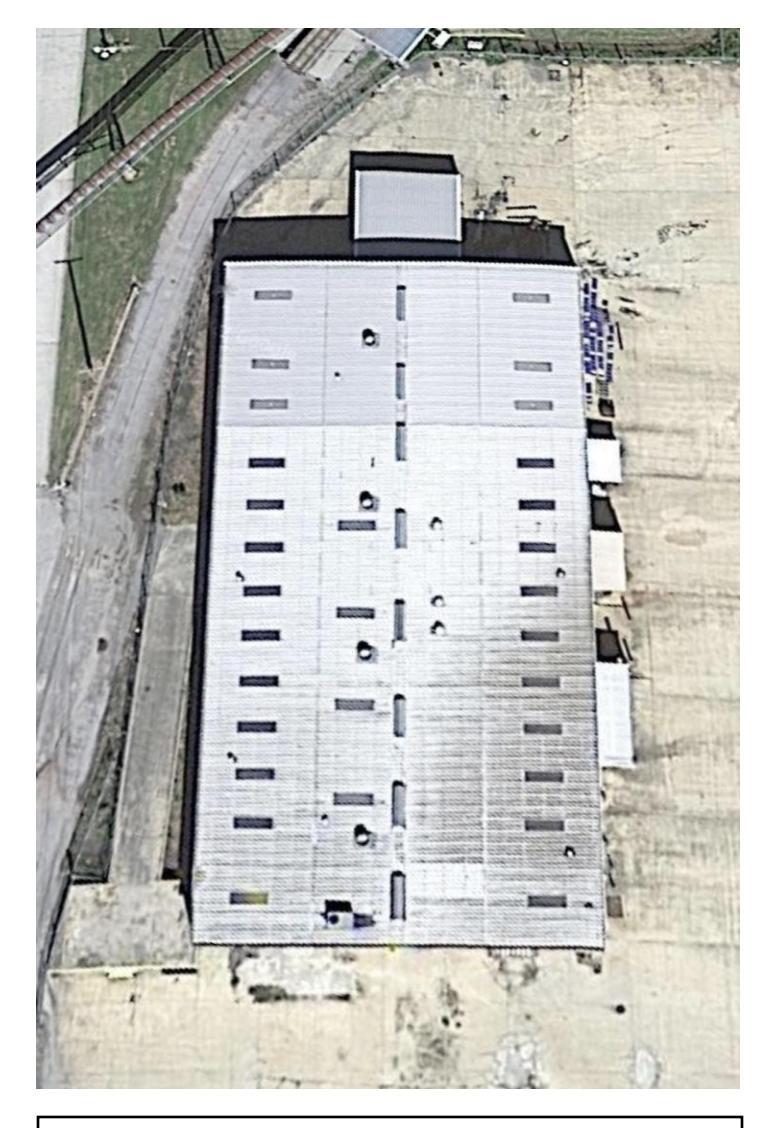
Photo 1. Google Earth image of building where the incident occurred.

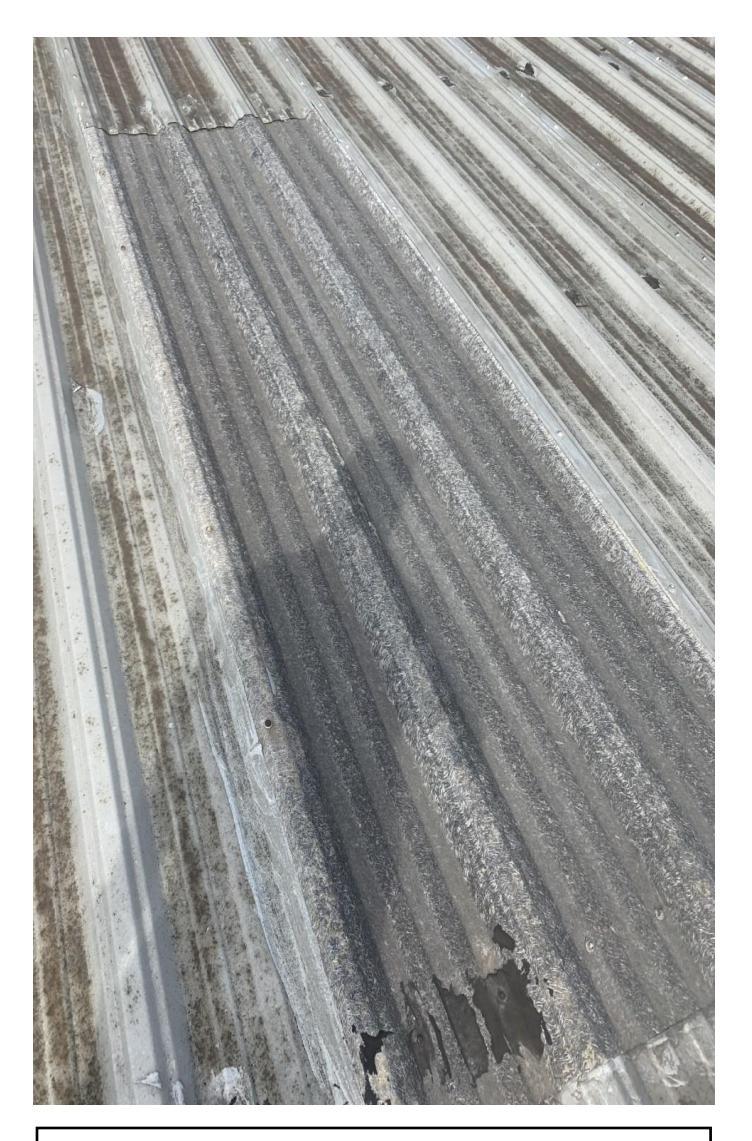
Photo 2. Photo showing 1 of 30 fiberglass skylights present on top of the building where the incident occurred (photo taken prior to incident).

Recommendation #2: Employers should guard skylights with railings or a skylight screen.

Discussion: The roof where the incident occurred was constructed of corrugated metal and contained a total of 30 fiberglass skylights. Originally, the plan was to cover the skylights with corrugated metal panels. However, matching panels could not be located due to the age of the roof. The decision was made to keep the fiberglass skylights in place and apply the rubberized coating around the skylights, keeping them exposed. Skylights present risk to workers, as they can often be difficult to differentiate from roof panels. OSHA standard 29 CFR 1926.501(b)(4)(ii) states that walking surfaces shall be protected from tripping on or stepping into or through holes, including skylights. Employers should guard skylights with railings (photo 6) or a skylight screen (photo 7) prior to performing work on roofs equipped with skylights. Skylight guarding provides employees with a physical barrier of protection from falling through skylights and serves as a visual aid by clearly identifying the location of the skylights.

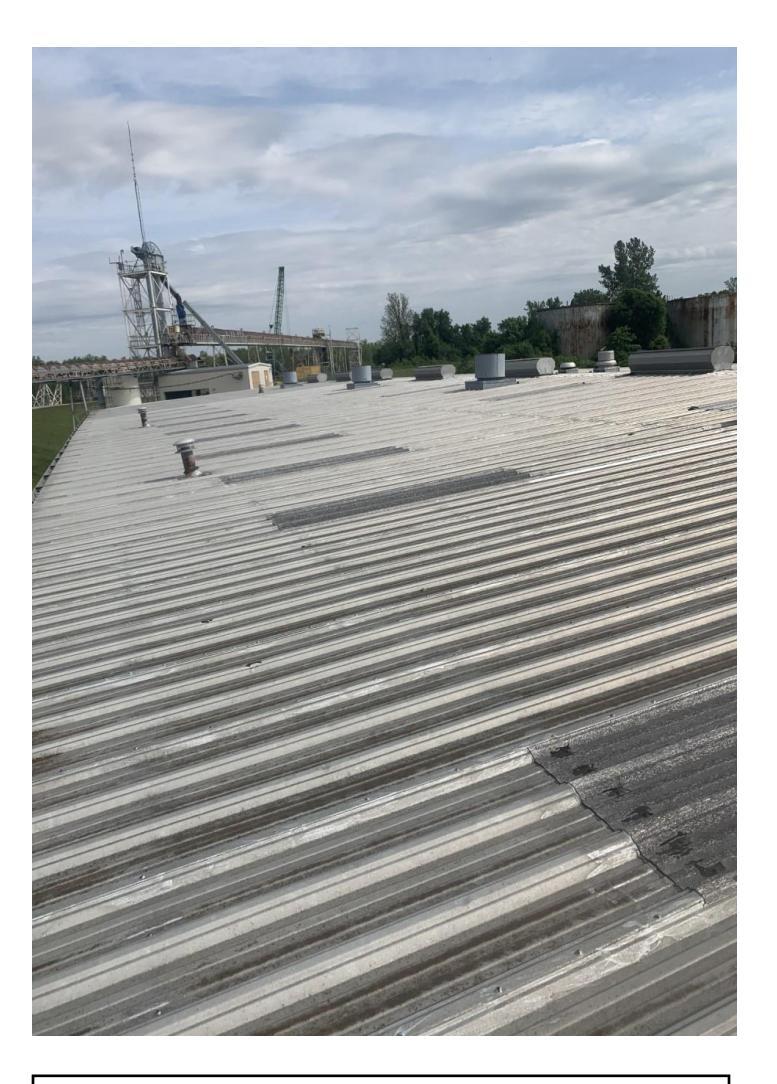
Photo 3. Photo showing fiberglass skylight arrangement and roof of the building where the incident occurred (photo taken prior to incident).

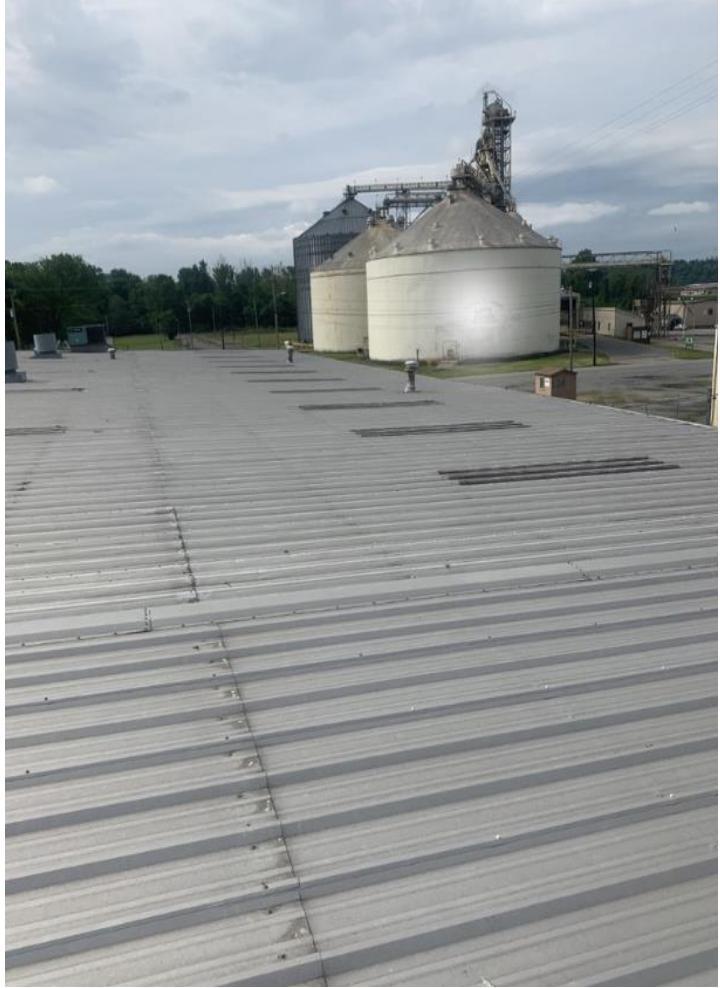
Photo 4. Photo showing fiberglass skylight arrangement and roof of the building where the incident occurred (photo taken prior to incident).

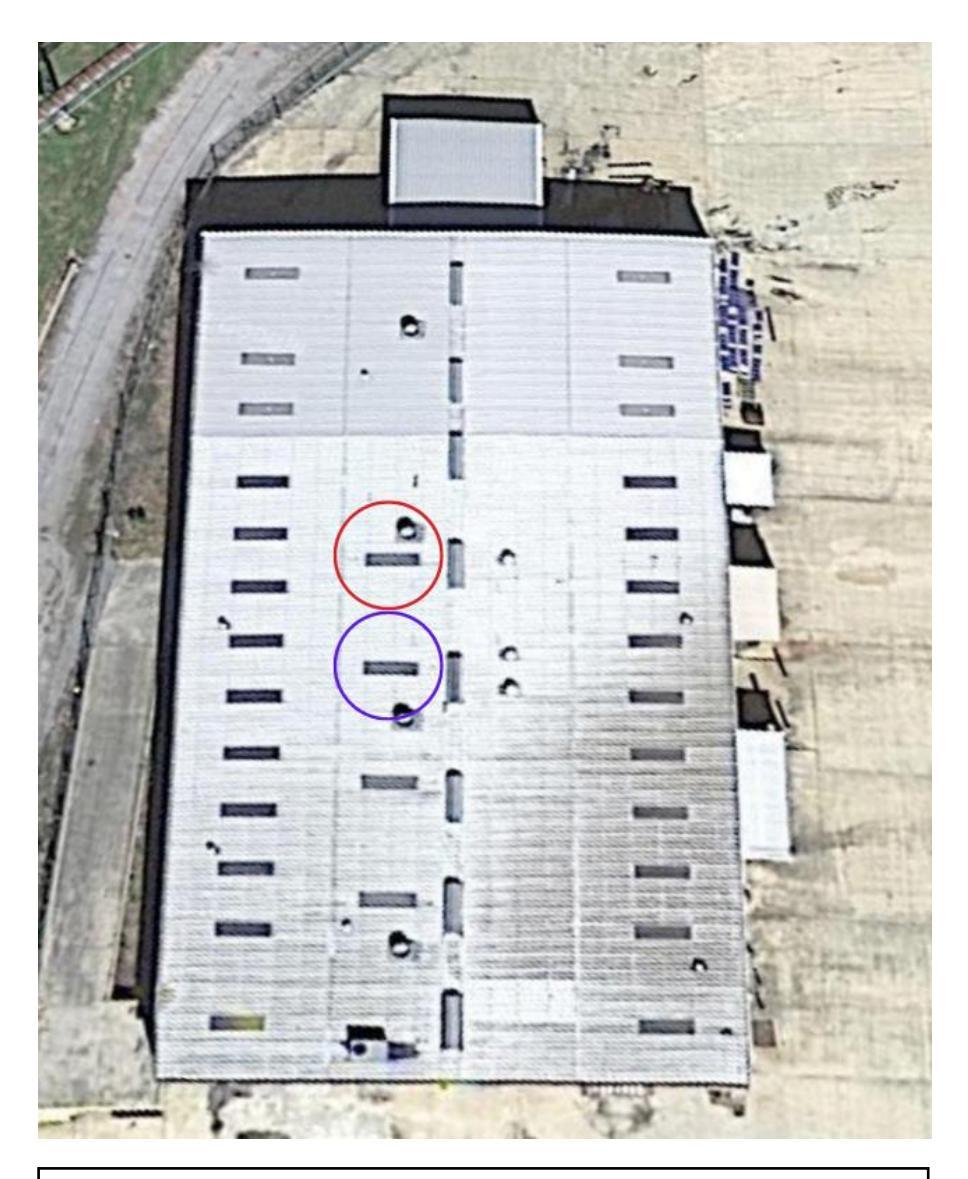
On November 11, 2022, the job foreman arrived on site at approximately 8:45 a.m. The foreman began set up and preparation for what was expected to be the last day of a 4-day commercial roof coating job. The coating was being applied to all surfaces of the roof except the fiberglass skylights; the skylights were left uncoated. At approximately 9:00 a.m., the part-time employee (victim) arrived at the job site to assist with the completion of the job. The rubberized coating is applied to the roof via a pneumatic sprayer. According to the foreman, the victim's primary job function was to manage the hose that fed the product to the sprayer, as the hose should not contact freshly applied product until it has had adequate time to properly cure. At approximately 9:15 a.m., the job foreman advanced to the roof with his hose and sprayer via a 28-foot aluminum extension ladder that was situated on top of a 3-foot concrete slab. The victim remained on the ground during the beginning stages of the application to verify the coating was properly flowing through the hose. The job foreman stated that he had expected the victim on the roof shortly after spraying began. At approximately 9:45 a.m., the foreman realized that the part-time employee (victim) was not present on the roof. The foreman stopped the application process to further investigate. As the foreman proceeded toward the ladder, he observed a breach in one of the roof's 30 fiberglass skylights. After closer examination, the foreman realized the victim had fallen 30 feet through the fiberglass skylight and landed face down on the concrete surface below. The foreman rushed to the victim's aid and placed a call to emergency services at 9:48 a.m. Local police and two ambulances were on scene at 9:55 a.m. EMS rendered aid, but attempts were unsuccessful; the victim was pronounced deceased at the scene by the local coroner.

Photo 5. Photo depicting the fiberglass skylights involved in each of the two incidents.

- **Red Circle** The skylight involved in the victim's incident.
- **Purple circle** The skylight involved in the non-employee family member's incident.

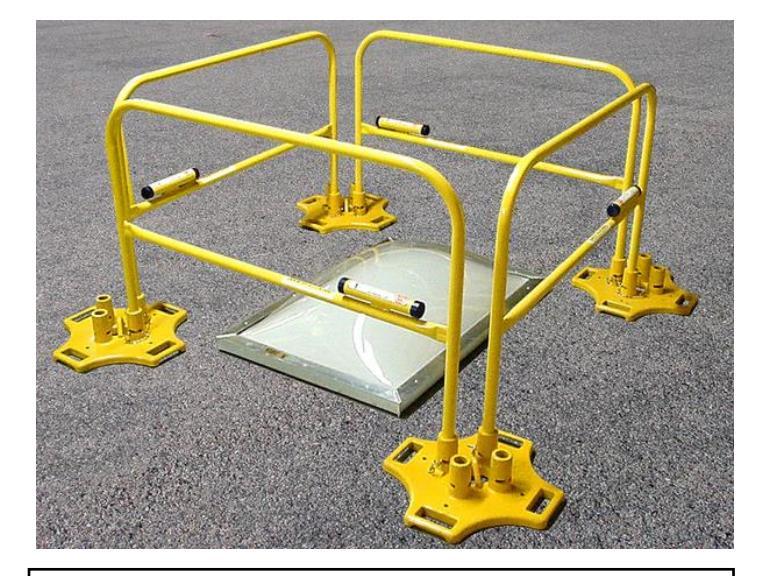
Photo 6. Photo depicting a skylight rail guarding system.⁶

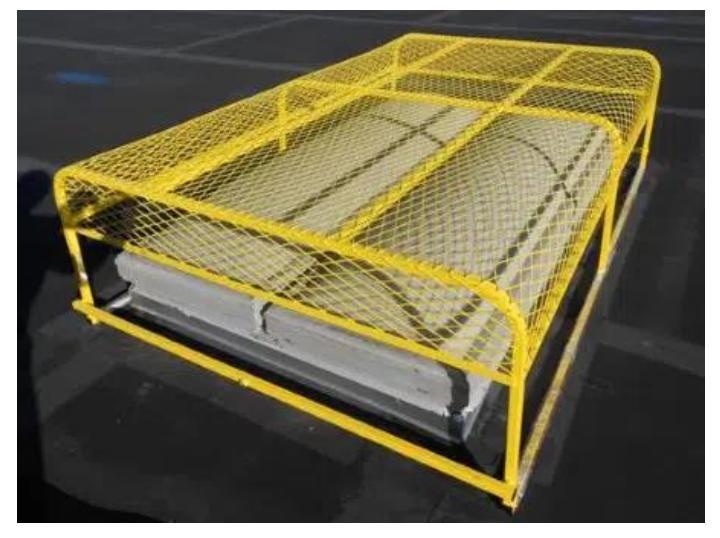
Photo 7. Photo depicting a skylight screen.⁷
