**REPORT#: 25KY055    REPORT DATE: 06/24/2026**

07/25/2025

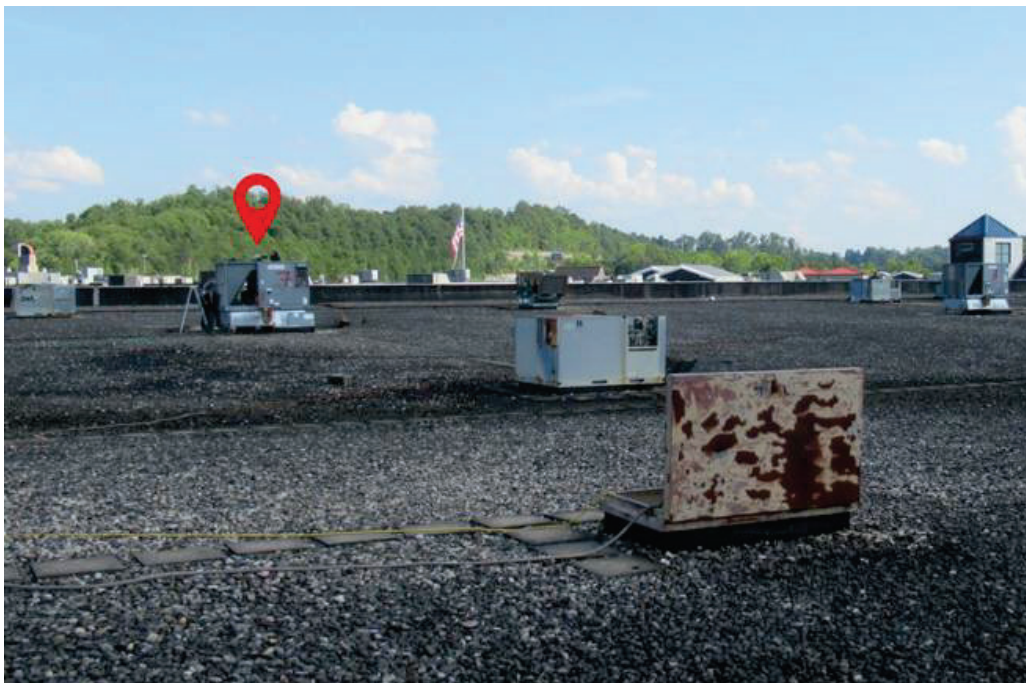
**Photo 3: Roof where the incident occurred. Red location marker identifies the HVAC system involved.** Photo obtained via open records request.

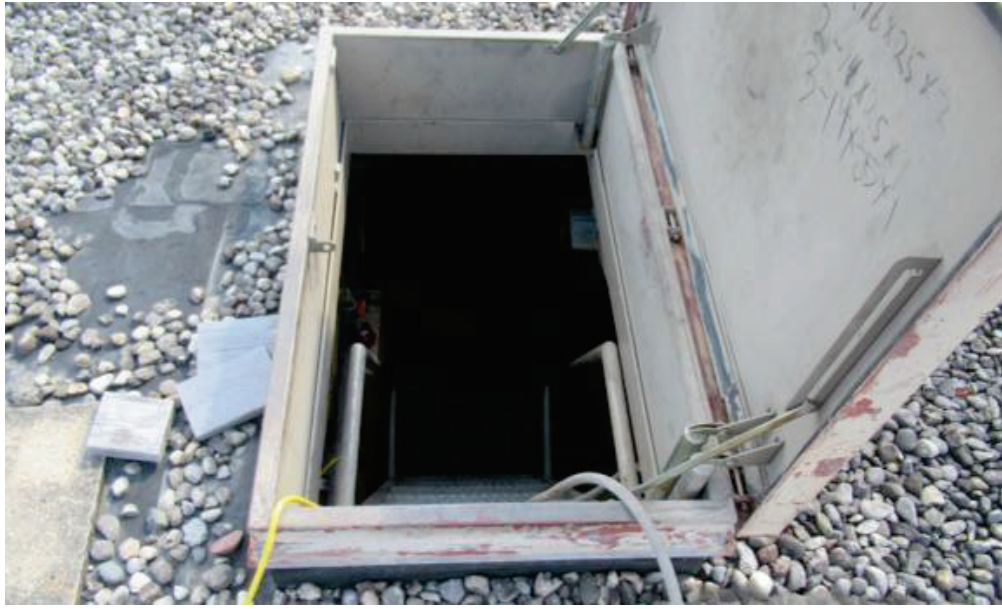
**Photo 4:** Roof access point utilized by the victim. Photo obtained via open records request.

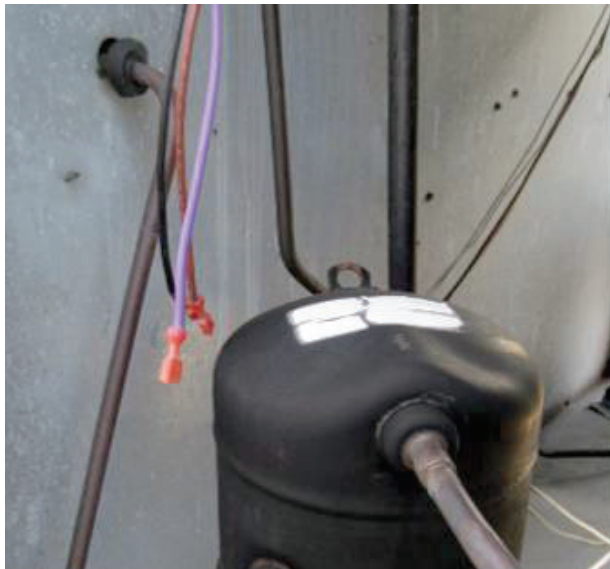
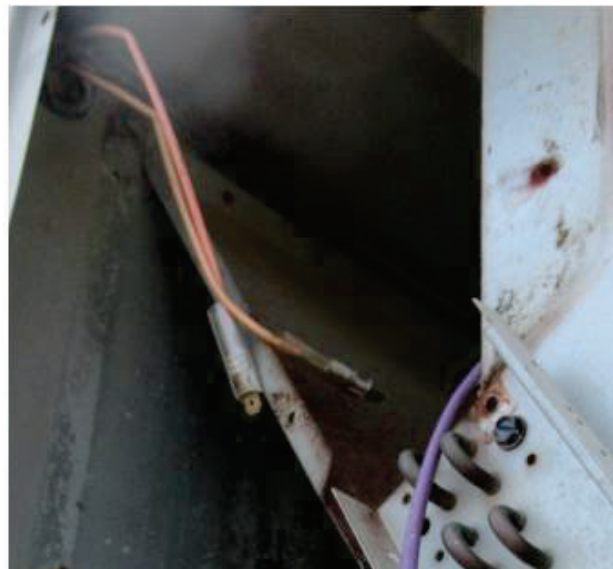
**Photos 5 & 6:** Loose wires described as "disturbed" per the coroner's report. The exact wire that delivered the electric shock is unknown. Photos obtained via open records request.

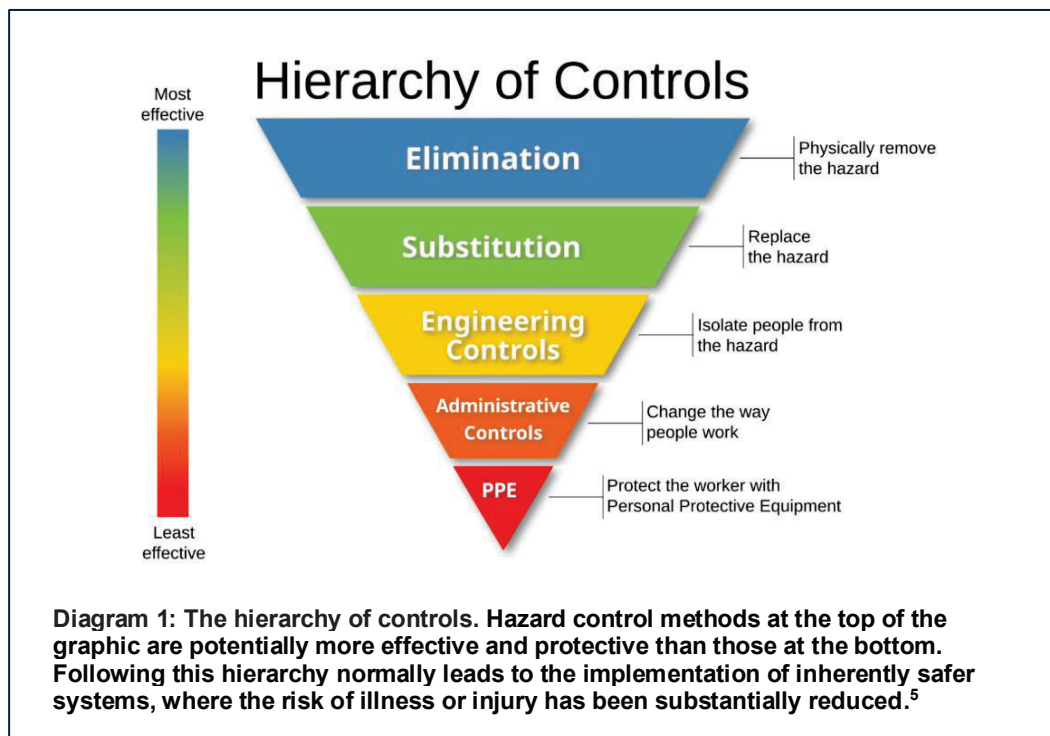
***Recommendation #4: Employers should eliminate lone work when possible, or manage associated hazards.***
