# Roofing Laborer Dies After 60-Foot Fall

Incident Number: 03KY097

## **Kentucky Fatality Assessment and Control Evaluation (FACE) Program**

**Subject:** Roofing Laborer Dies After 60-Foot Fall

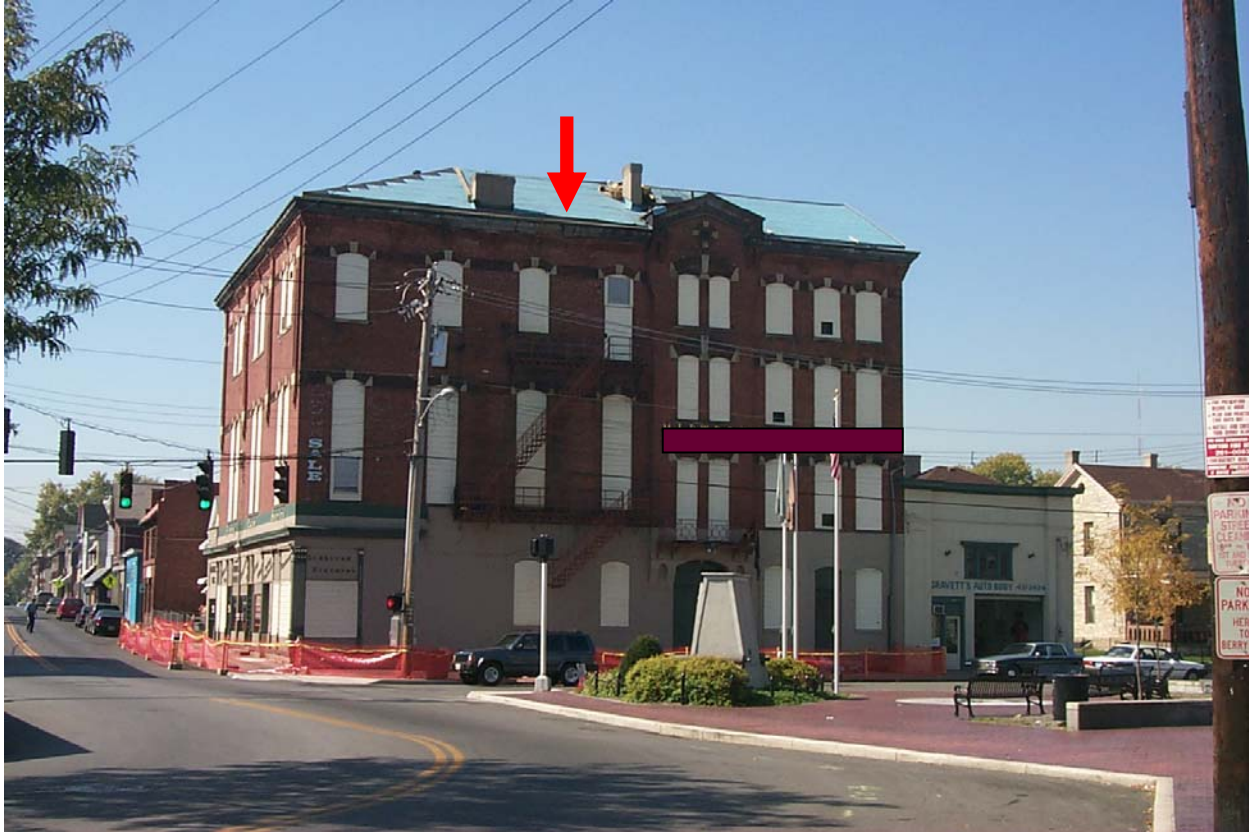
Building from which laborer fell. Red arrow indicates location of fall.

At 8:00 AM on the morning of October 7, 2003, a 33-year-old roofing laborer, was discarding his first bag of debris off a commercial building's roof when he slipped and fell 60 feet to the sidewalk below. There were 2 other laborers and the contractor at the work site that morning. It was the second work day at this particular job site and the three were to finish removing bags of debris from the roof as they had done the day before. The decedent and one of the laborers accessed the roof through the building, up stairs and various ladders to a five-step step-ladder which led to the roof opening. A safety harness and a safety belt, each with attached lanyards clipped to roof anchors, were located inside the roof access. Before entering the roof area, each laborer was to wear a personal fall protection system. After putting on the safety equipment, the laborers could then access the roof safely. It was suspected that there was dew on the roof. It is unknown if either man was wearing anti-skid shoes or gloves. A third laborer was sitting in the cab of the pick-up truck parked on the sidewalk parallel to the building. The contractor was standing on the sidewalk by the truck waiting for the two laborers on the roof to throw down bags of debris into the bed of the pick-up truck.

As the laborers approached the roof access, Laborer No. 1 dressed in the safety harness and accessed the roof. Laborer No. 2, the decedent, accessed the roof without dressing in the safety belt. Laborer No. 1 did not see Laborer No. 2 climb past the safety belt without putting it on and access the roof. Without it, Laborer No. 2 grabbed a bag of trash and began walking toward the edge of the roof when he slipped and fell 60 feet to the sidewalk below. Laborer No. 1 did not see Laborer No. 2 fall, but heard him falling off the roof. After the laborer fell, the owner and other laborer on the ground went to him, assessed the situation and called emergency services who arrived on the scene within minutes. Several people observed the laborer fall from the roof. One witness also called emergency services. Emergency personnel arrived and contacted the coroner who declared the victim dead at the scene.

Recommendation No. 4: Employers should have a site specific fall protection plan written by a qualified person.

A hazard assessment of each job site should be performed each day before work commences. The identified hazards and safe work practices should be examined and discussed with all affected employees. It is thought that there may have been dew on the roof and appropriate precautions should have been taken (i.e.: anti-skid shoes in addition to the appropriate personal fall arrest system).

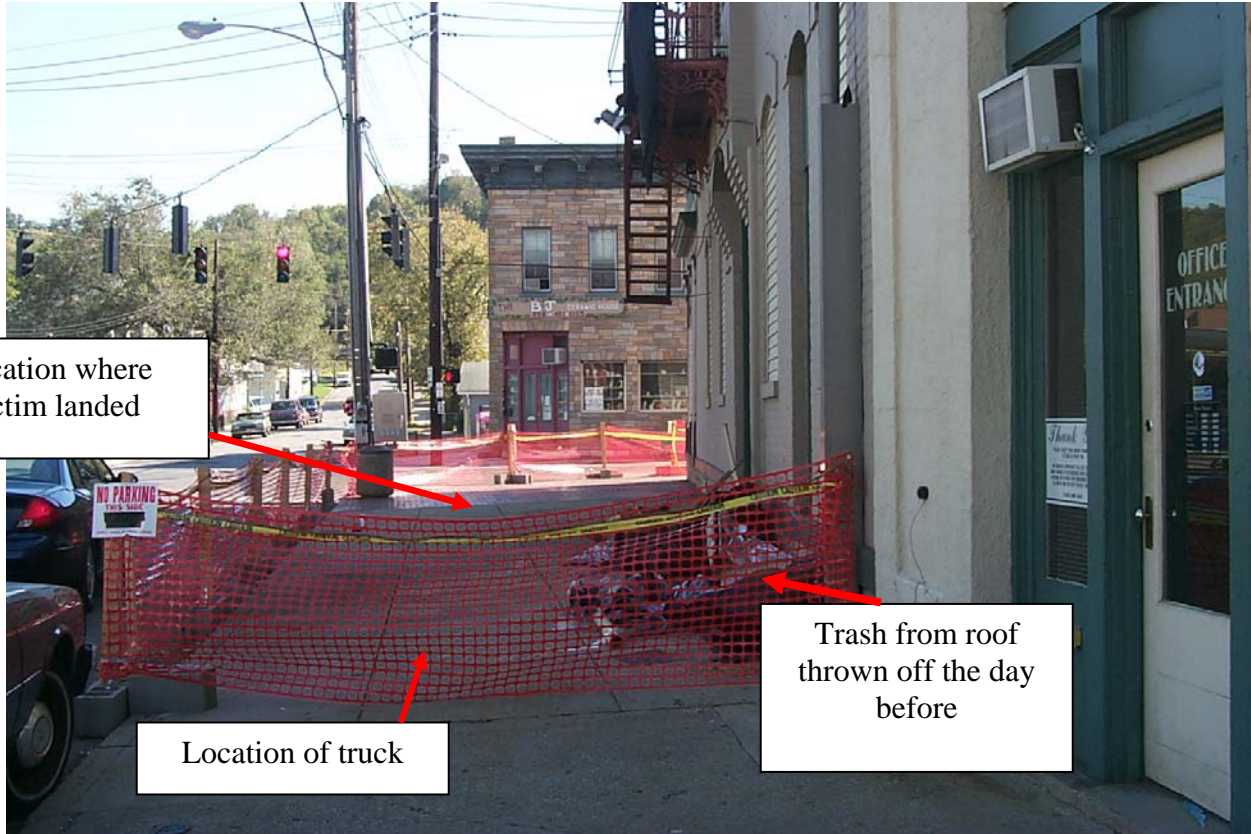
Location where  
victim landed

Location of truck

Trash from roof  
thrown off the day  
before
