Horse Farm Owner Dies When Pinned Under Golf Cart Incident Number: 04KY060

Incident Number: 04KY060
Incident Date: January 31, 2004
Release Date: June 2, 2005
Subject: Horse Farm Owner Dies When Pinned Under Golf Cart

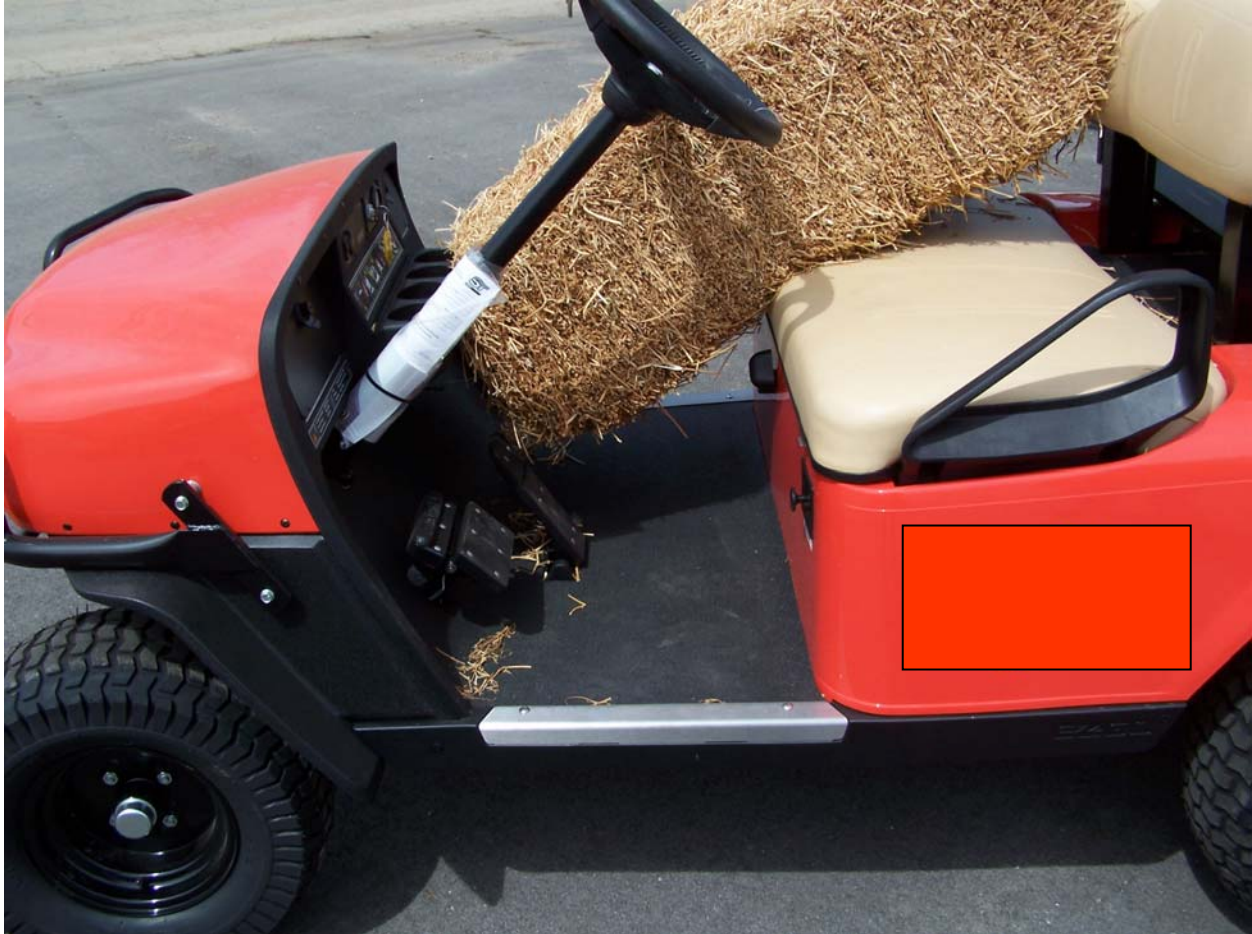
An example of a cart and hay bale similar to the hay bale configuration which pinned the farm owner.

Golf carts are equipped with a "kill" switch in the gas pedal. A "kill" switch allows the ignition switch to be in the "on" position, but the cart will not move until the gas pedal is depressed. Depressing the gas pedal is similar to shifting a car into "drive". Relieving pressure on the gas pedal of a cart acts like applying the brake in a passenger car. Leaving the ignition switch of a golf cart in the "on" position allows the driver to start and stop the cart simply by depressing or releasing the pedal. According to several golf pros and a golf cart dealer, it is common practice for golf cart users to step out of a golf cart and leave the ignition switch in the "on" position. This practice allows a quick start when the driver is ready to resume operating the cart so the operator can skip the step of turning the ignition switch to the "on" and "off" positions. In this incident, if the ignition switch had been in the "off" position, the hay bale would have fallen onto the gas pedal but not activated the cart into forward motion.

Golf cart seats are designed for human use with a lot of leg room between the seat and the front of the cart. According to a golf cart vendor, it is not uncommon for dogs or objects on the passenger side to slip off the seat and depress the gas pedal. A dog climbing into or out of a cart could easily depress the pedal and if the ignition switch is in the "on" position, cause the cart to move. Likewise, objects such as square hay bales left unattended on the seat can slip off the seat onto the floor board and depress on the gas pedal, exposing anyone in the vicinity to serious injury.

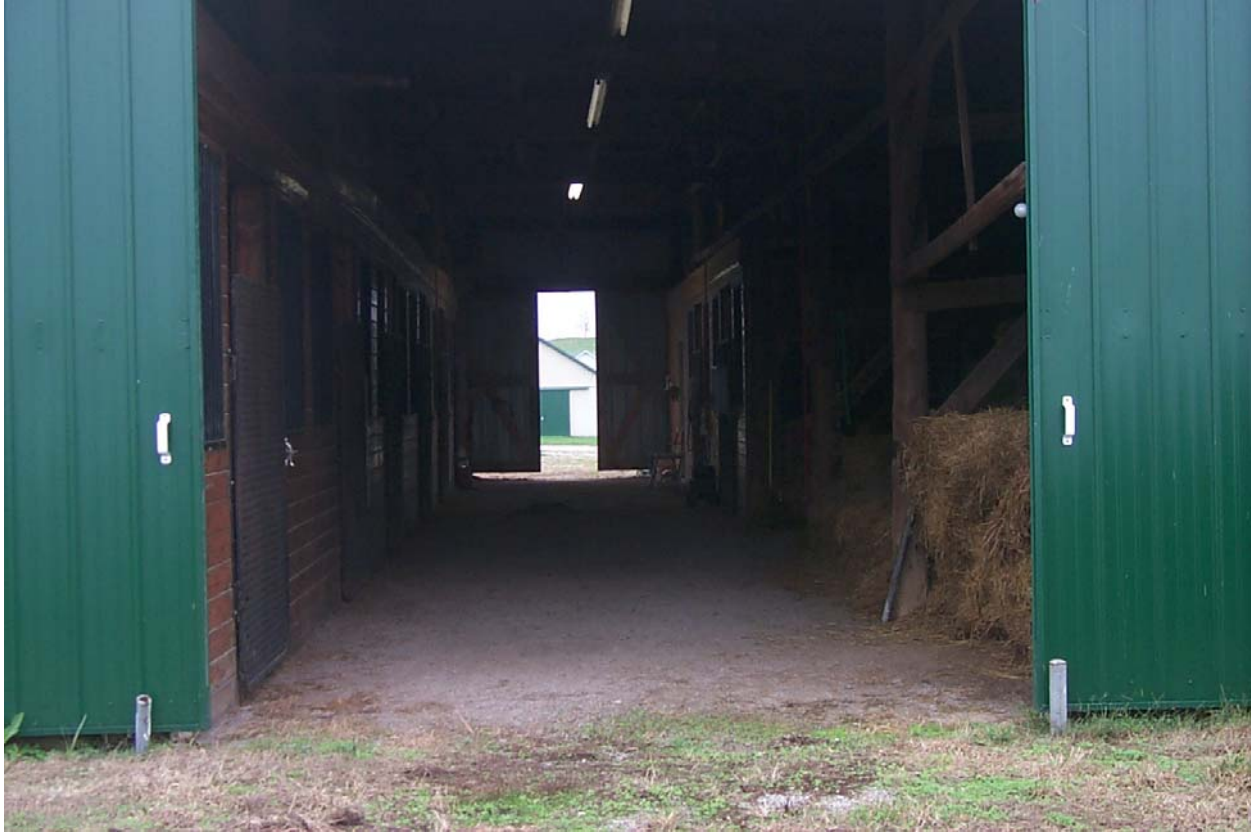
Photo of barn where incident occurred. Both sets of doors were closed at the time of the incident.
