Emergency Roadside Technician Dies When Struck by a Single-Unit Truck on an Interstate Shoulder

Incident Number: 05KY001

Kentucky Fatality Assessment and Control Evaluation (FACE) Program
Incident Number: 05KY001
Release Date: August 3, 2007
**Subject: Emergency Roadside Technician Dies When Struck by
a Single-Unit Truck on an Interstate Shoulder**

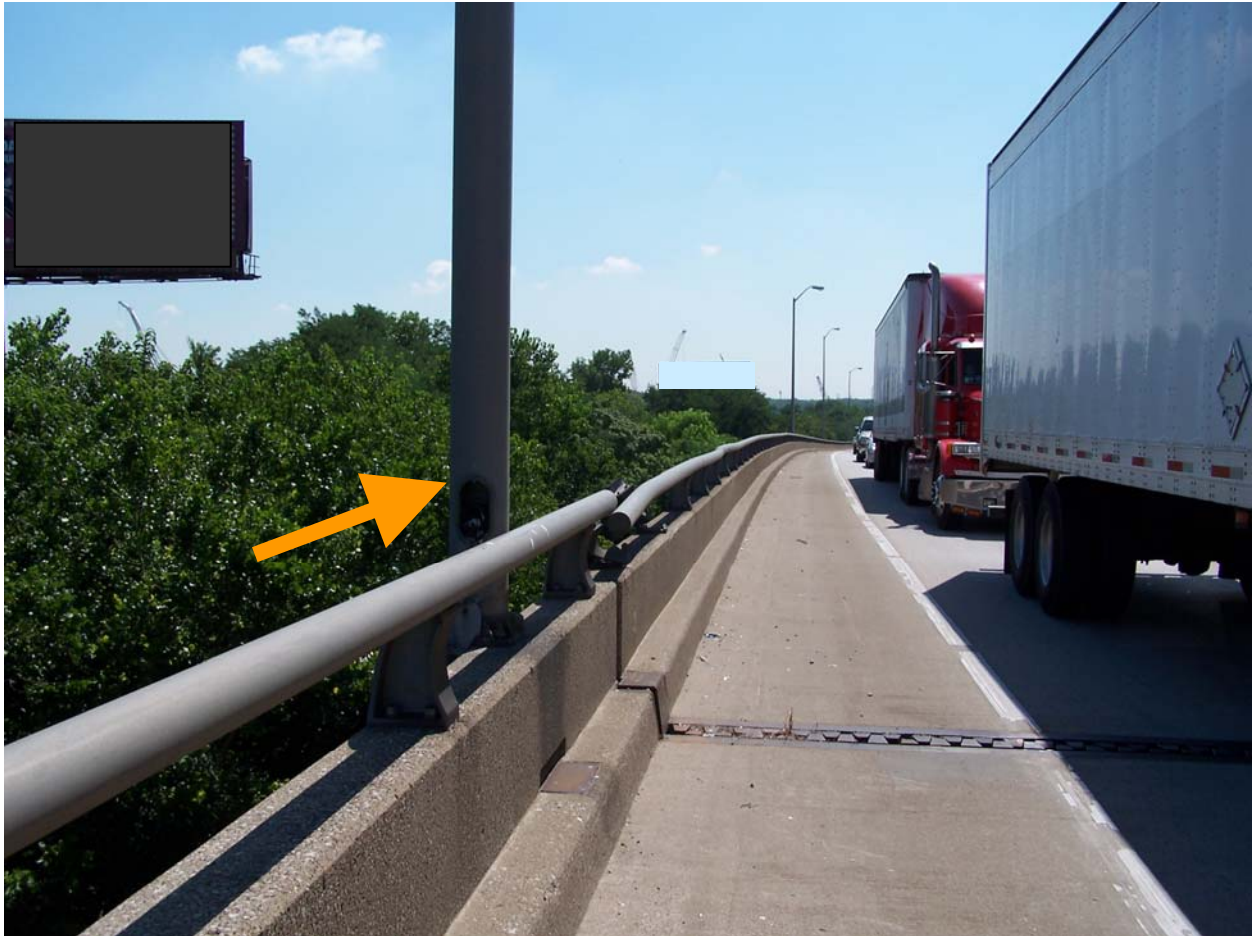
Location on bridge where responder attempted to avoid semi.

Discussion: According to a company representative, ERTs, when working on busy roadways, were trained to exit vehicles away from traffic and to walk as far away from traffic as possible. In this instance, the ERT had exited from the vehicle on the driver's side and was walking to the police cruiser for consultation regarding the situation. The driver should then have approached the hazardous scene by walking along the outside of the shoulder. This would have created a longer safe zone for responders to work in.

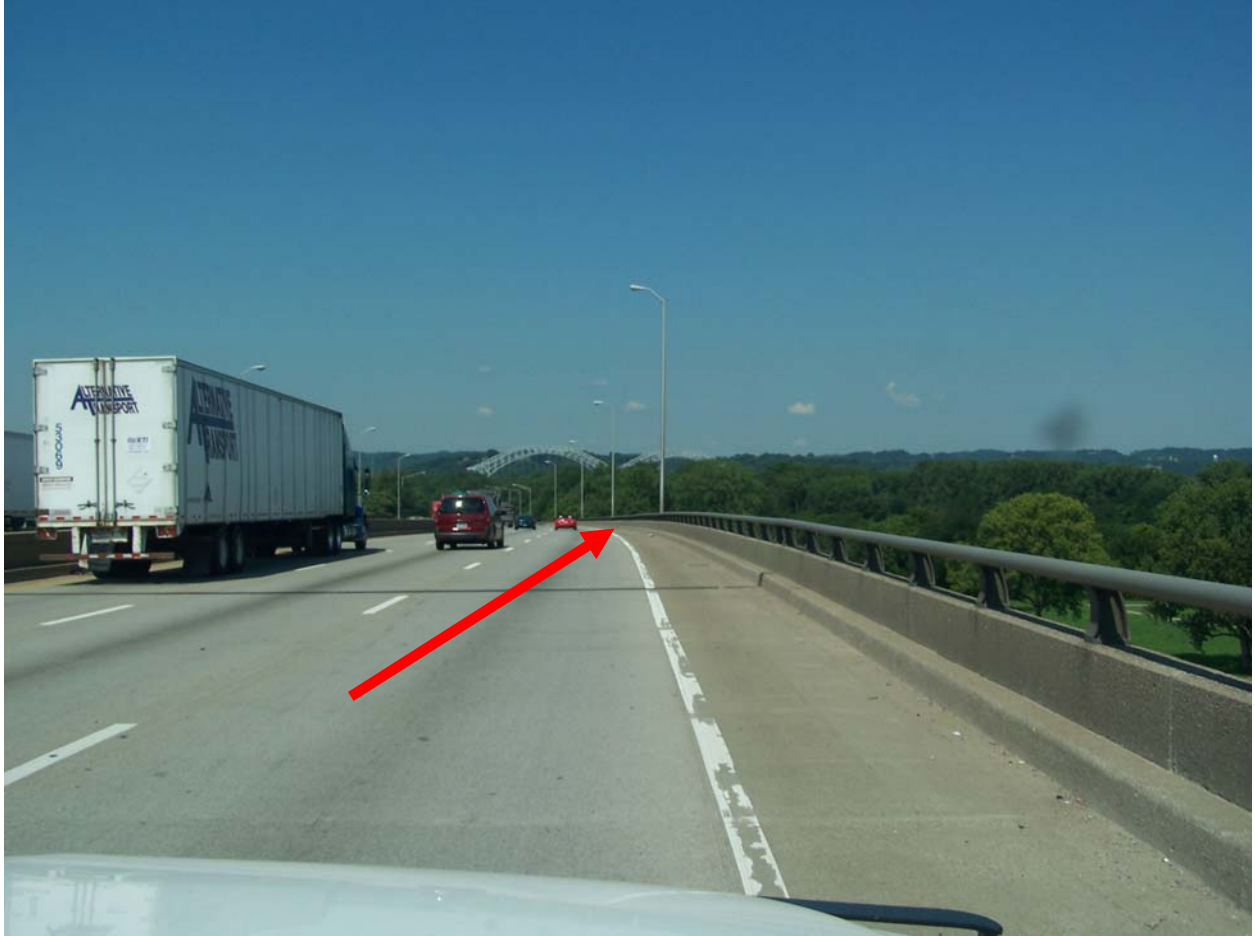
Location where semi parked on shoulder.
