Male Semi-Truck Driver Killed In Rollover Crash On County Road

Incident Number: 05KY008

Kentucky Fatality Assessment and Control Evaluation (FACE) Program
Incident Number: 05KY008
Release Date: February 15, 2008
Subject: Male Semi-Truck Driver Killed In Rollover Crash
On County Road

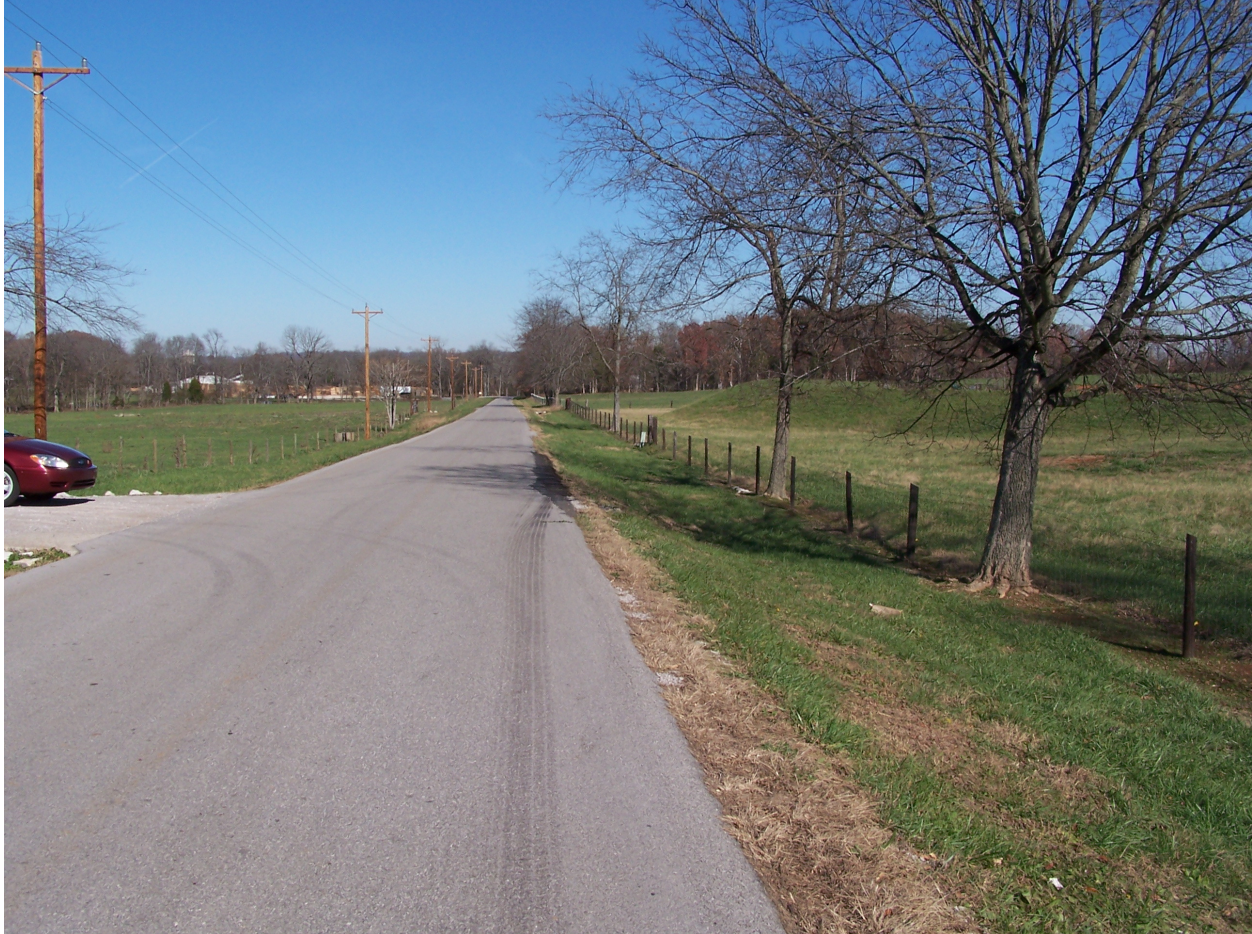
Photograph of county road where a semi-tractor trailer left the pavement and turned over. Grade is steeper than it appears in this photo.

After traveling for approximately one mile, the tires on the right side of the trailer dropped off the pavement. The roadway was straight and did not have paved shoulders on either side. Instead, the ground dropped off at a steep slope and according to the police report, was saturated with water. There was evidence that the driver attempted to correct the trailer and return it to the pavement but could not due to the saturated ground and the weight of the lumber. The tractor trailer struck a tree then overturned onto a fence. There were no witnesses to the crash.

Recommendation No. 5: County roadways in Kentucky should be designed and constructed with an adequate shoulder area, or have guardrails that will deter commercial vehicle drivers from leaving the roadway.

The roadway involved in this incident was an old railroad bed turned into a county road which had been gravel until the county upgraded the surface to asphalt. It was 18 feet wide. Sections of the roadway's edge met with level ground. However, there was a steep embankment by the edge of the roadway where this incident occurred. This made it difficult for the driver to correct the semi-tractor trailer when the right tires slipped off the pavement. A guardrail or a few feet of shoulder may have helped the driver recover the errant vehicle.

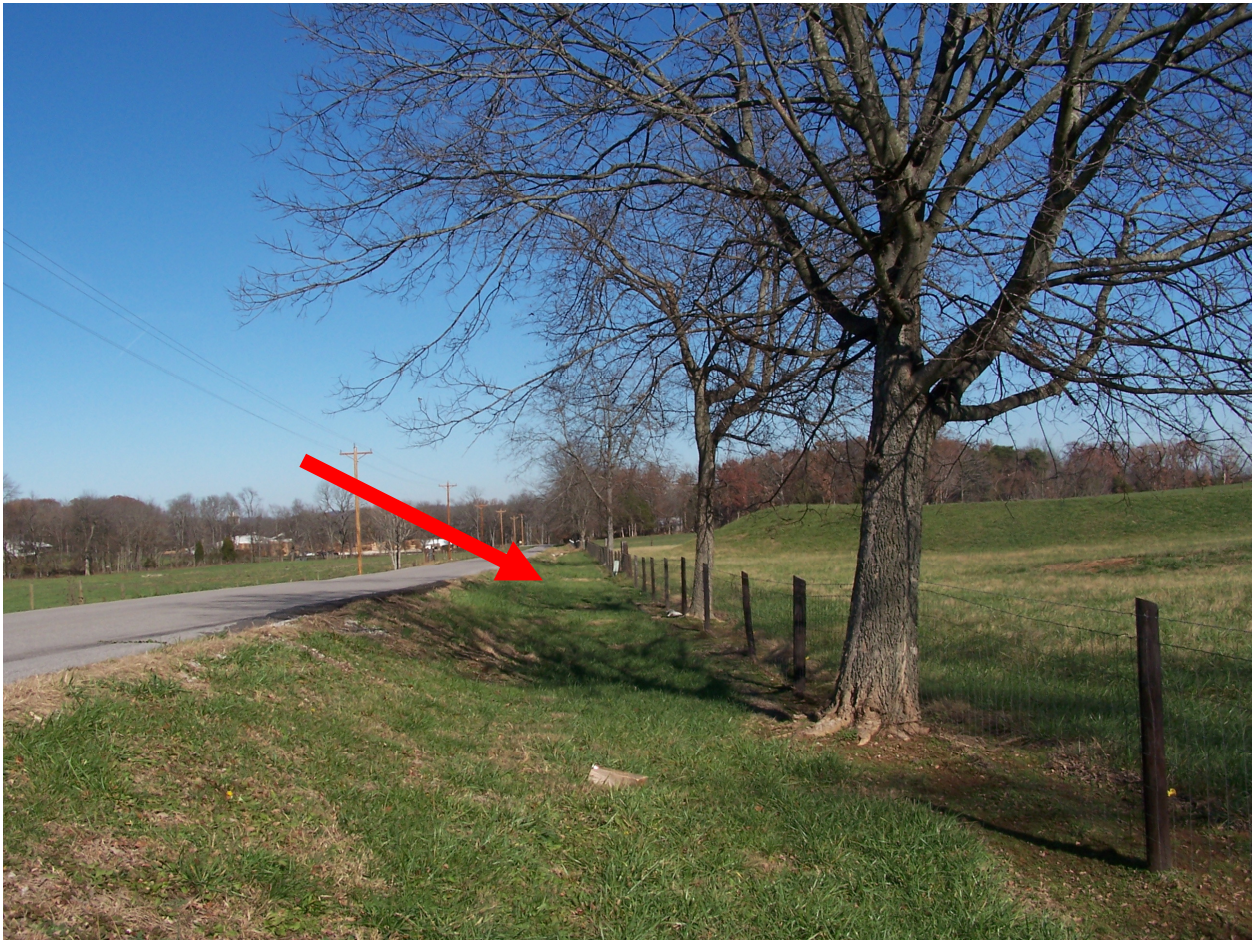
Red arrow shows the approximate location where the semi-tractor trailer went off the roadway and overturned.
