# Passenger Dies When Semi-Truck Trailer Hits Cow In Roadway

Incident Number: 05KY089

## **Kentucky Fatality Assessment and Control Evaluation (FACE) Program**

**Subject: Passenger Dies When Semi-Tractor Trailer Hits Cow In Roadway**

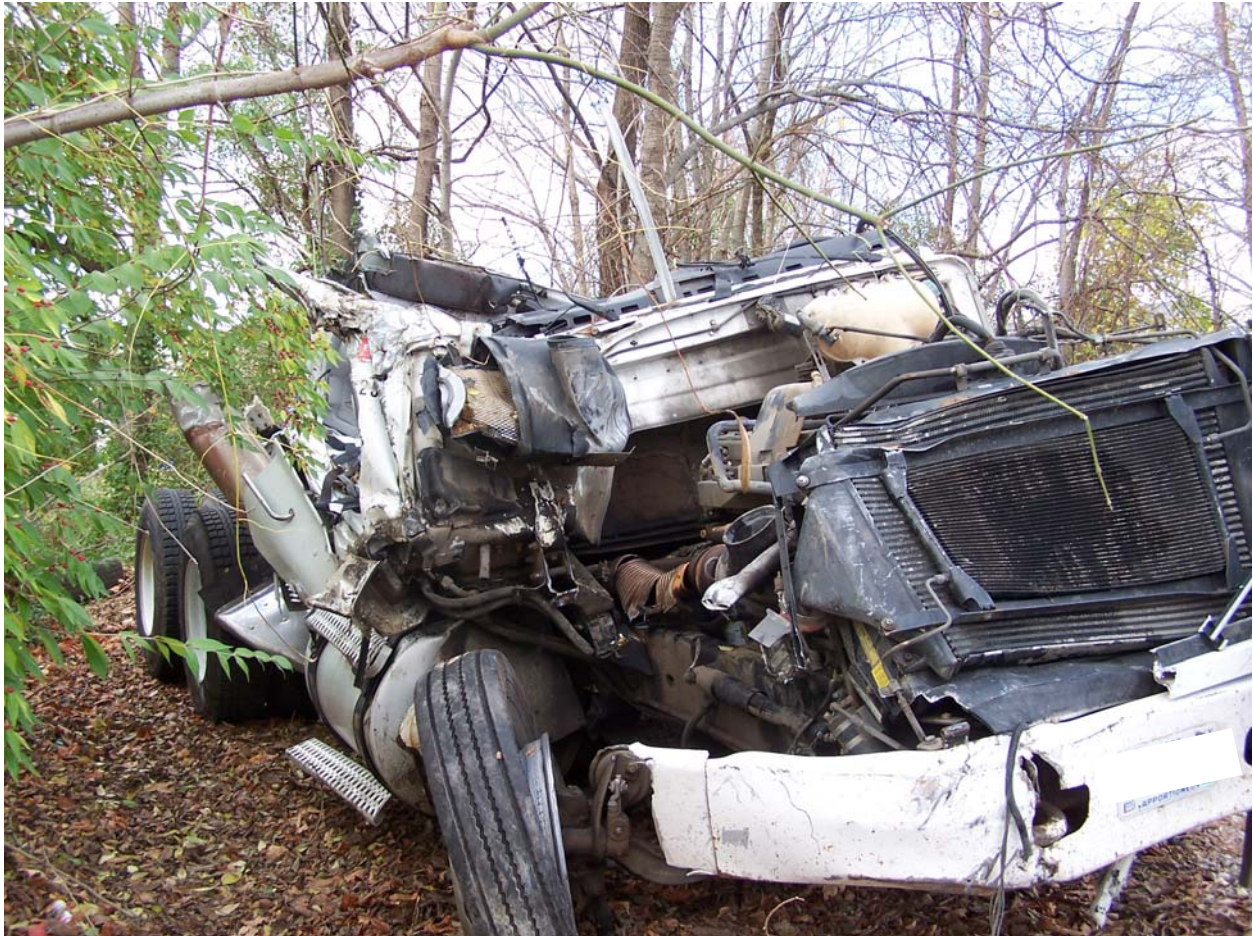
Tractor-trailer cab involved in fatal crash. Cab was cut away with torches so EMS personnel could reach occupants and administer aid.

Emergency services arrived at 5:22 AM to find the cab of the semi-tractor trailer had broken through the guardrail and was resting on the steep slope of the parkway shoulder. Emergency personnel observed both occupants wearing their seat belts and both men were thought to be alive. Due to the steepness of the slope and the condition of the cab, emergency personnel were not able to administer first aid to either of the two men. A wrecker was called to the scene to move the trailers and pull the semi-tractor trailer cab up onto the pavement of the parkway. Torches were used to cut away the metal of the cab. Once emergency crew members reached the men, they cut away each man's seatbelt and removed the men from the cab. The driver was alive, but the passenger had died. An ambulance transported the driver to the nearest hospital, arriving at 8:02 AM. The local coroner was summoned to the scene and upon arrival, declared the passenger dead. It took five hours after the incident to clear the eastbound lanes of the parkway and open it for traffic.

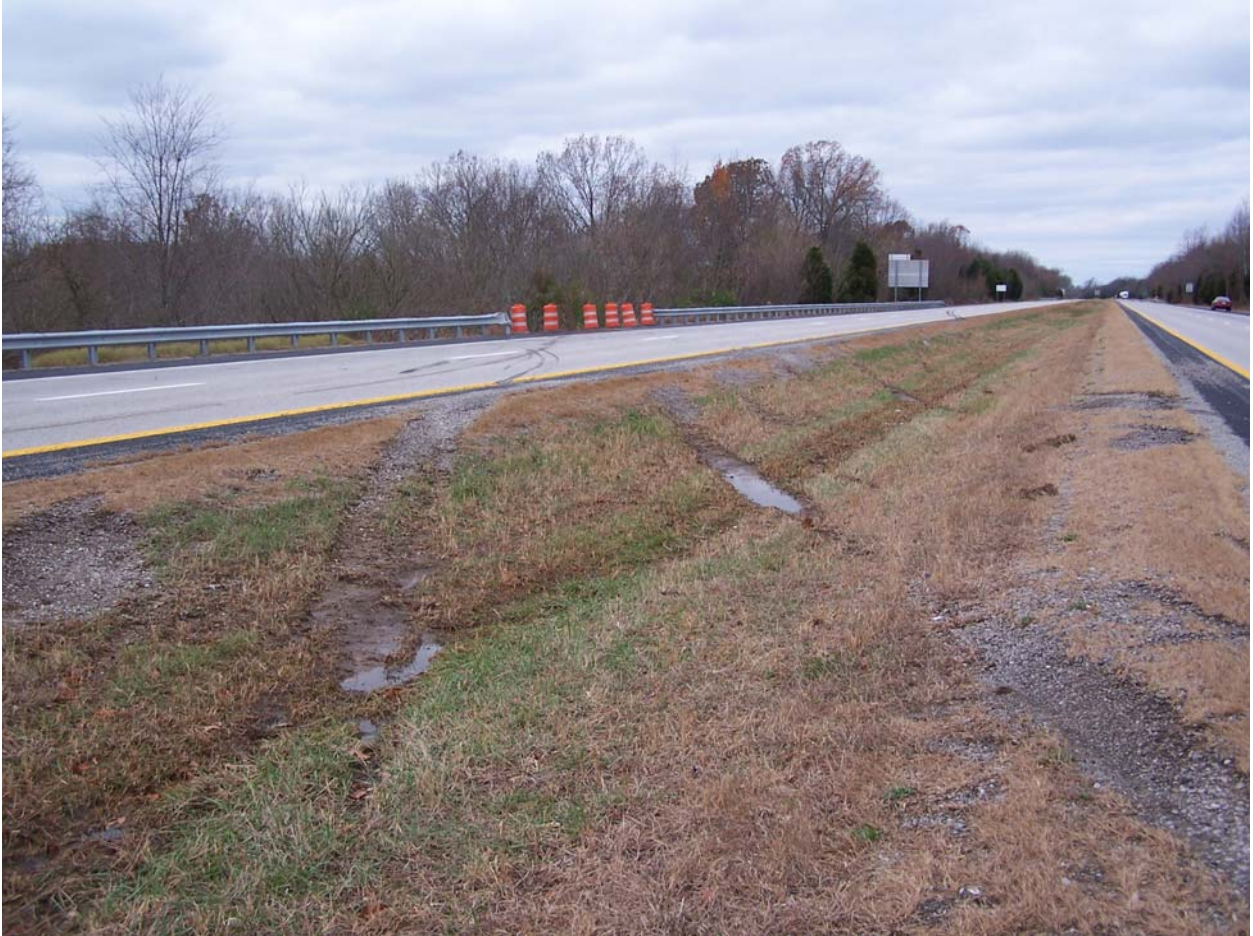
Tire marks from semi-tractor and two trailers crossing parkway median after collision with a cow.

At 4:15 AM the two-man team pulled away from the warehouse and began the westbound drive on a parkway to a city 90 miles away. They would be on the same parkway at about the same time as two other company semi-tractor drivers; one semi-truck (also westbound) left 30 minutes before the two man team and was ahead of them on the parkway, while the other semi-truck (eastbound) was returning to the central warehouse from making deliveries in another state. The two-man team was to make deliveries to customers' homes and a warehouse location then return to the central warehouse later that day. At approximately 5:15 AM, the semi-truck was 56 miles from the home warehouse, traveling west on a hilly, four-lane divided parkway. It was still dark. The driver was in the right hand lane on a flat stretch of road when he suddenly noticed a red cow in his lane of the parkway. He tried to avoid hitting the animal by braking and swerving to the left. The front of the semi-tractor hit the cow and the two trailers jackknifed. The semi-tractor and both trailers went across the median, and flipped onto their right sides. They slid across the two eastbound lanes pushing the cab front-end first through the guardrail along the outside lane. The cab came to rest on a steep slope of the embankment and the two trailers laid across the two eastbound lanes. The top of the semi-tractor was crushed down into the cab. At 5:18 AM a passing motorist called emergency services and informed them a semi-tractor trailer had hit a cow and slid across the median. A cargo van traveling east did not see the trailers laid across the eastbound lanes until it was too late. He swerved to avoid hitting the trailers, however, he sideswiped the rear trailer then came to a rest in the median of the parkway. The driver of the cargo truck was not physically injured.

Recommendation No. 4: Parkway medians should be designed and constructed with median barriers to deter crossover median crashes.

Parkway medians are designed and constructed to drain water away from road surfaces, give errant drivers space to regain control of their vehicles, provide space for emergencies, and help prevent crossover median crashes. Crossover median crashes result in higher fatality rates than non-crossover crashes (Federal Highway Administration). To help prevent crossover median crashes, installation of barriers in medians less than 60 feet wide should be considered. The median in this incident was 30 to 40 feet wide. Use of continuous, cast-in-place concrete median barriers that are at least 42 inches tall should be considered in parkway medians that are less than 60 feet in width. Also, according to the Federal Highway Administration, this type of barrier is able to contain large trucks and help prevent median crossover crashes of large, heavy semi-tractor trailers.

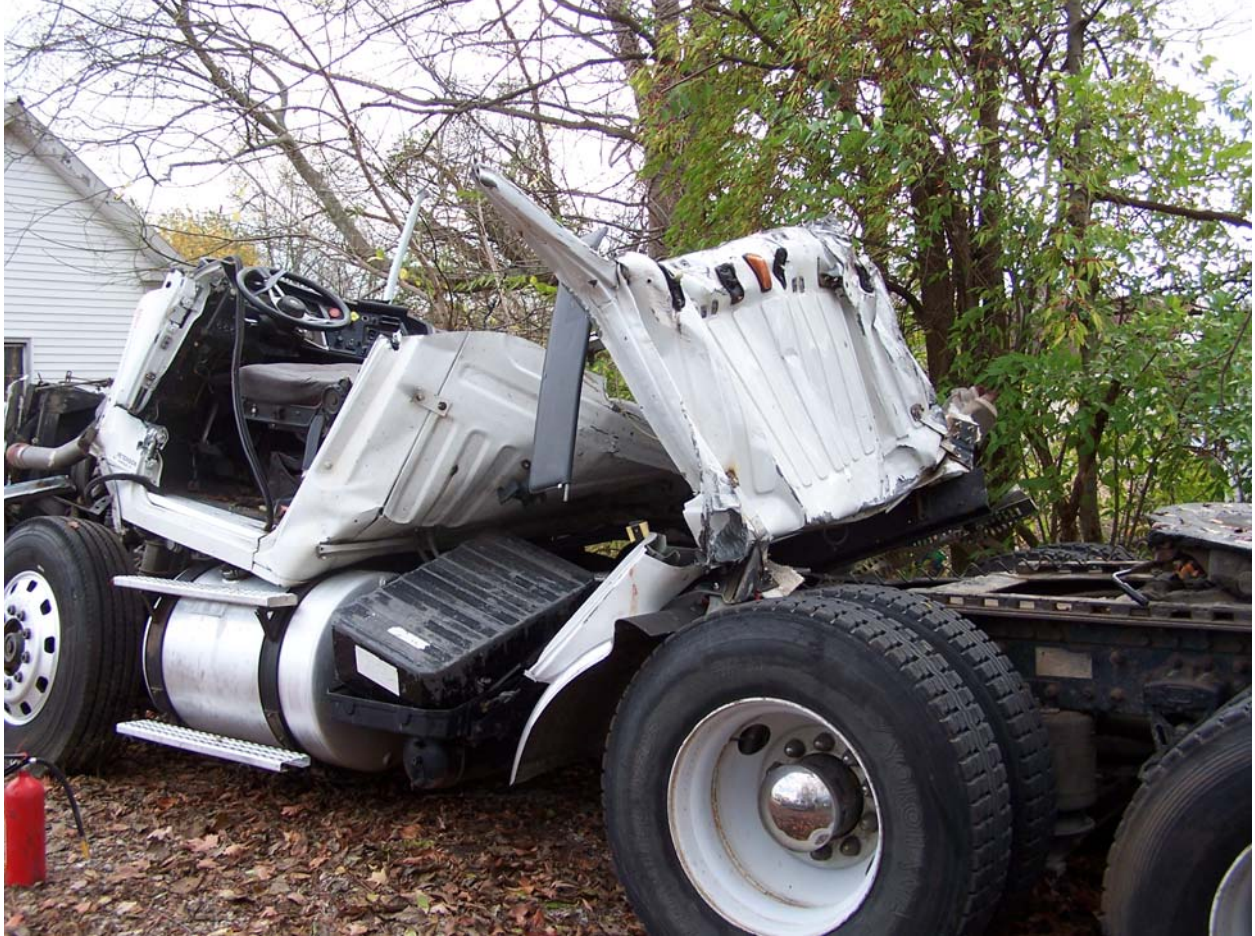
Cab of semi-tractor at towing company after collision. Top of cab was cut away with torches. Seat belts were cut to free both occupants.
