Coal Truck Driver Dies in Rollover After Tire on Trailer Fails

Incident Number: 06KY100

Kentucky Fatality Assessment and Control Evaluation (FACE) Program
Incident Number: 06KY100
Release Date: May 12, 2009
Subject: Coal Truck Driver Dies in Rollover After Tire on Trailer Fails

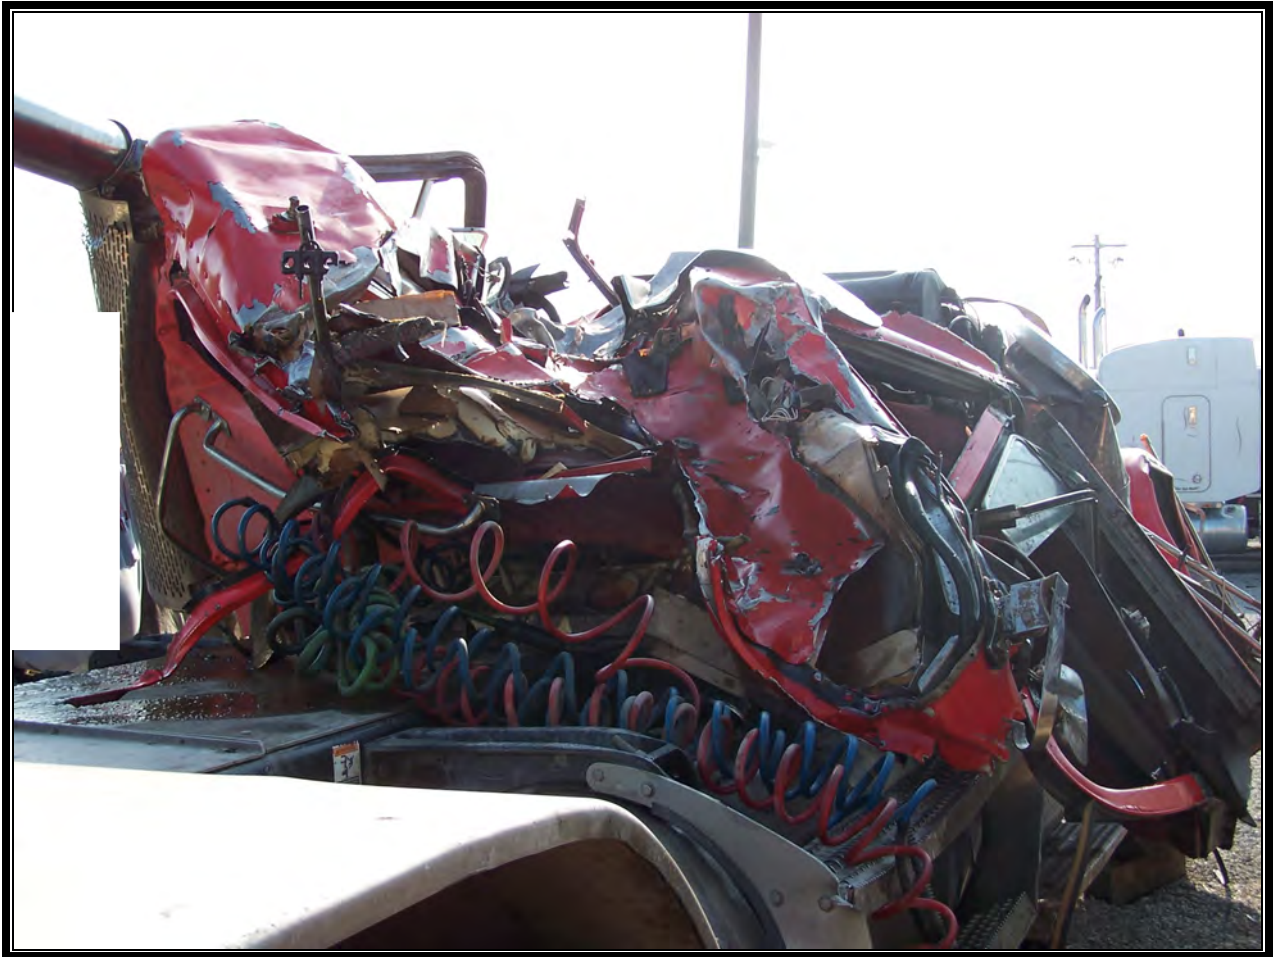
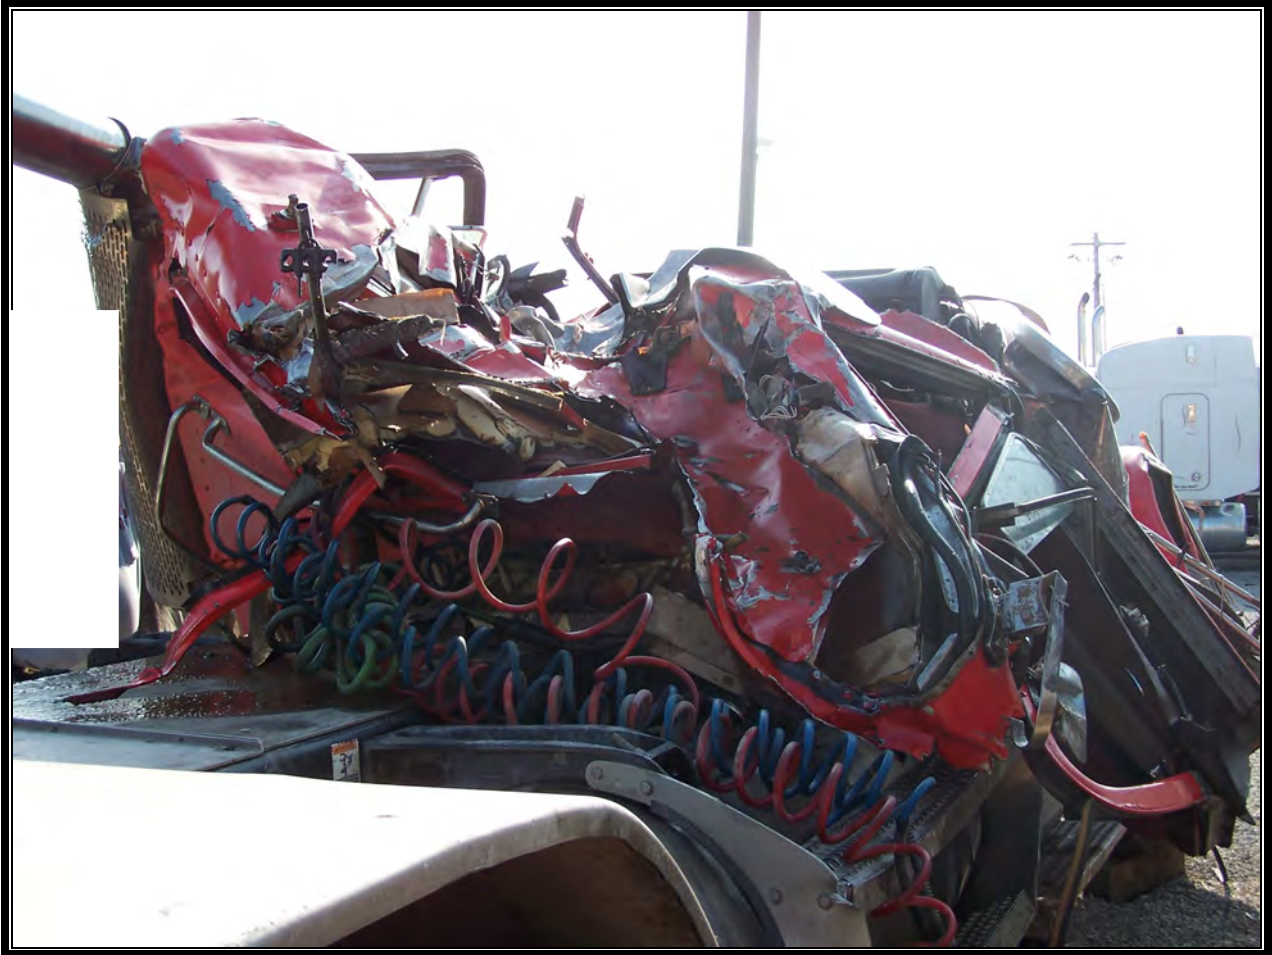
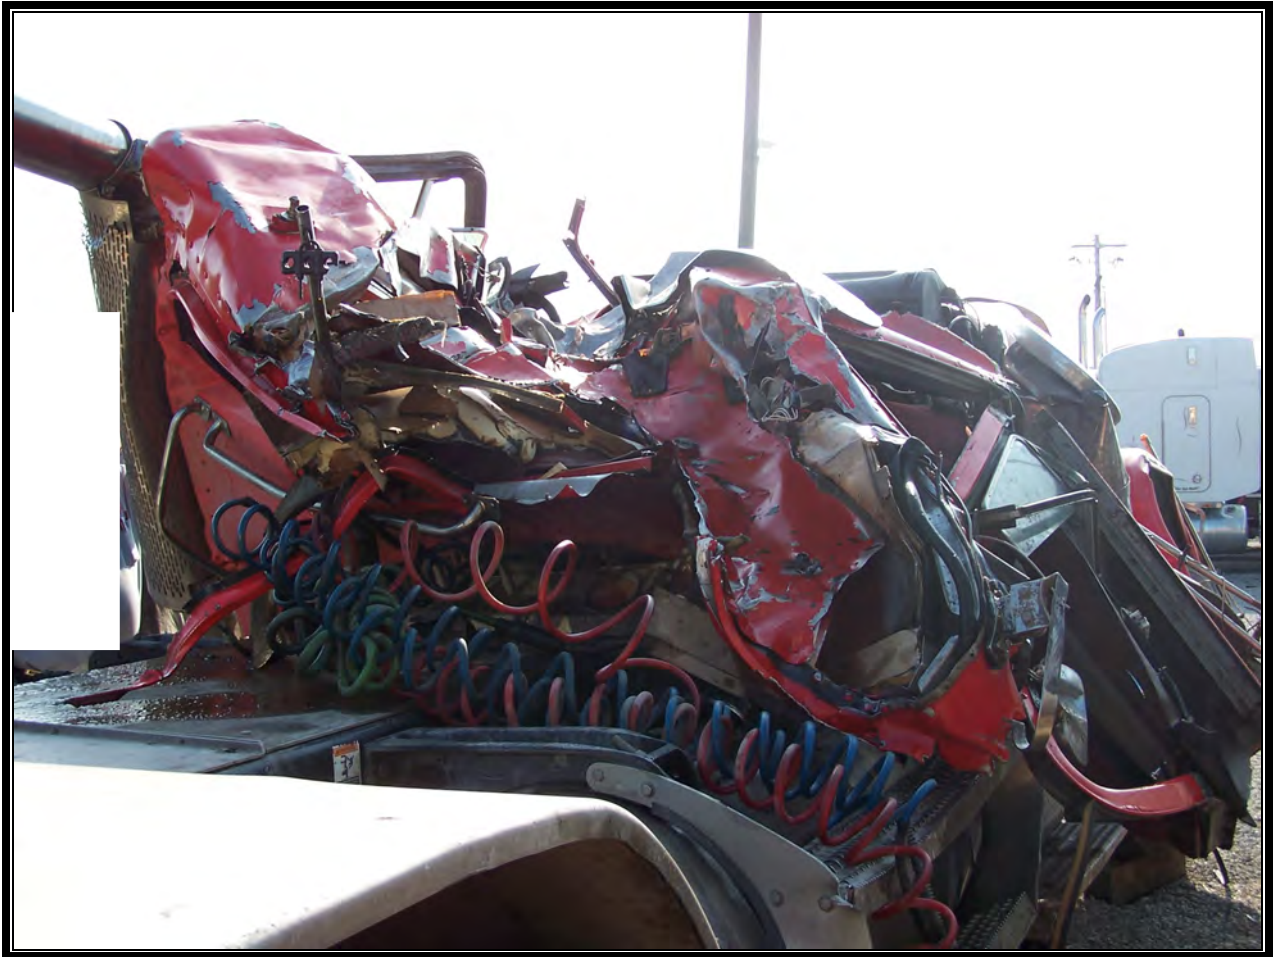
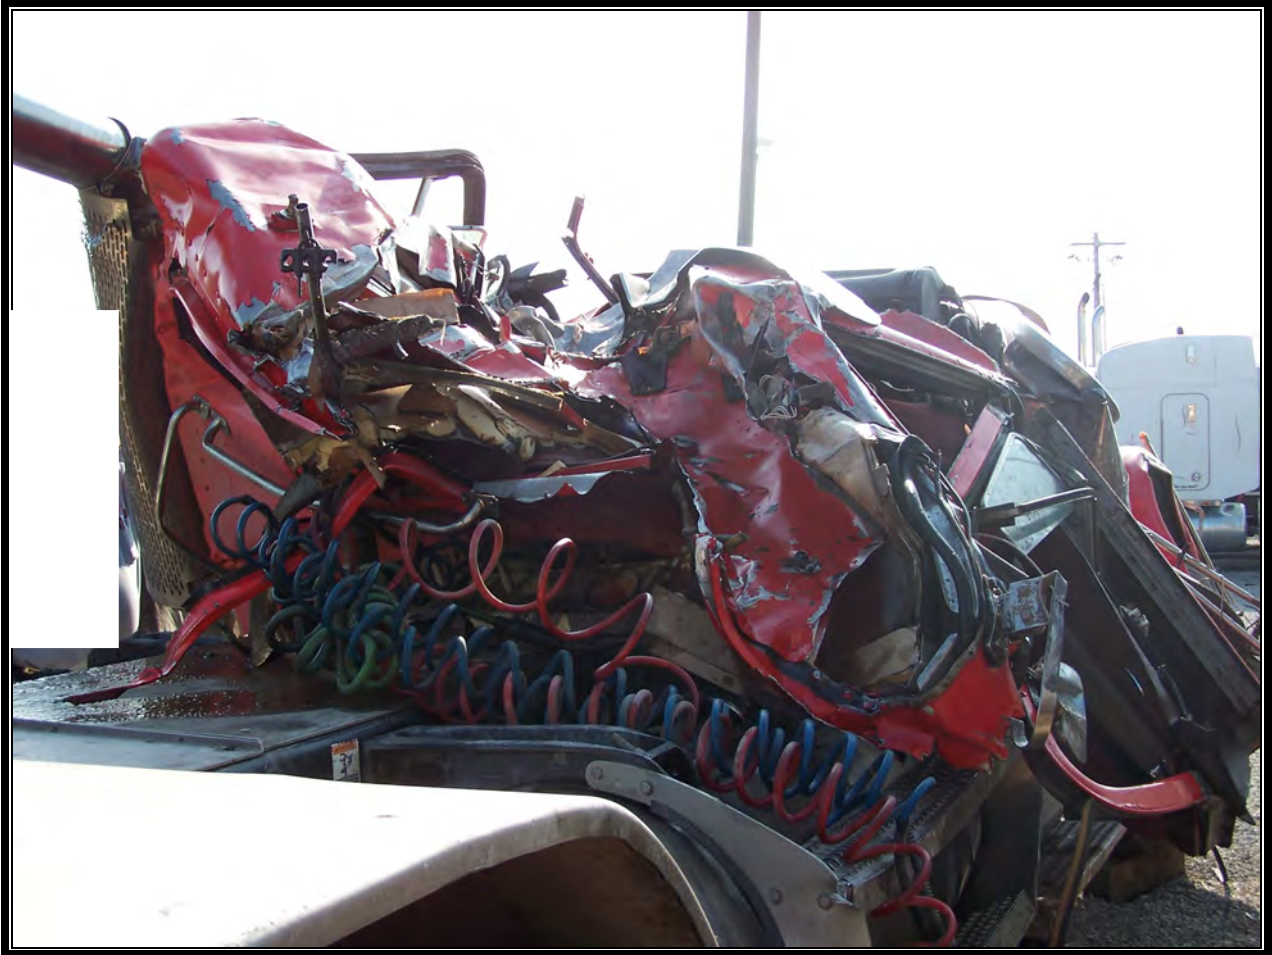
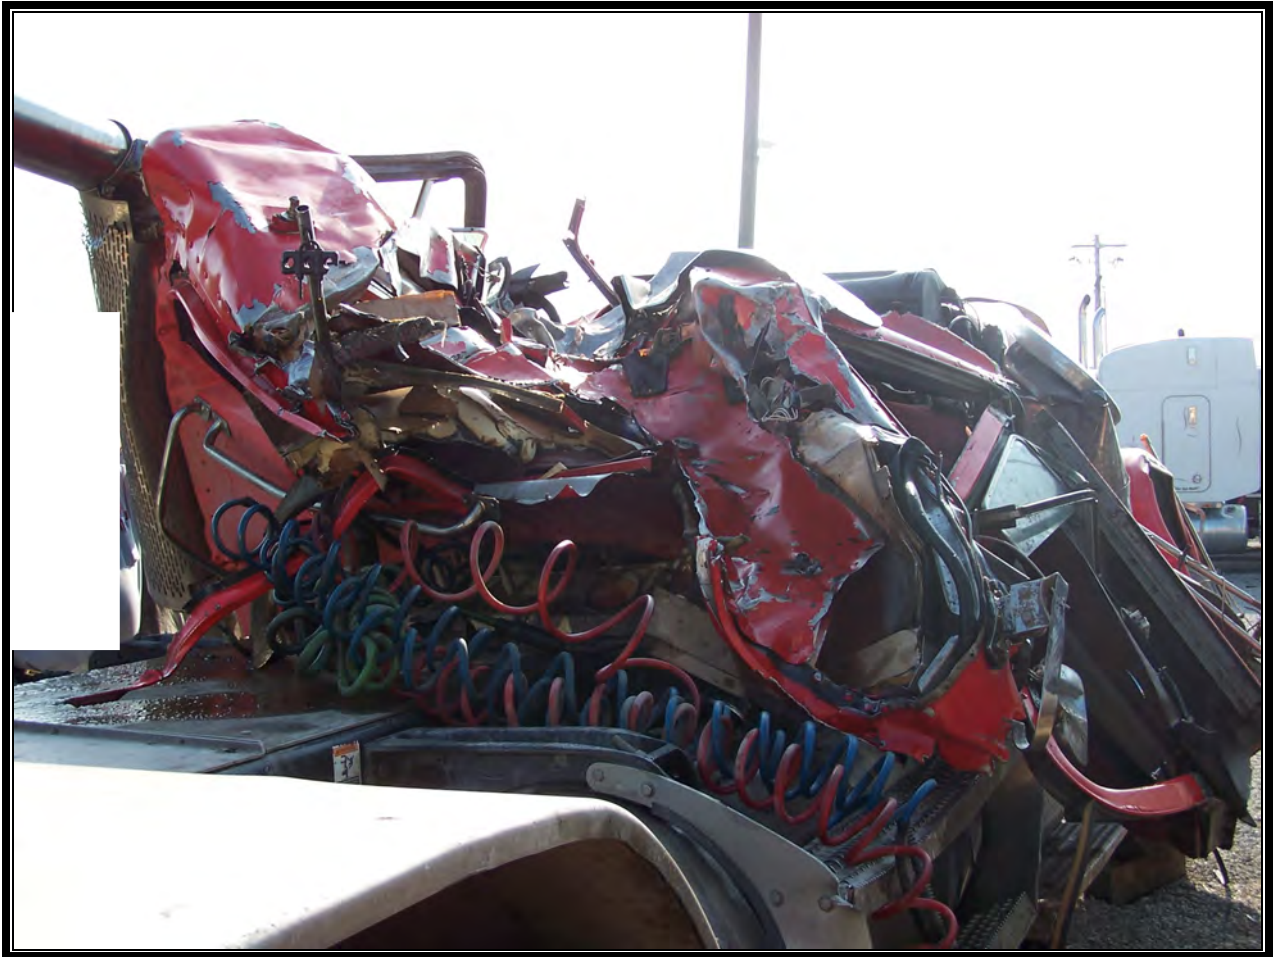
Photograph of semi involved in crash. Photograph taken by KY FACE personnel.

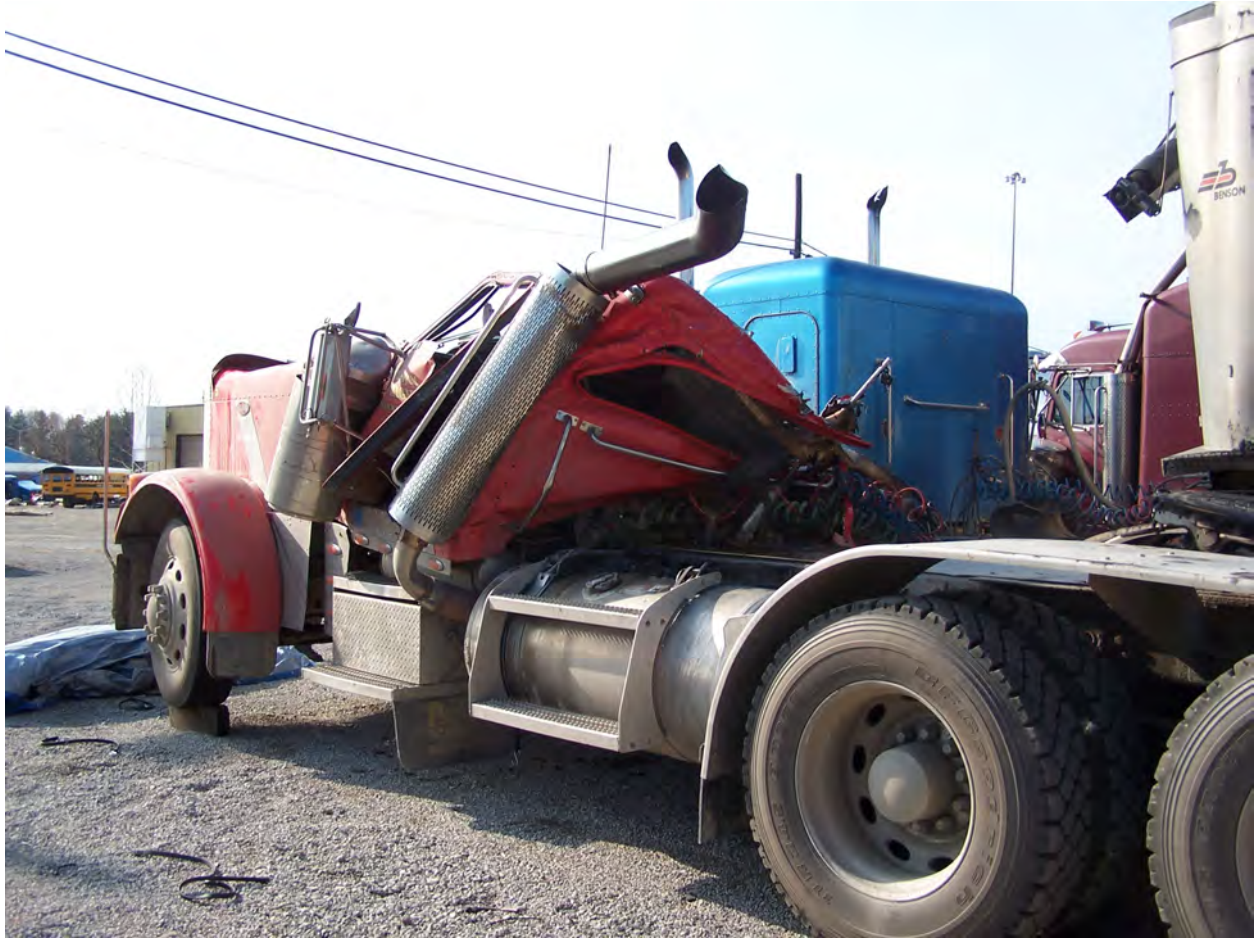
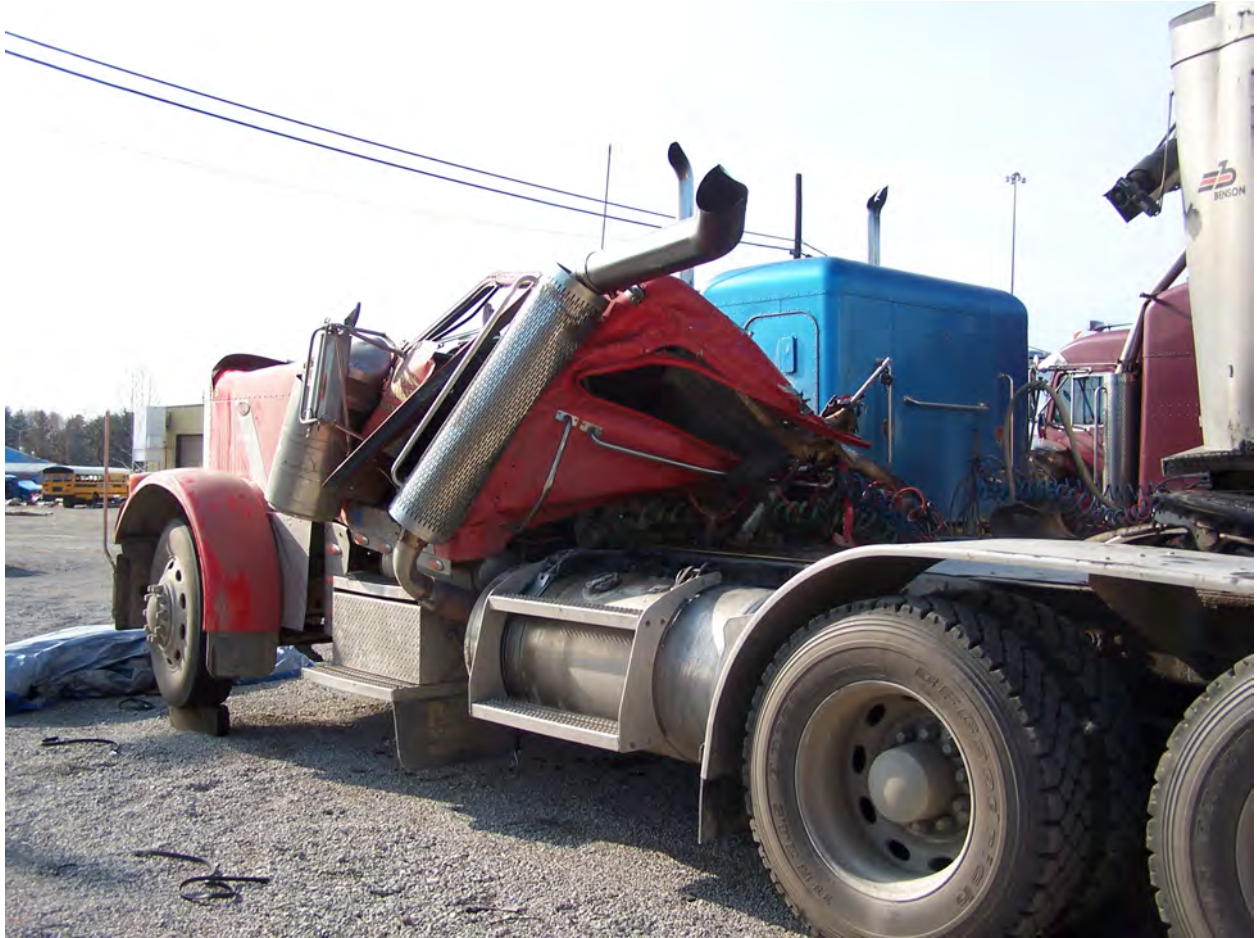
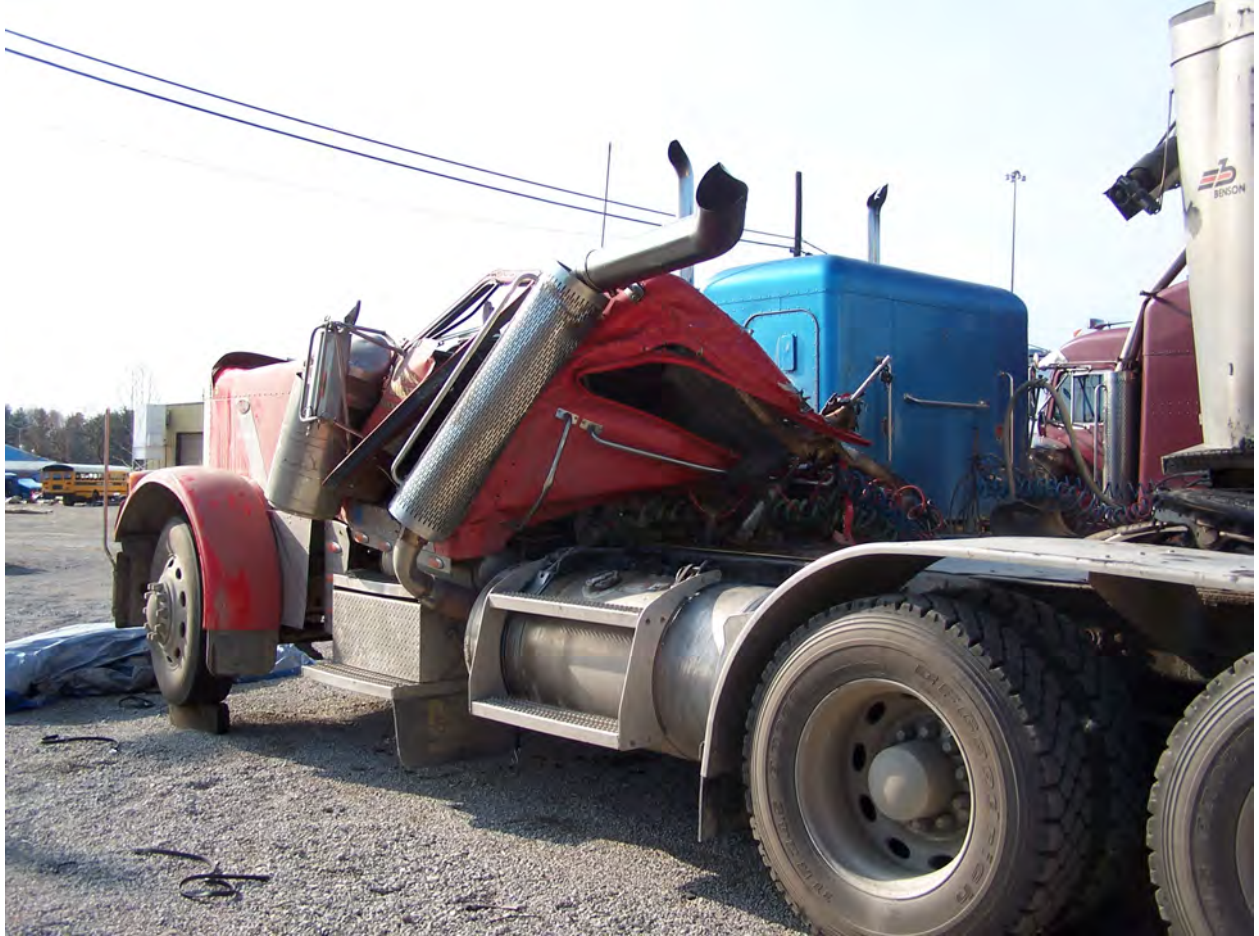
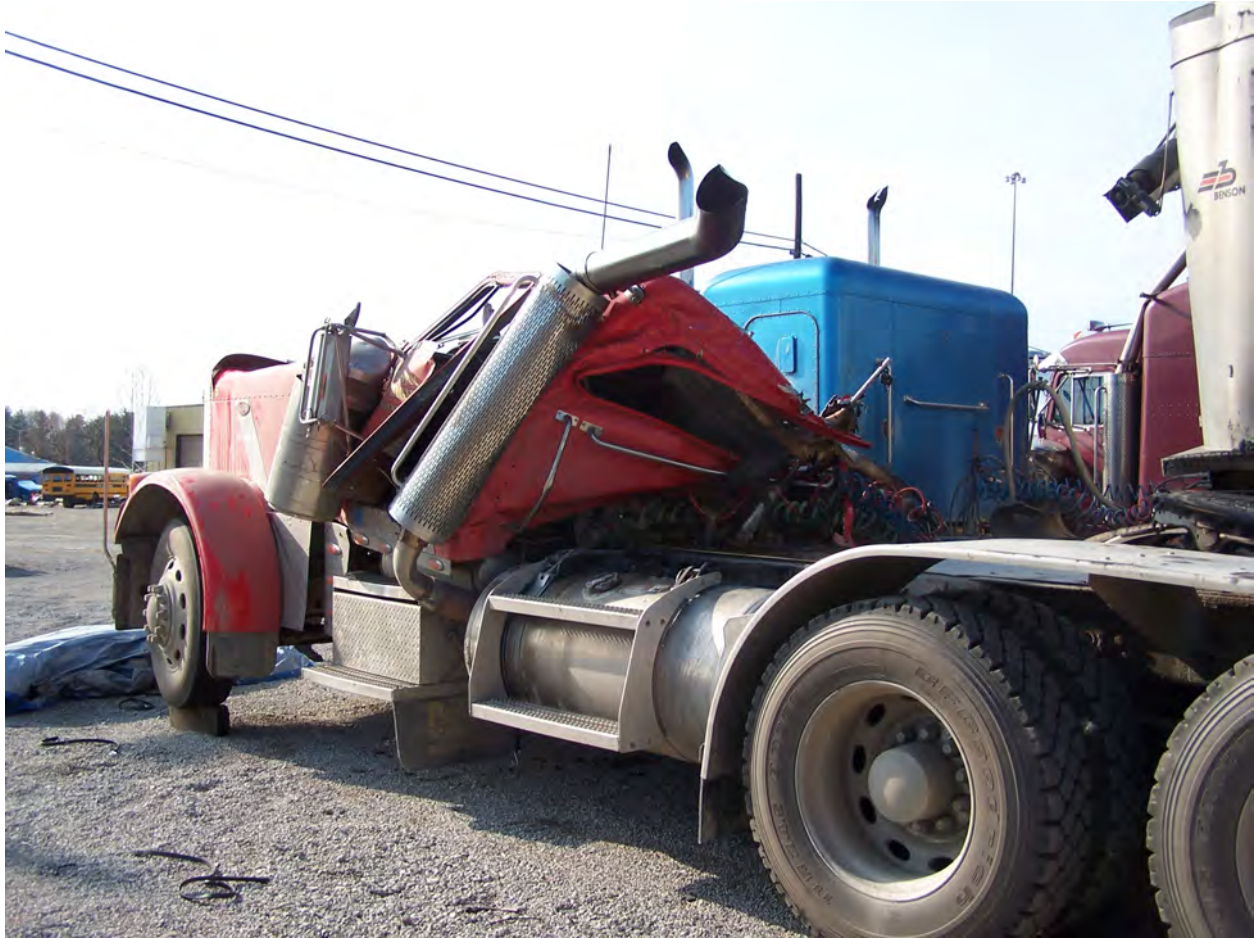
Photograph of tractor involved in MVC rollover. Photograph taken by KY FACE personnel.

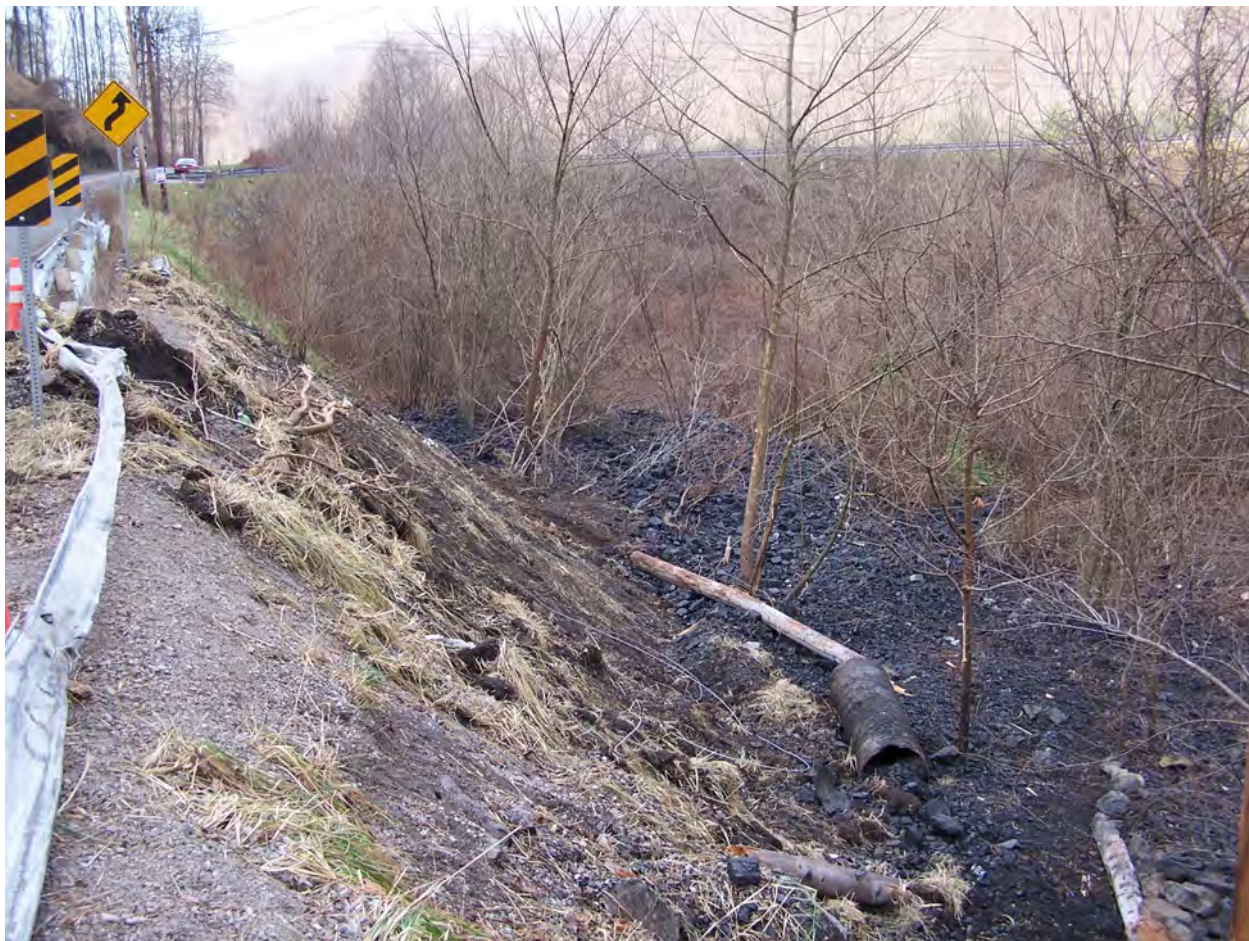
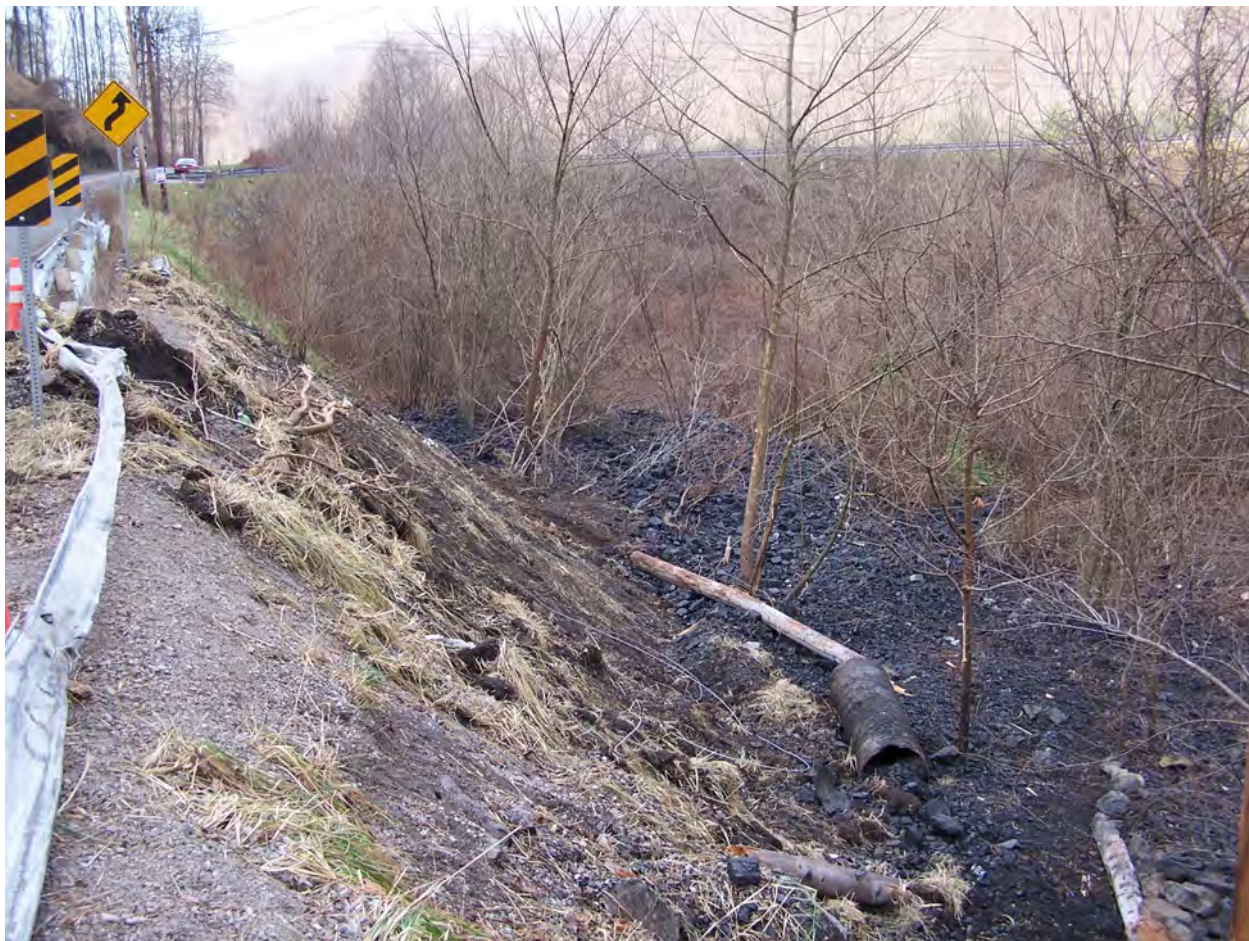
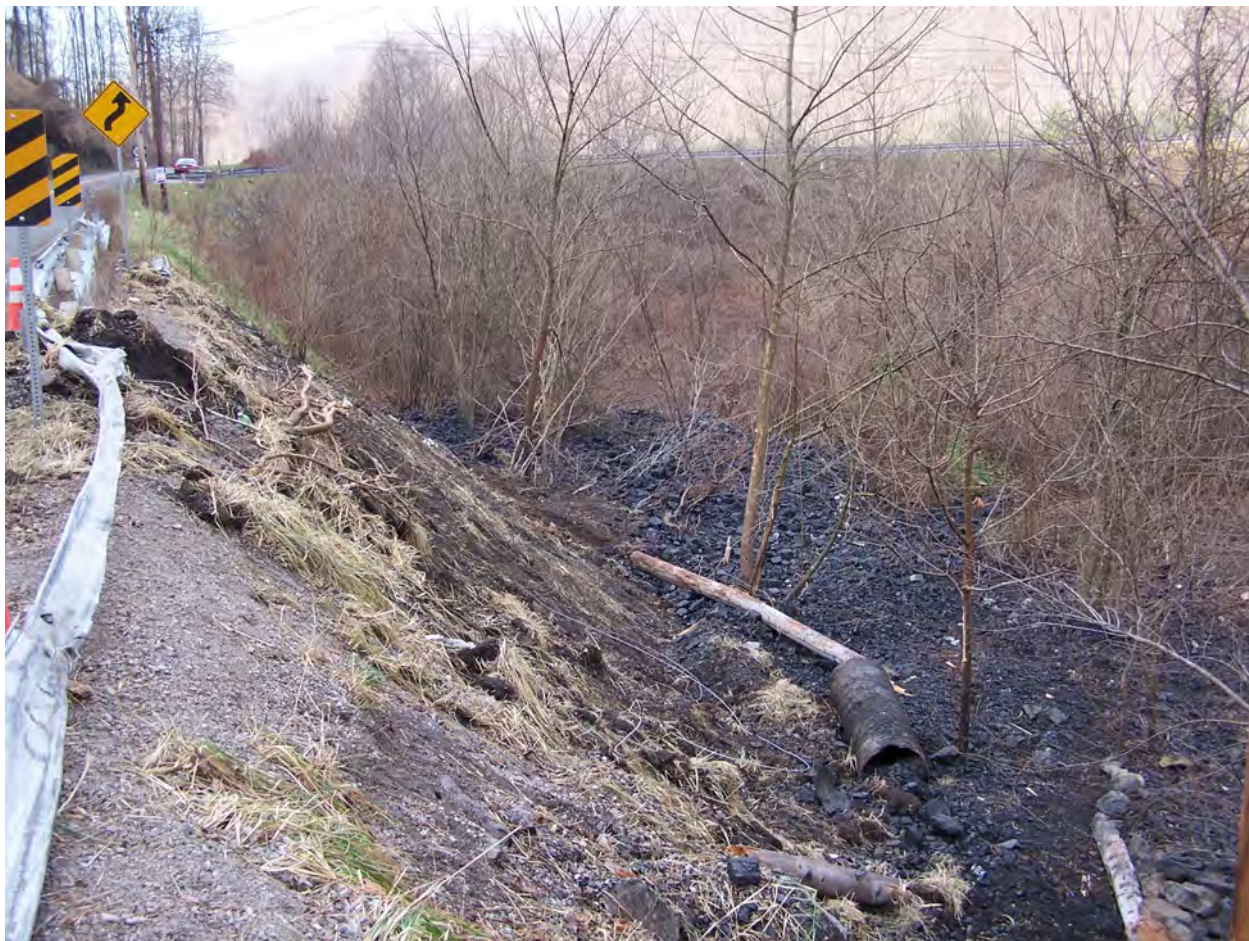
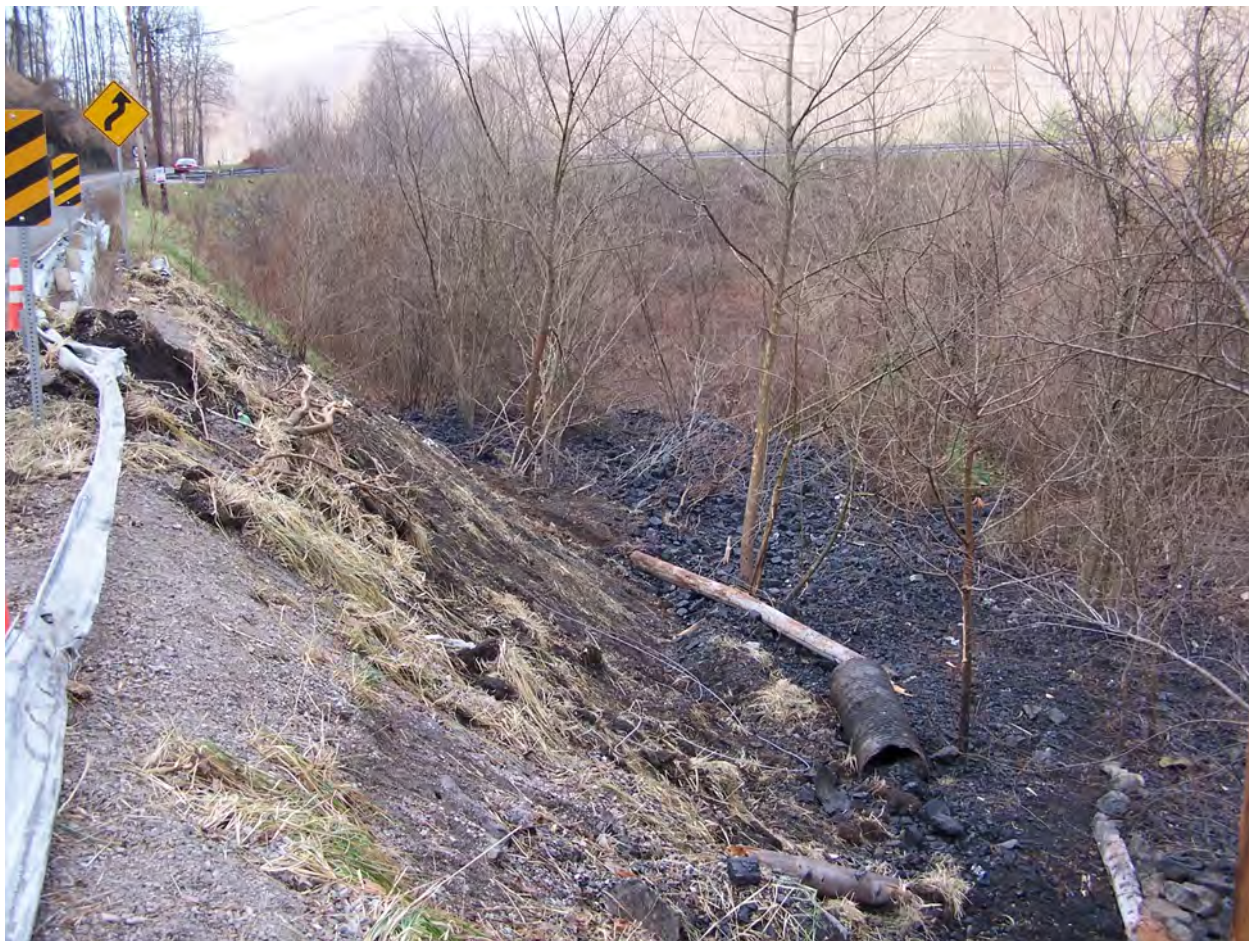
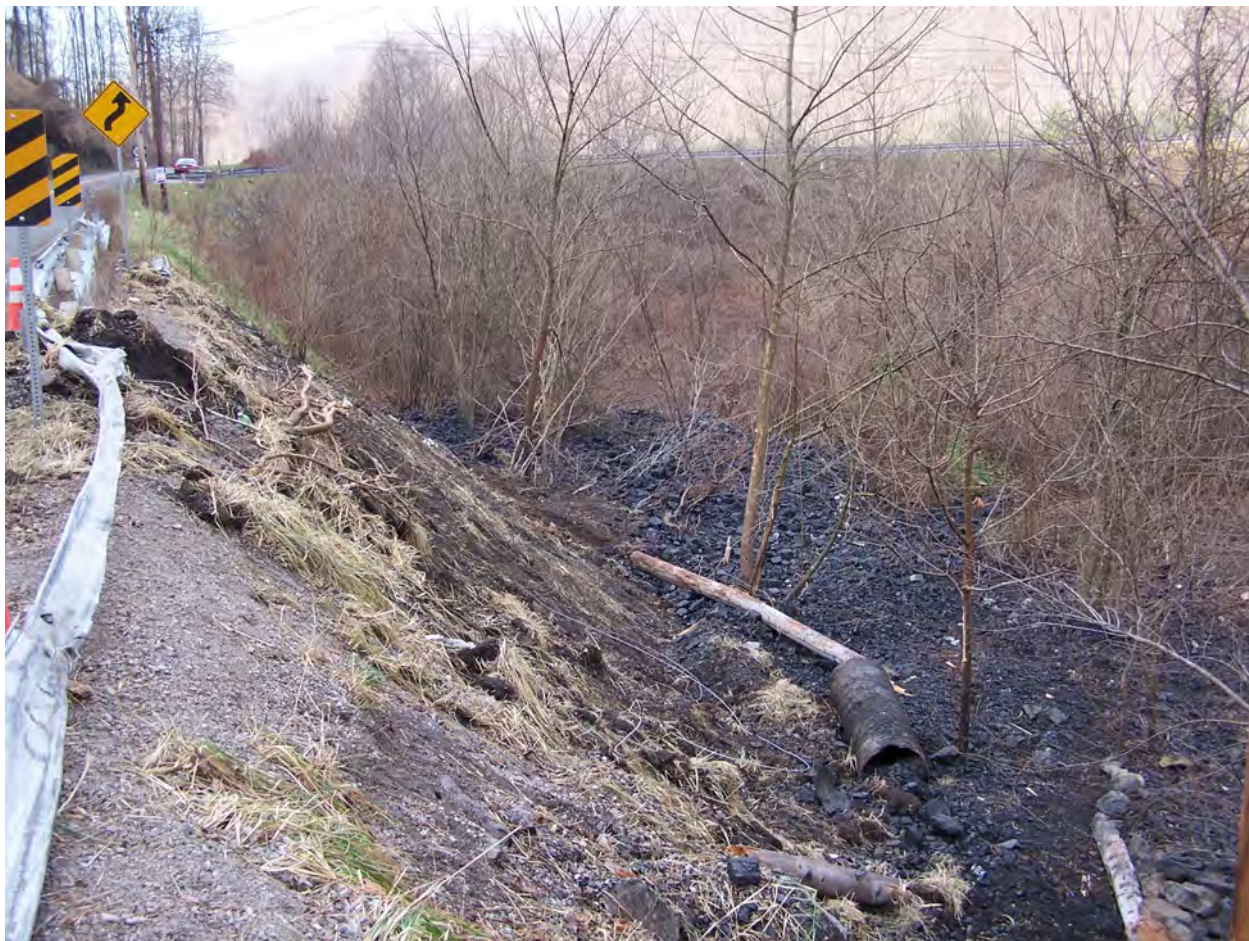
Photograph of hillside and coal dumped from trailer. Photograph taken by KY FACE personnel.
