Solid Waste Driver Dies After Single Vehicle Rollover Incident Number: 08KY074

Kentucky Fatality Assessment and Control Evaluation (FACE) Program

Incident Number: 08KY074

Subject: Solid Waste Driver Dies After Single Vehicle Rollover

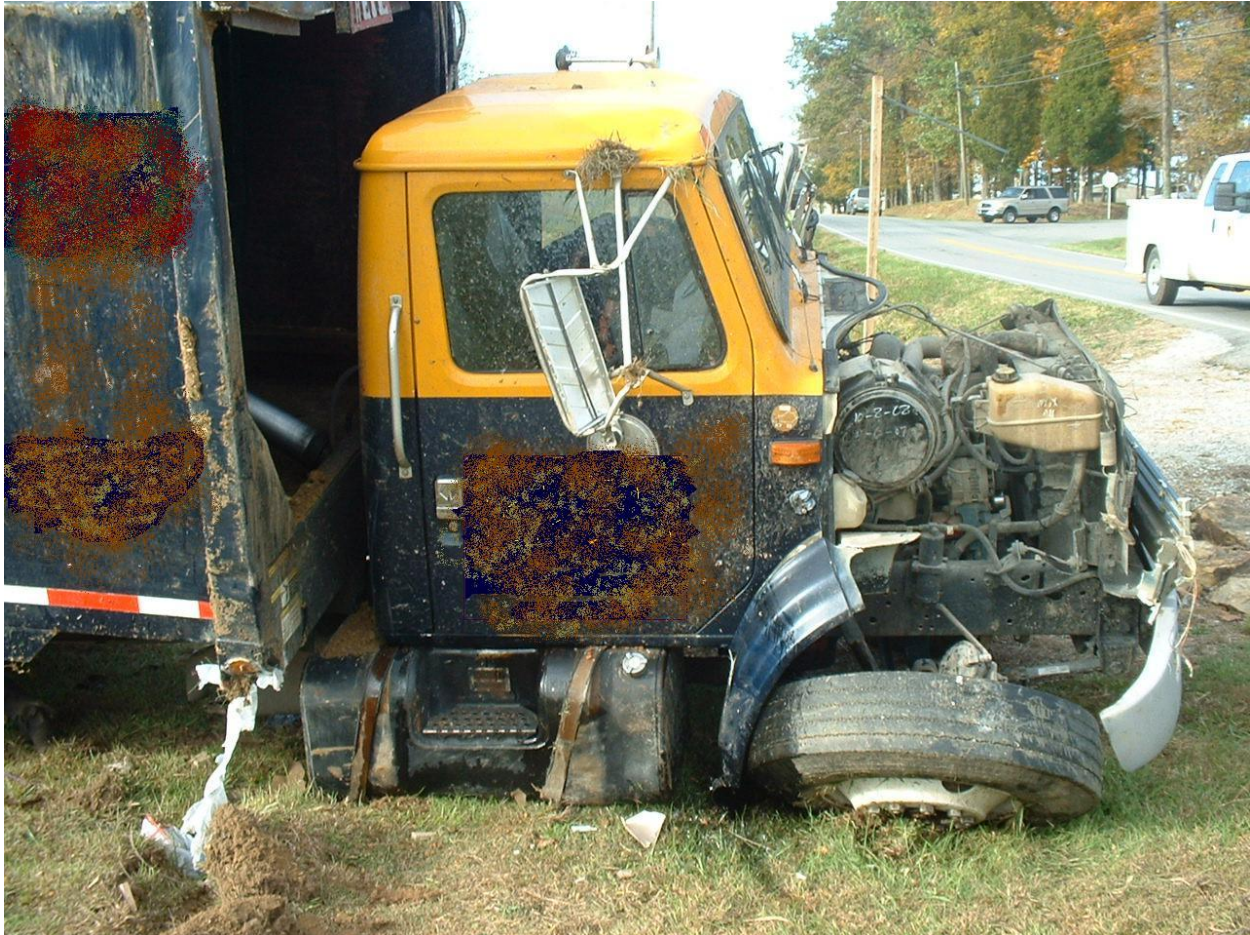
Photograph of solid waste truck involved in motor vehicle crash. Courtesy of law enforcement.

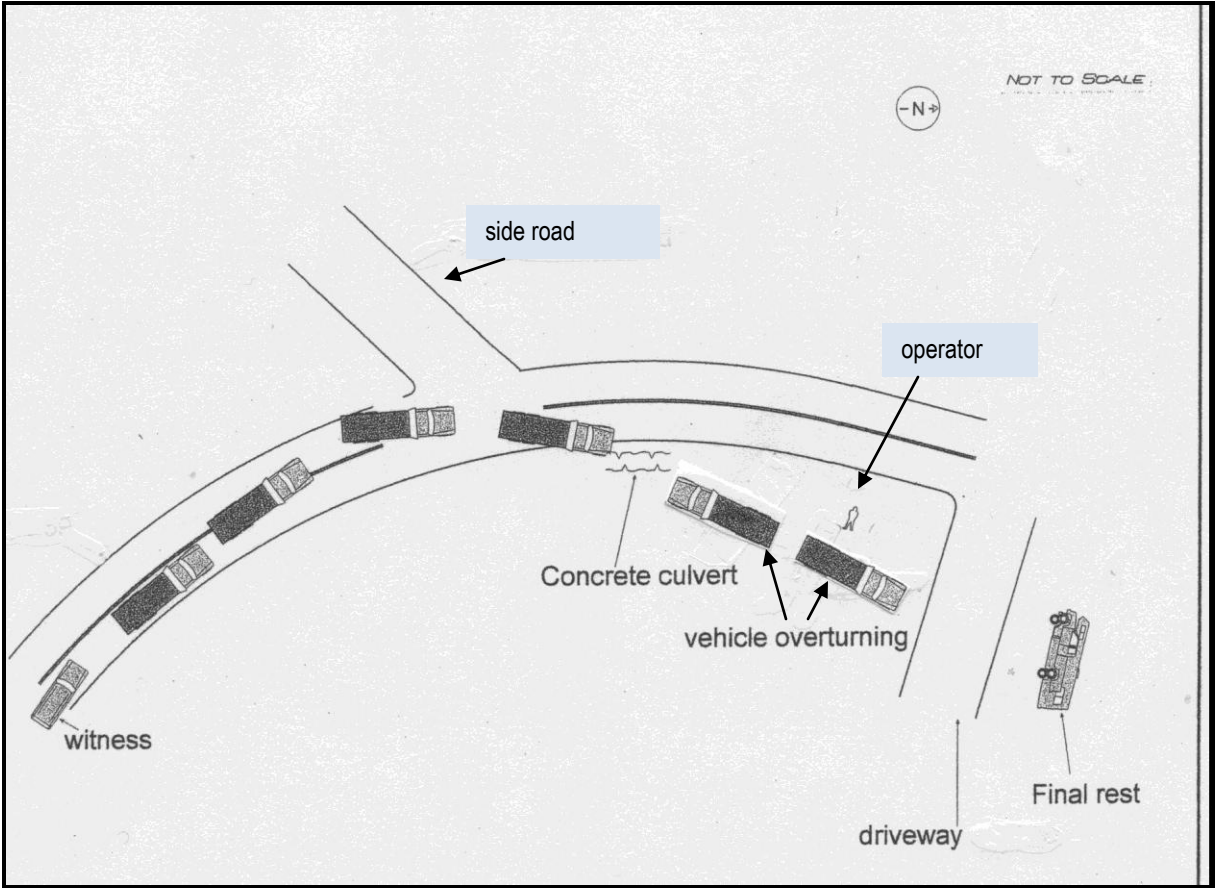
Diagram 1: Schematic of incident. Courtesy of law enforcement.

As they drove north, Driver 2 observed Driver 1 weave, and cross the center line at least two times. They had driven a little over 2 minutes and had traveled 1.8 miles from the restaurant when they were in a right-hand curve of the highway and Driver 1 crossed the center line and drove into the southbound lane. Driver 1 then drove across the northbound lane, off the right side of the highway, and with the right front of the truck, struck a 9 ft 8 in x 1 ft 1 in concrete culvert located 5 ft. 3 inches from the edge of the pavement. The tie rod broke, the right front tire broke off, and the truck frame was scraped by the culvert. The truck rolled end-over-end for approximately 90 feet into the front yard of a private residence. As the truck rolled, the back right tire struck the ground and the driver was ejected out the driver's door. Driver 1 landed on the ground and the truck continued to roll another 30 feet over a 16 ft. wide gravel driveway where it came to rest on its right side next to the driveway, and 12 feet from the highway, having rolled a total distance of 137 feet from the culvert (Diagram 1).

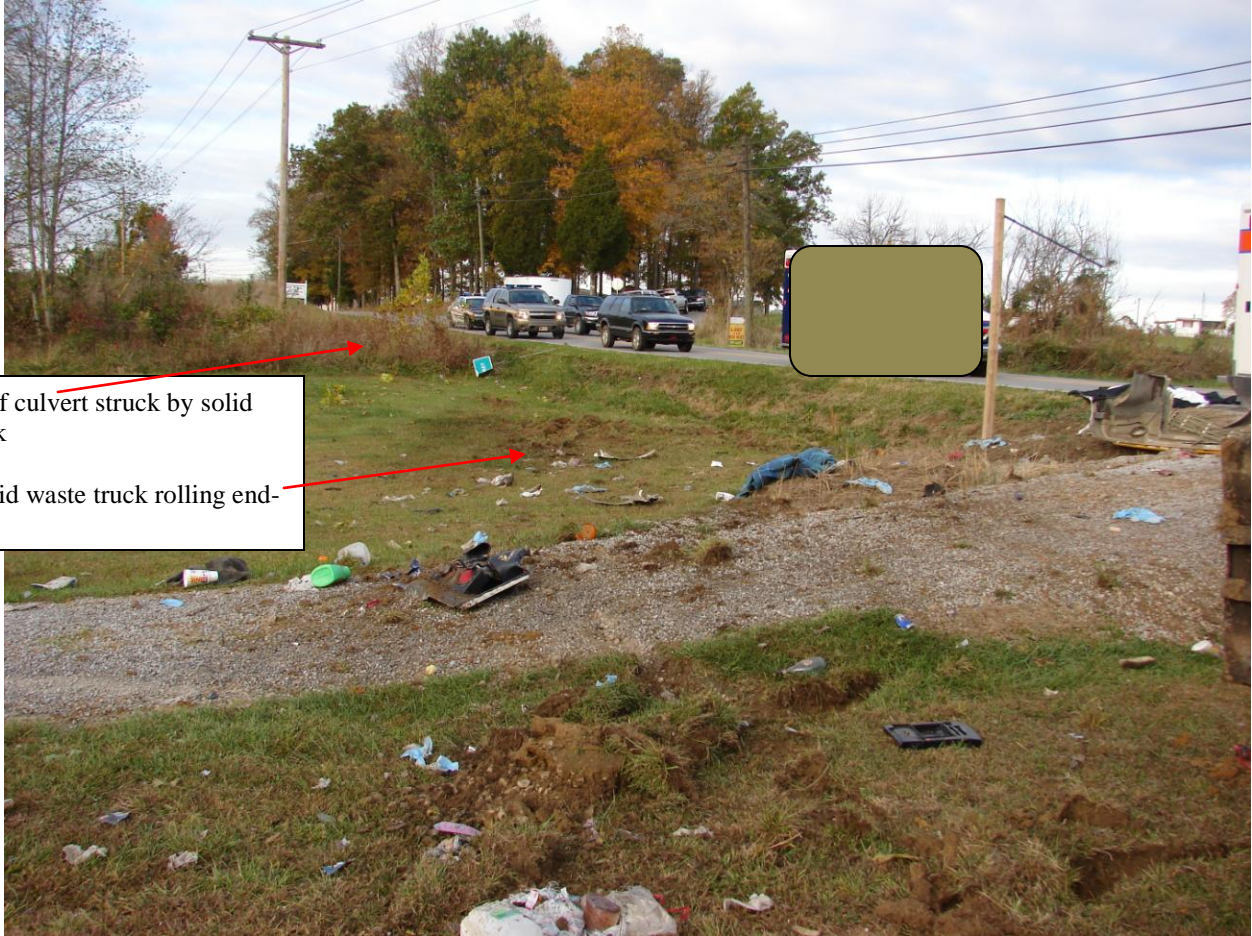
Location of culvert struck by solid waste truck

Path of solid waste truck rolling end-over-end

Photograph of path of solid waste truck after leaving the highway and striking a culvert. Photograph courtesy of law enforcement.

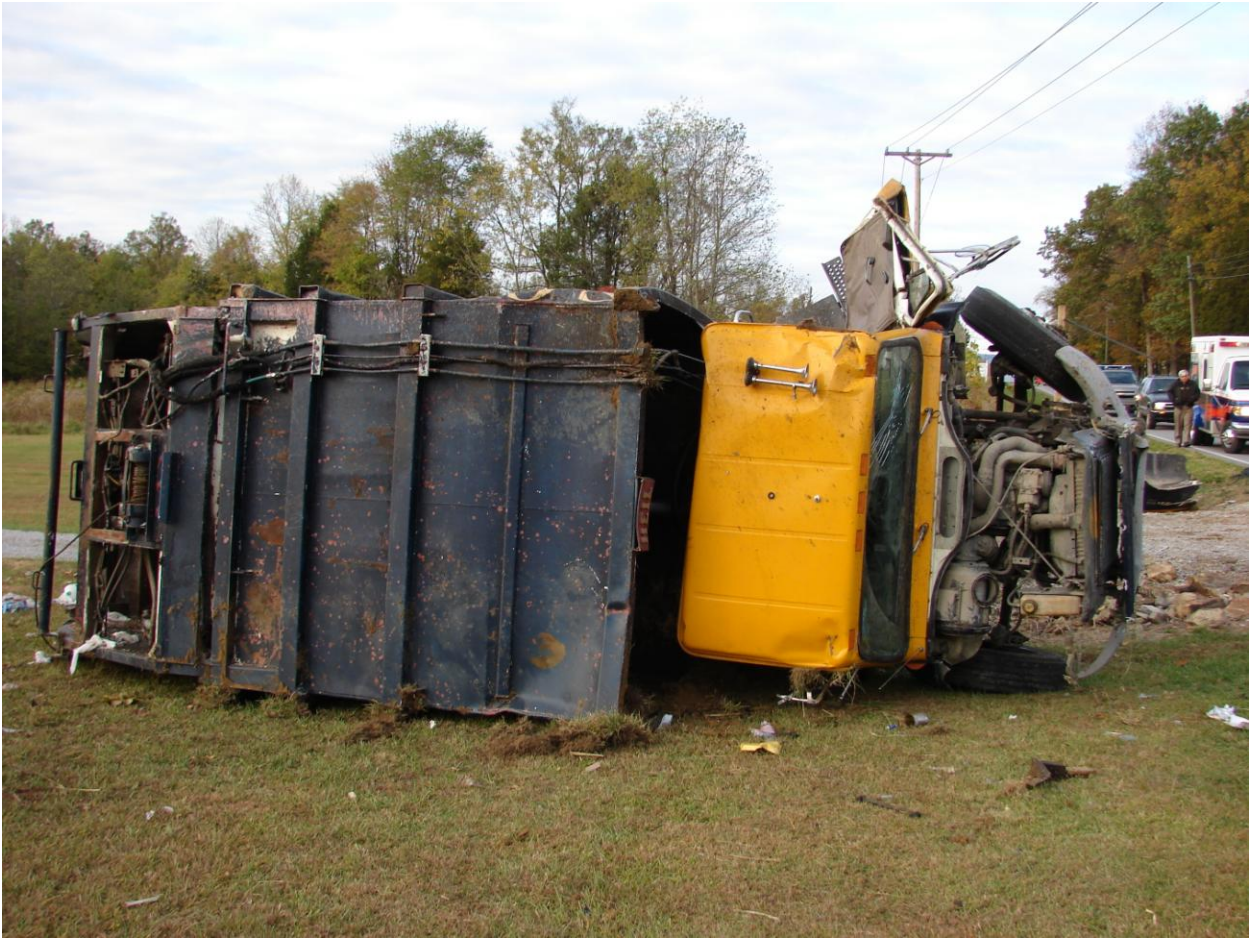
Photograph of solid waste truck where and how it came to rest after rolling end-over-end. Photograph courtesy of law enforcement.
