Day Care Monitor Dies After Crash of 15-Passenger Van

Incident Number: 12KY026

Kentucky Fatality Assessment and Control Evaluation (FACE) Program
Incident Number: 12KY026
Release Date: June 26, 2013
Subject: Day Care Monitor Dies After Crash of 15-Passenger Van

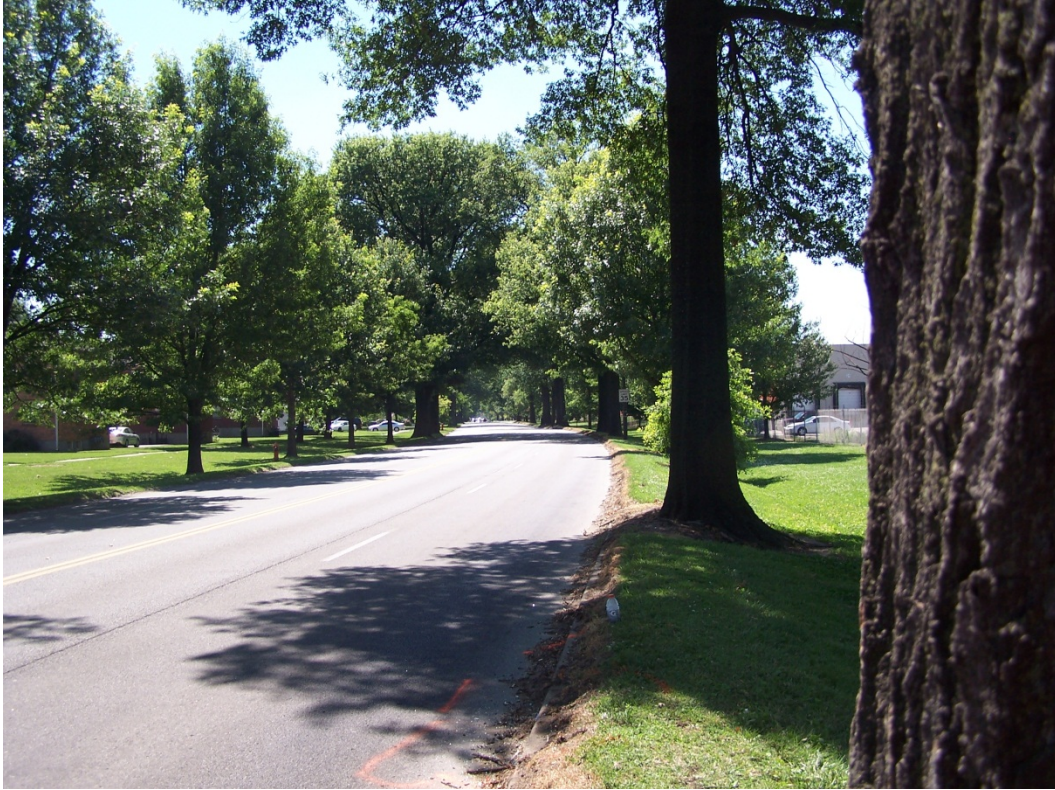
Street scene from the spot where the van crashed into the tree.

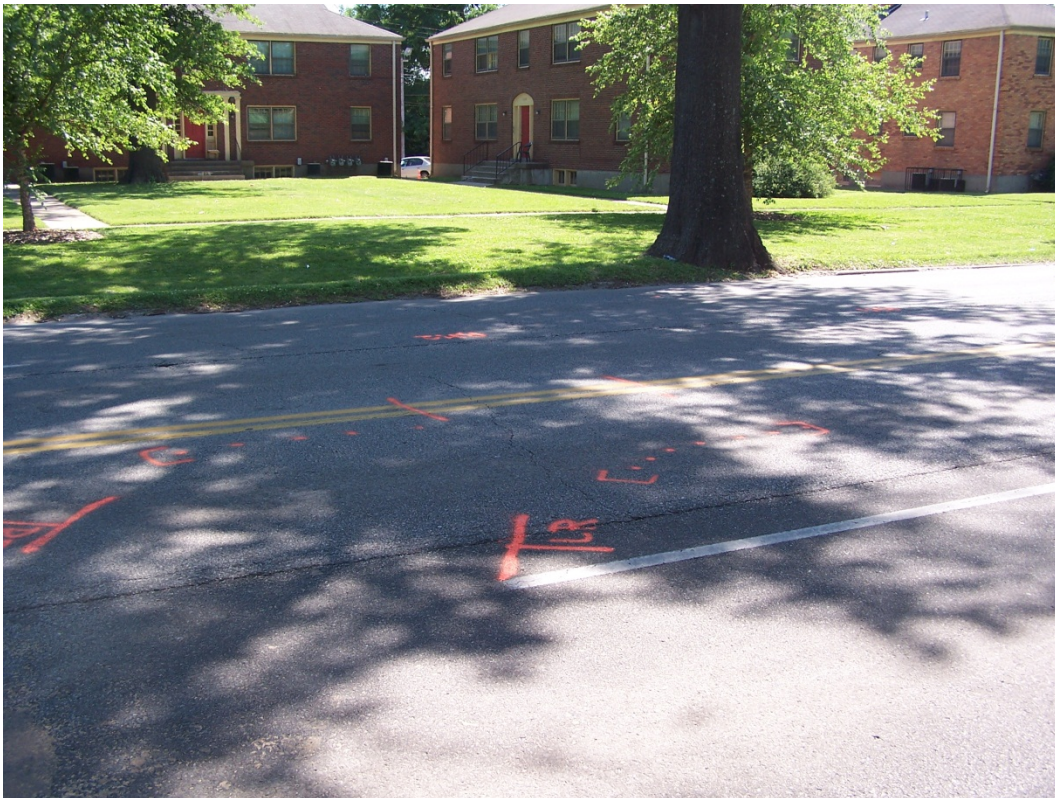
Markings show path of the van after the tire blowout, crossing into westbound lanes.

The driver proceeded out of the daycare's parking lot and dropped off two children at their residences, leaving 14 children and 2 adults still in the van. As they drove toward another child's residence, the van was in the left hand lane, traveling approximately 46-50 miles per hour, headed east on a straight stretch of a four lane road. East and westbound lanes were divided by a double yellow line. The roadway was flat and the pavement was dry; the speed limit was 35 miles per hour, and traffic was normal. It was approximately 5:10 p.m. when the right rear tire failed. Upon failure of the tire, the van became uncontrollable and it veered left, crossing both westbound lanes, striking a tree head-on and causing the front axle to break.

The reconstruction of the incident revealed damage had occurred in the middle of the rear right tire sometime prior to the crash and the interior tire belt had broken. Also, the tires on the van had less than 2/16" tread. There was no evidence of braking after the tire failed. Both front airbags were reported to have deployed upon impact with the tree. A passenger manifest was not located in the van, nor could one be found at the office of the daycare. It was reported by a witness that four children had been secured together with one restraint system. This would follow from the fact that the capacity of the van had been exceeded by 3 passengers at trip outset. The driving record of the van operator prior to the crash is unknown.
