# Flagger Struck by Motorist and Killed

**Incident Number: 13KY066**

**Kentucky Fatality Assessment and Control Evaluation (FACE) Program**  
**Incident Number: 13KY066**  
**Release Date: December 8, 2014**  
**Subject: Flagger Struck by Motorist and Killed**

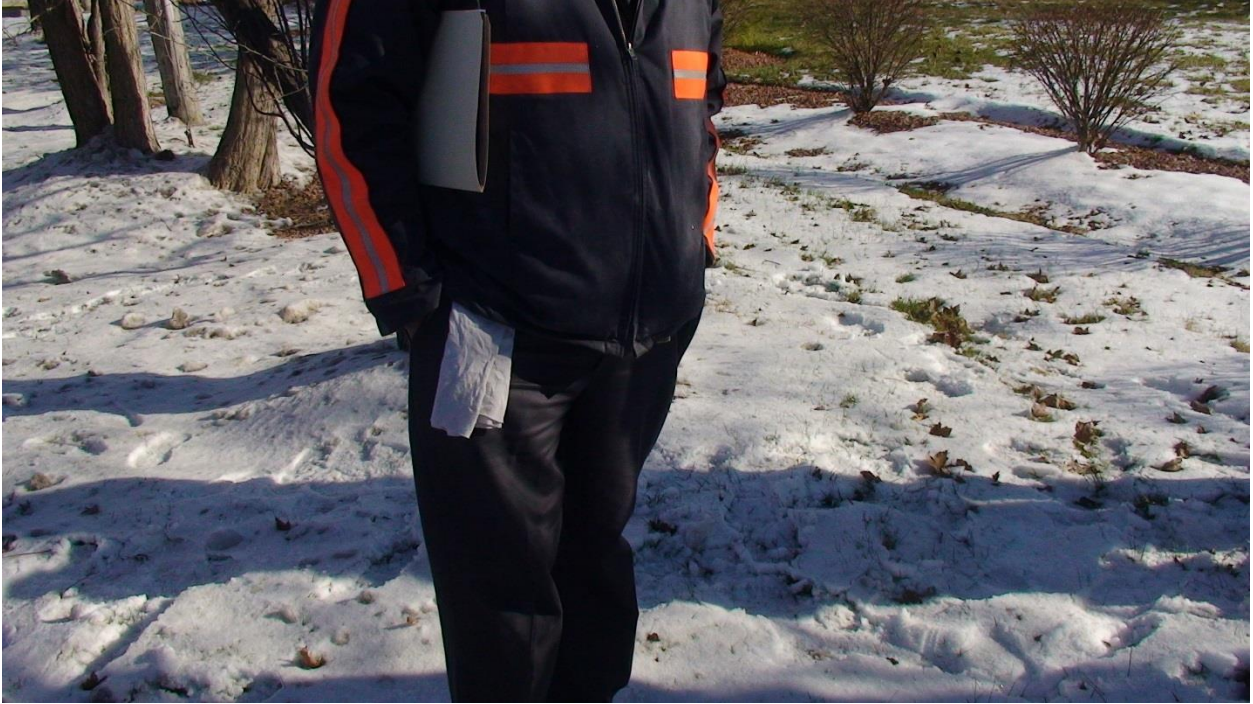
Photo #1 Clothing the victim was wearing.

The victim was wearing the basic company uniform, consisting of a gray jacket with an orange reflective stripe on each sleeve, orange stripe over the front pockets, and an orange stripe across the upper back. He was using a hand held stop sign that was not reflective, along with a small flashlight (see photo # 3). The uniform was not American National Standards Institute (ANSI) or MUTCD approved for flagging in a 55 mph speed area at night, nor was the stop sign ANSI approved. See photo #1. There was no advance warning system used to warn motorists of a flagging situation ahead. Photos #2 and #4 are the MUTCD approved apparel and reflective stop sign that should have been used.

**Recommendation No. 2: Employers should provide proper MUTCD reflective clothing when employees are required to perform traffic control activities.**

The MUTCD requires high visibility clothing for daytime work that meets ANSI/ISEA 107-2004 for class 2 exposure, stating that “the flagger’s vest, shirt or jacket shall be either orange, yellow, yellow-green, or a fluorescent version of these colors.”<sup>2</sup> For night time work, similar garments shall be retro reflective meeting ANSI/ISEA 107-2004 for class 3 exposure. The retro reflective material shall be either orange, yellow, white, silver, yellow-green or a fluorescent version of these colors, and shall be visible at a minimum distance of 1,000 feet. The retro reflective clothing shall be designed to clearly identify the wearer as a person.”
