# **Foreman Falls into Running Auger after Stepping on Door Panel with Broken Door Interlocks**

**Incident Number: 14KY022**

**Kentucky Fatality Assessment and Control Evaluation (FACE) Program**  
**Incident Number: 14KY022**  
**Release Date: February 11<sup>th</sup>, 2015**  
**Subject: Foreman Falls into Running Auger after Stepping on Door Panel with Broken Door Interlocks**

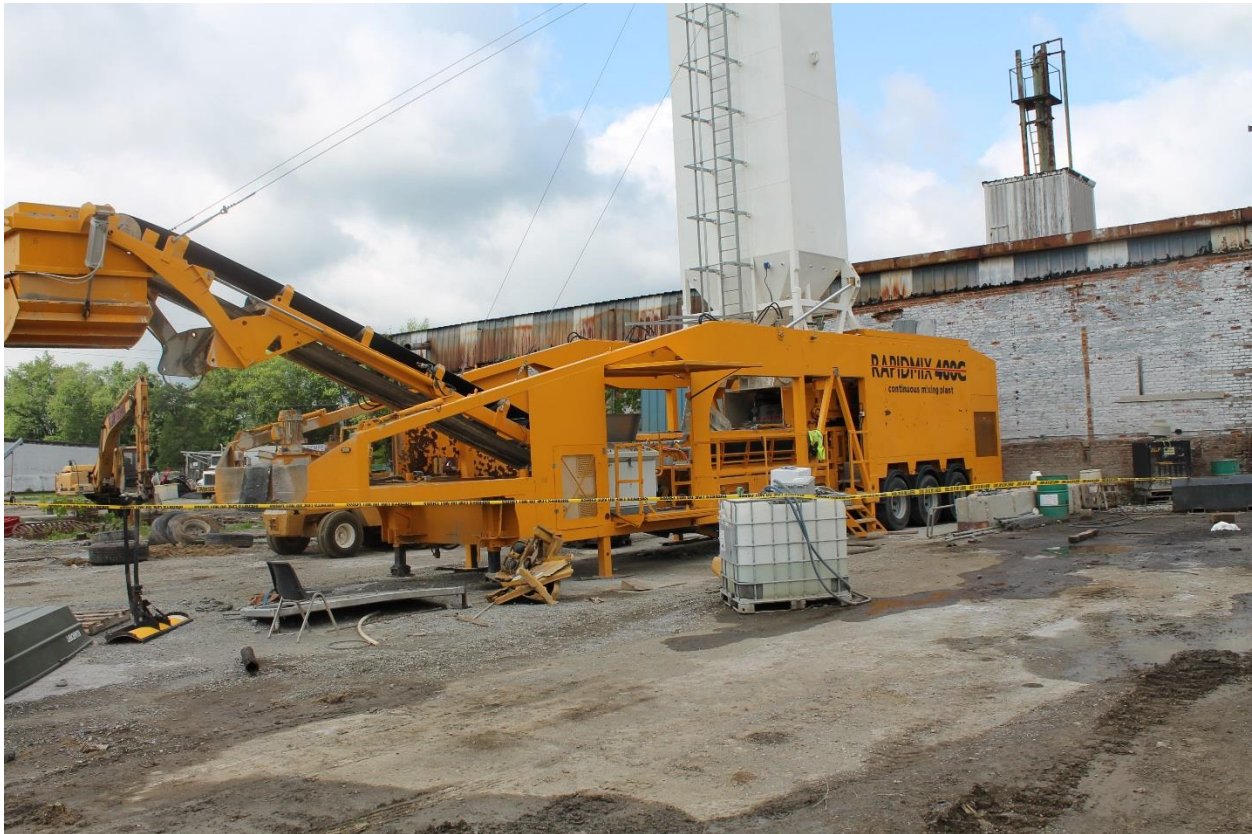
Photo #1 Rapidmix 400 C Continuous Mixing Plant.  
OSHA

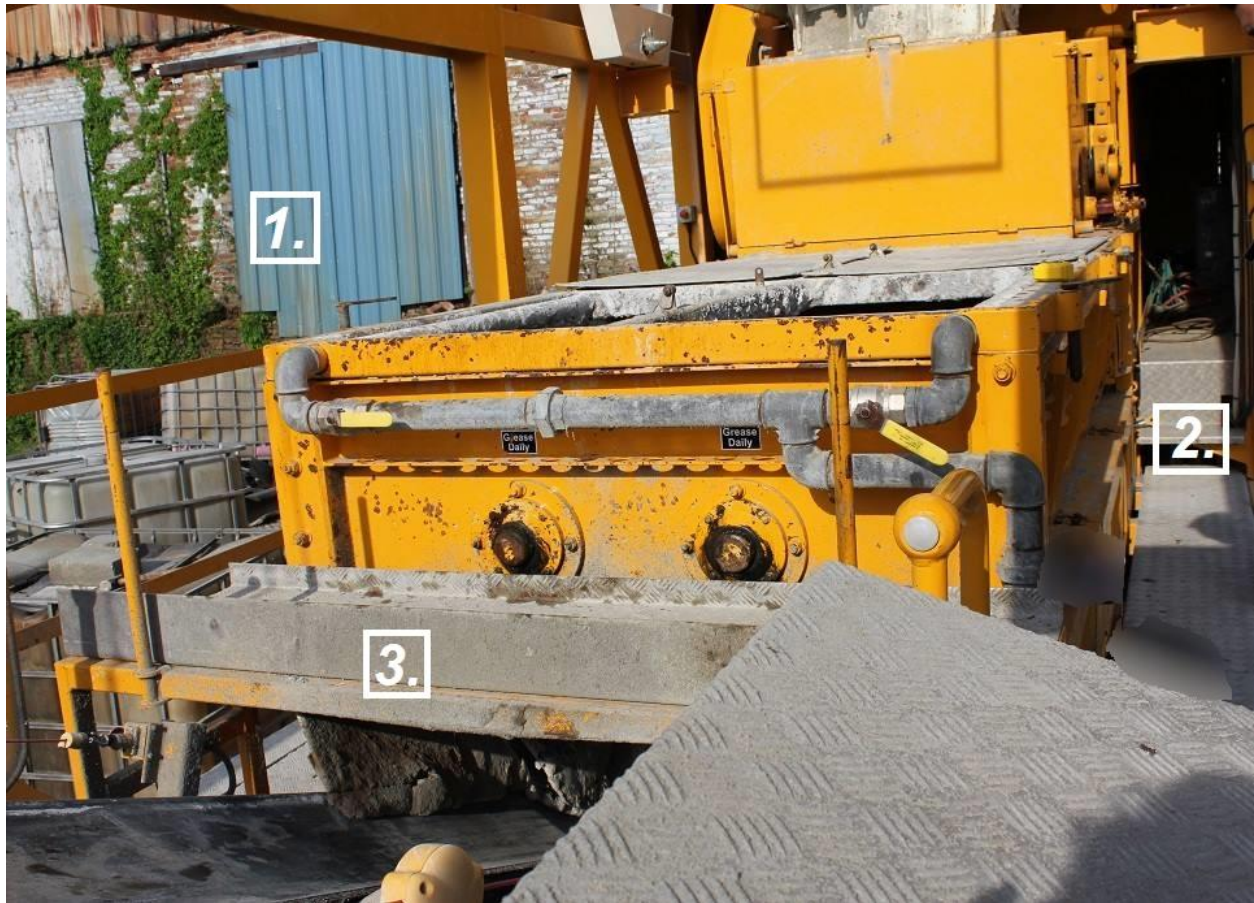
Photo 2: One walking platform on each side of the mixer, and a third elevated platform directly over the conveyor belt that connects sides 1 and 2.

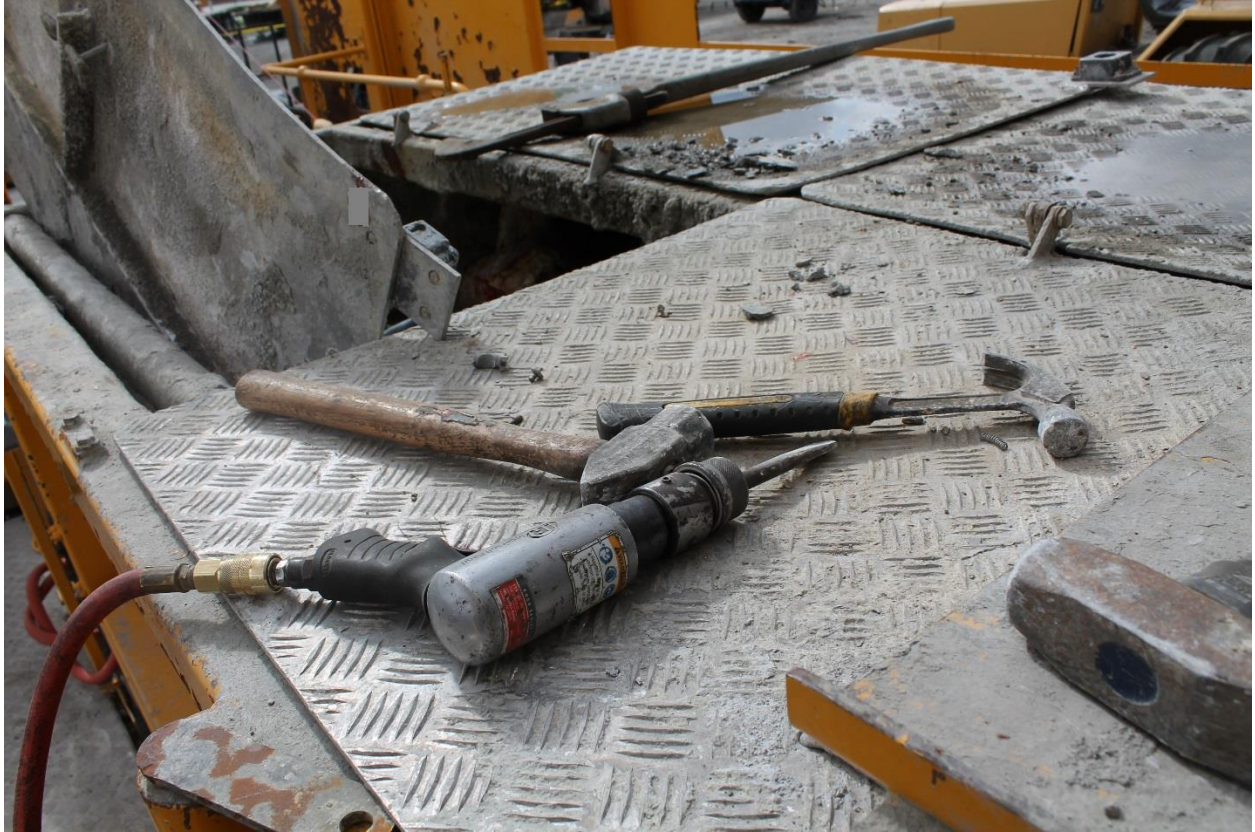
The incident occurred on top of a Rapid mix 400 C continuous mixing plant located in the company's lot next to the maintenance shop. This machine is designed to be a totally mobile and self-contained mixing plant for semi-dry concrete mixes. The mixing unit (auger section) measured 65 inches wide by 53 inches long and 48 inches tall. There was a walking platform on three sides of the mixer unit, one on each side of the mixer unit and a third near the conveyor belt that connected the two side platforms requiring two steps up for access (see photo 2). Two pairs of two doors covered the opening of the mixer unit (see photo 3). Each door measured 31 ½ inches wide by 53 inches long. Each pair of doors was hinged in the center with two, two inch tall hinges. Each door opened and closed on the outer edge of the mixer unit (see photo 3).

On the outer edges of the mixer unit, an interlock (see reference 2) connected the doors on the right, the bottom of the top set of doors and the top of the bottom set of doors, and another interlock connected the two doors on the left, the bottom of the top set of doors and top of the bottom set of doors. Inside the mixing unit were twin, 14 foot long mixing shafts that rotated at 110 RPM. On each shaft were 72, eight inches long by six inch tall paddles (see photo 4).

Photo 3: top of auger, the four doors.

**Recommendation 4: Manufacturers should consider installing a switch so that the equipment doors could not be open during operation.**

Installing a shut off switch that automatically shuts off the equipment if doors are attempting to be opened would be a safety device. Or manufacturing the doors to where they could not be opened while the machine was in operation could also be a resolution.

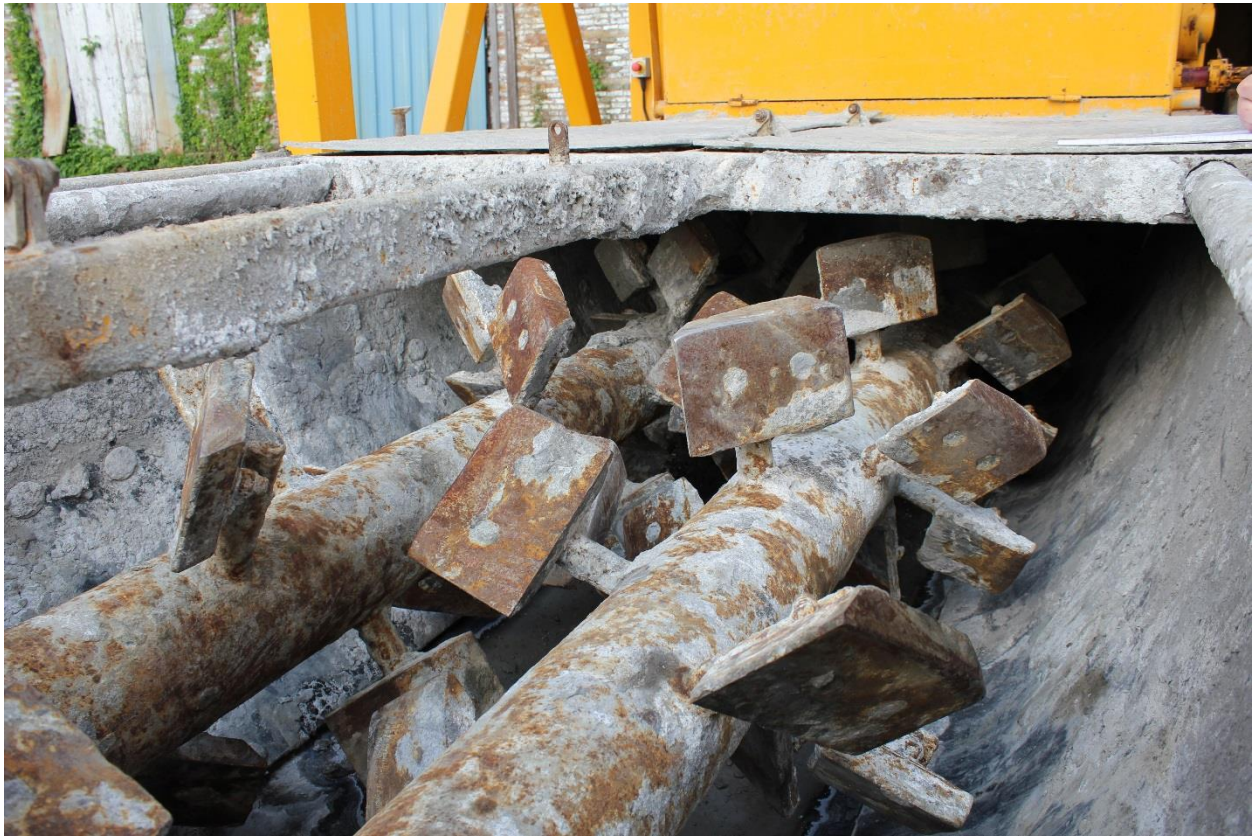
Once the two employees and the foreman cleared much of the dried, stuck-on concrete in the vein feeder, the foreman started the mixer section to remove the rest, which created a cloud of dust. The foreman instructed the two employees to leave the area so they would not breathe in the dust particles. The foreman was on the north side of the mixer and stepped on top of the mixer's metal doors to exit on the south end. As he stepped up, one of the four metal doors collapsed into the mixer, along with the victim. By the time one of the employees hit the emergency stop switch, the foreman was chest high in the auger blades.

Photo 4: the auger mixer paddles victim fell into.

Written procedures would assist new employees in recognizing hazardous defects of the equipment and how to avoid injury or death while operating the equipment. Furthermore, workers should be instructed that under no circumstances should they ever stand on the metal doors covering the mixing unit while the augers are running.

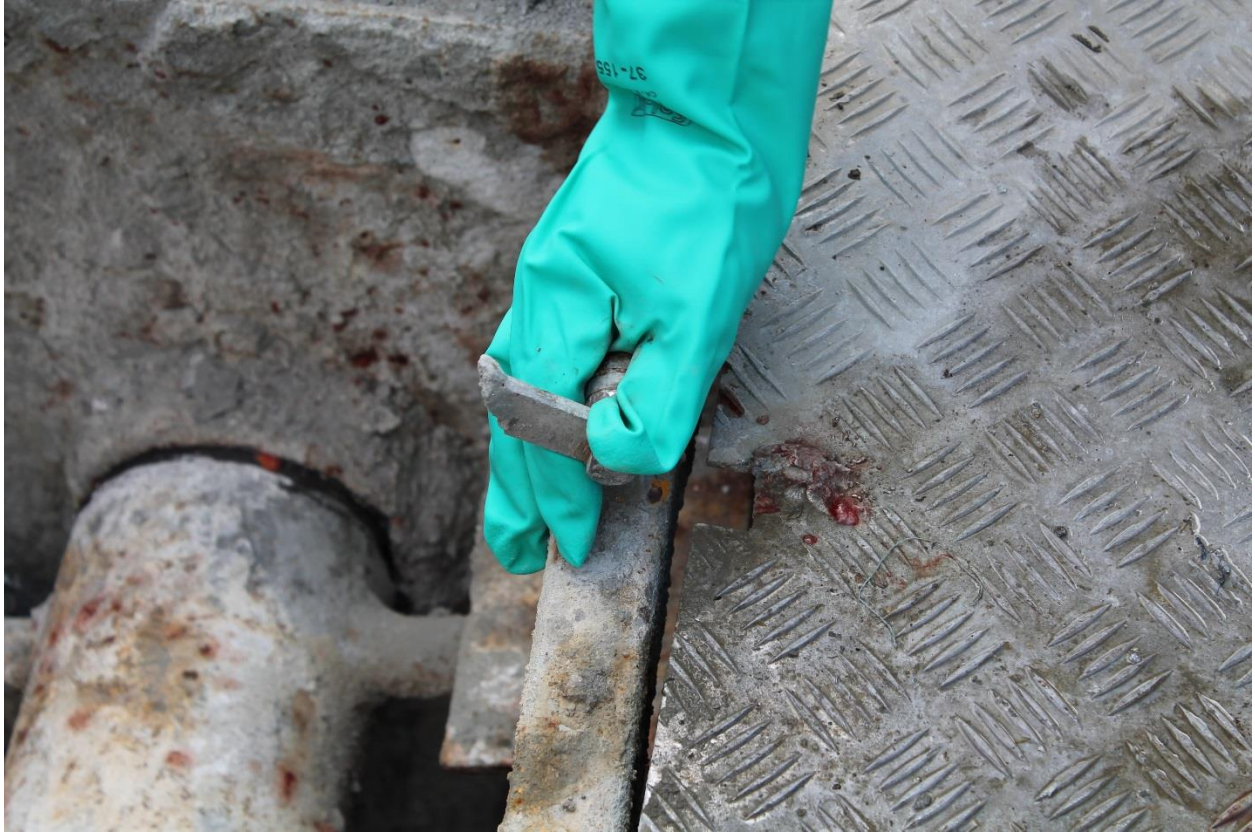
Documented procedures for scheduled maintenance would instruct employees on routine cleaning, pre-inspection and post-inspection, as well as requiring that broken or defective parts be immediately addressed. Broken hinges on the doors covering the mixer section were not repaired, and interlocks on the doors of the mixer section were missing which allowed the doors to be opened while the machine was running.

Photo 5: broken door hinge on the metal door covering the auger.

**Recommendation 1: Employers should develop and implement written procedures for maintaining the Rapidmix 400 C continuous mixing plant to include pre-inspection, cleaning the mixing plant inside and out immediately after each use, making prompt repairs to broken parts such as the broken door hinges, and promptly replacing missing and /or damaged parts such as interlocks for the doors covering the mixer section.**
