Factory Manager Bypasses Lockout/Tag-out and is Electrocuted

Incident Number: 14KY031

Kentucky Fatality Assessment and Control Evaluation (FACE) Program
Incident Number: 14KY031
Release Date: October 17, 2014
Subject: Factory Manager Bypasses Lockout/Tag-out and is Electrocuted

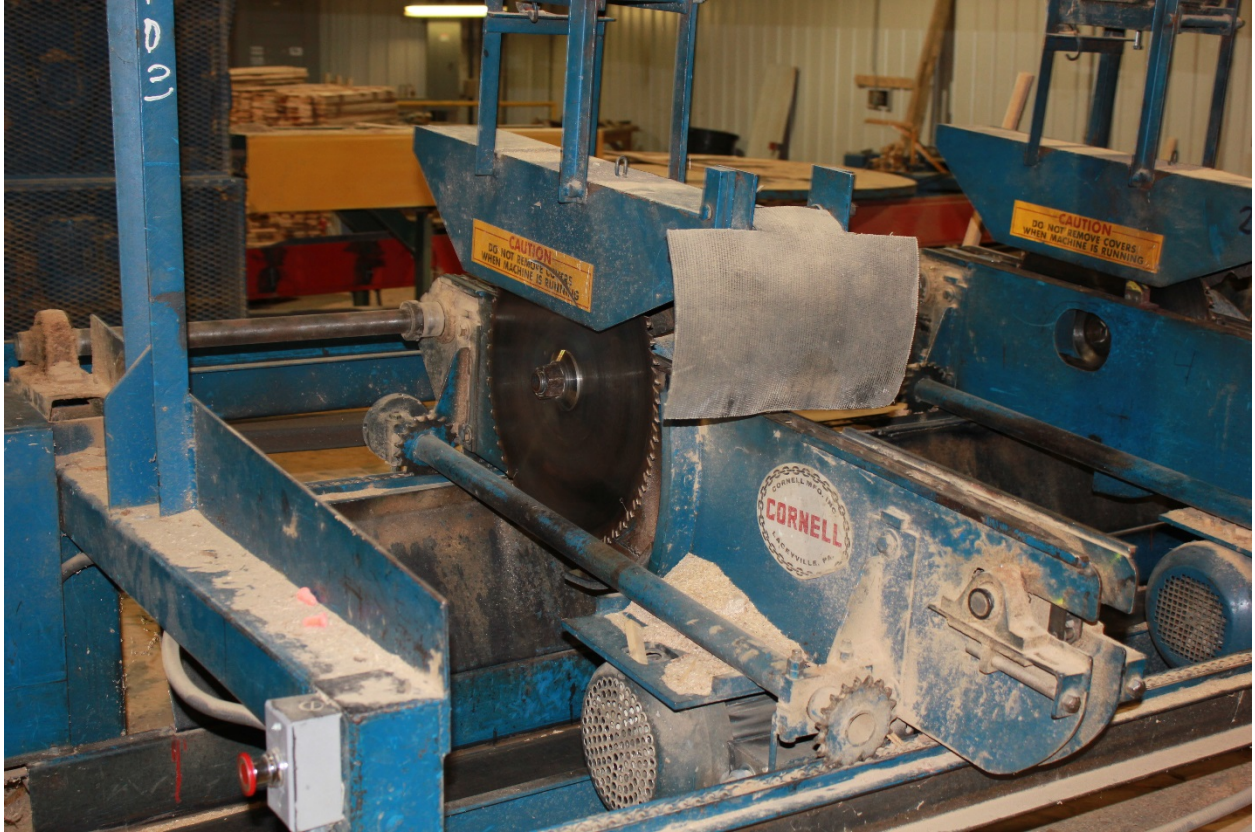
The incident occurred inside a fabricated metal building. The victim was by the control box of a five blade multiple trim saw. The saw was manufactured by Cornell Manufacturing, Inc. and was a model MSTB, Serial #294-4-86.

Multiple blade saw

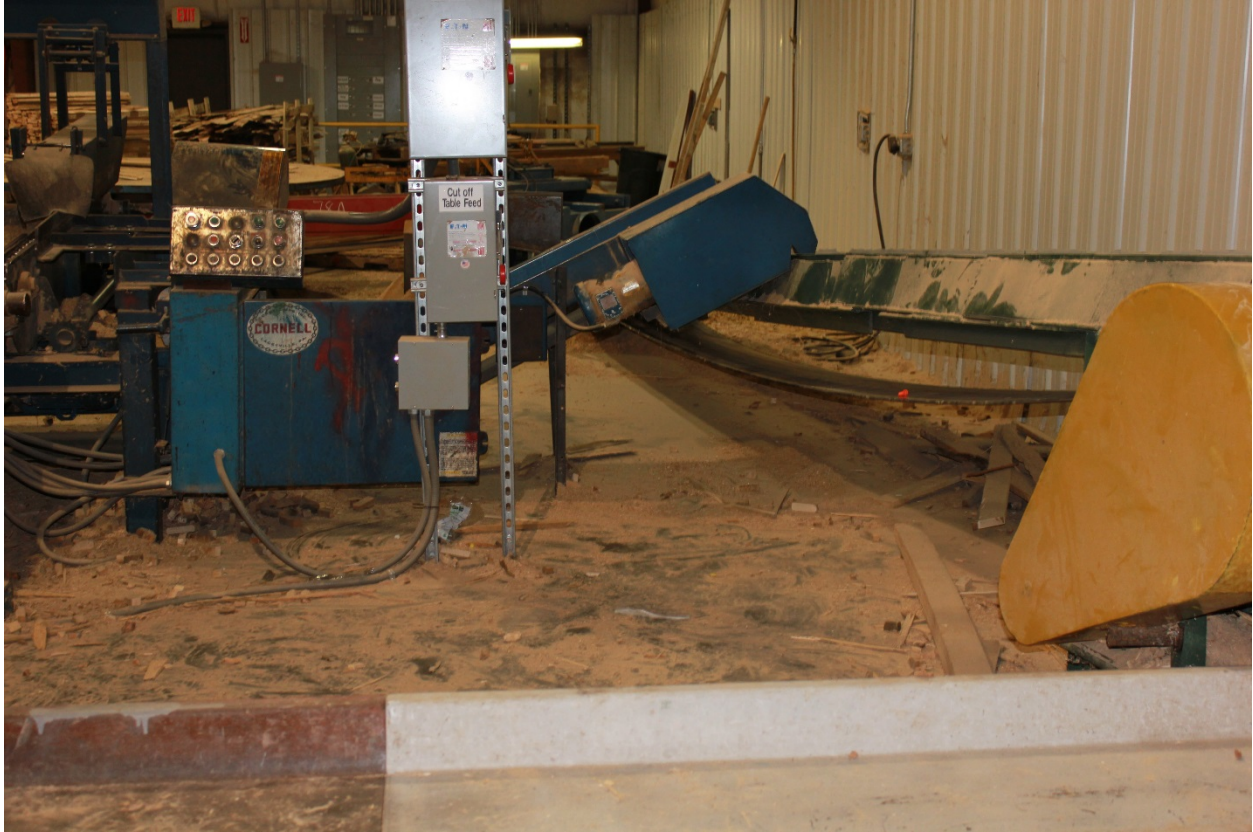
Incident Scene

The Department of Housing, Buildings and Construction Electrical Division was contacted by the Fire Marshall, who requested an electrical inspection of the incident scene. An investigation was opened on June 13, 2014. The inspector spoke with employees, who reported seeing the victim bend down in front of the open door of the machine control panel without first de-energizing it. The saw was fed from panel A, and protected by a 100 amp 3 pole breaker. The conduit and wiring from the main electrical panel to a 100 amp rated 3 pole was traced. The inspector found no electrical violations or concerns with equipment or wiring. He concluded that faulty equipment or wiring was not to blame for the incident that occurred.

Work area where victim was electrocuted.

Recommendation No. 1: Employers should ensure that all employees servicing or maintaining electrical equipment practice proper lockout/tag-out (LOTO) procedures.
