Teen Laborer Rides on Side of Forklift, Falls While Jumping, and is Run Over by Rear Tire

CASE SUMMARY

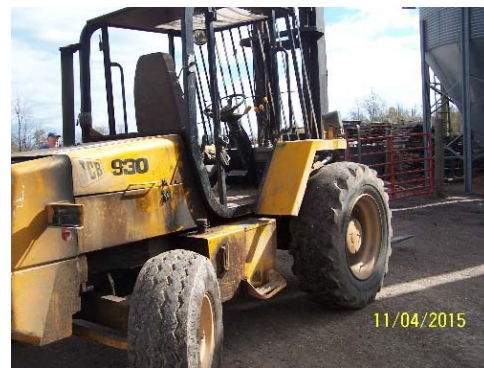
Figure 1. Rough Terrain JCB 930 forklift.

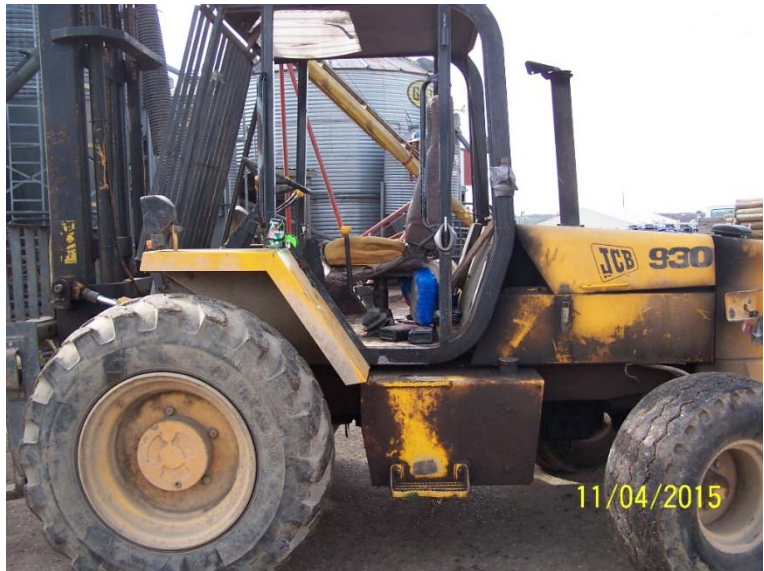
The equipment used at the job site was a JCB930 rough terrain forklift. This forklift is designed with a lift capacity of 6,000 to 10,000 pounds and a lift height of 15-22 feet. The lift was used to load and unload equipment purchased by customers and delivered by suppliers, and was equipped with one seat for a single operator. The forklift was not loaded at the time of the incident. A review of the user manual revealed that the JCB 930 was not designed to allow passengers, and that doing so could cause injury.

Figure 3. The JCB 930 rough terrain forklift at the scene of the incident.

OSHA regulations prohibit a passenger from riding on a forklift unless there is a passenger seat available for safe transport. The JCB 930 operator’s manual specifically stated that the forklift truck was not designed to accommodate passengers safely.

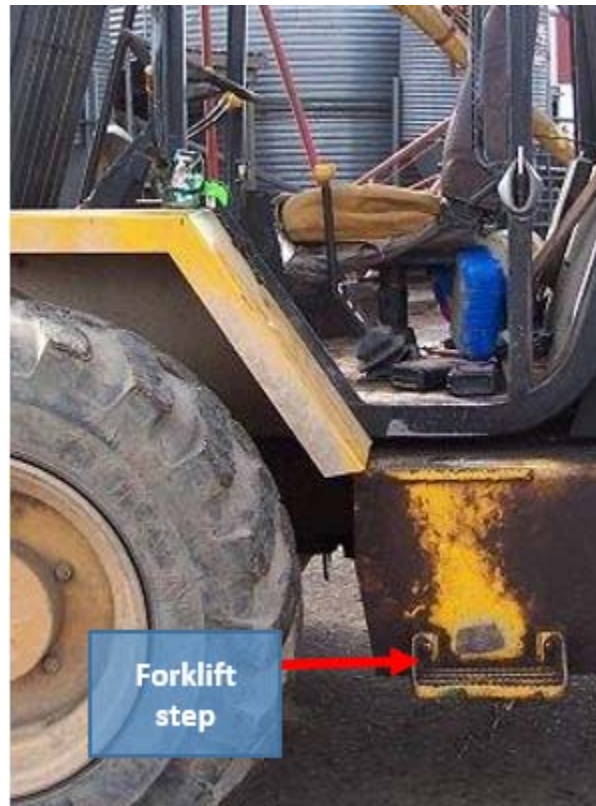
The victim shadowed a 19-year-old laborer who had been employed for one month, assisting him with various tasks. At approximately 4:50 pm, the 19-year-old laborer announced that he needed to lock the rough terrain forklift up for the night, and offered the victim a ride back to the storage area. The victim climbed onto the side of the forklift, standing on the side step and holding onto the frame of the forklift as they rode approximately 245 feet to the gated storage area (Figure 4). Moments later, as they approached the storage area, the victim volunteered to open the gate to the storage area. The victim jumped off the moving forklift, caught his foot under the forklift's wheel well, and fell face first to the dirt ground below. Unaware the victim had fallen, the young forklift driver proceeded forward until he sensed something beneath the wheel and stopped. The rear tire had run over the victim's chest, rib, and abdominal area. The forklift driver immediately backed the forklift off of the victim. A nearby customer, who happened to be a physician, heard the forklift driver screaming for help and rushed over to assist, instructing the employees not to move the victim. After experiencing a seizure, the victim regained consciousness and complained that he was experiencing severe pain. The physician stated the tire had ridden up the side of the victim's abdomen, right shoulder and the side of his head. Emergency medical services were immediately contacted at approximately 5:00 pm and arrived within 15 minutes. After assessing the extent of the victim's injuries, the EMS called for air transport. The victim was flown to a major trauma center where he arrived at 6:15 pm and died at 6:52 pm from his injuries.

Figure 4. The victim was riding on the forklift's side step at the time of the incident.

Recommendation No. 1: Do not allow passenger(s) to ride on a forklift unless the forklift is specifically designed to accommodate passengers.

29 CFR 1910.178(m)(3): “Unauthorized personnel shall not be permitted to ride on powered industrial trucks (forklifts). A safe place to ride shall be provided where riding of trucks is authorized.”²
