REPORT#: 17KY037

Gutter Installer Dies after Falling from Ladder Placed on Roof While Taking Measurements.

Fatality Assessment and Control Evaluation (FACE) Program

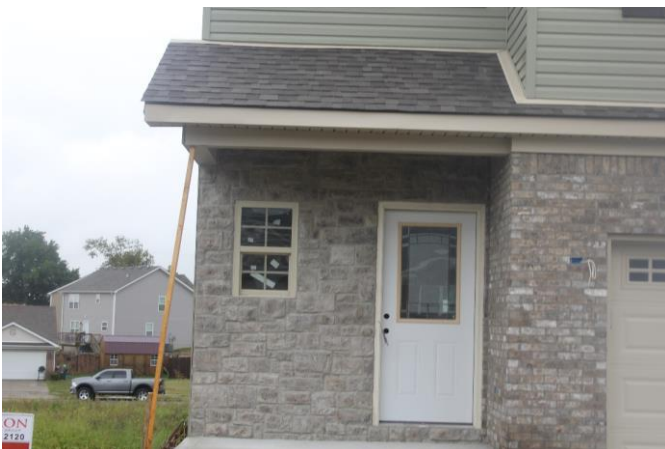
Photo 1: Porch area from which the victim fell (photo courtesy of KY OSHA).

Discussion: The victim and a coworker were on the roof of the porch, 10 feet 9 inches above the ground. In interviews with other employees, they acknowledged that the owner of the company had never directed them to wear fall protection nor were they ever trained on how to inspect or adjust a personal fall arrest system (PFAS). Failure to protect employees while working at heights and failure to properly train and document completion of fall protection training directly violates two separate OSHA standards.

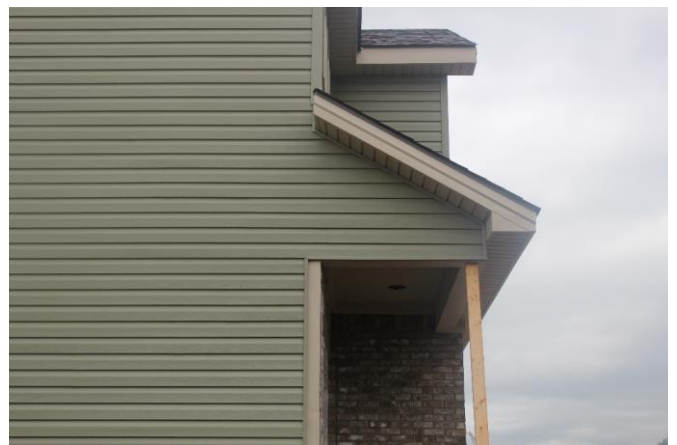
Photo 2: Side angle of the porch area (photo courtesy of KY OSHA).

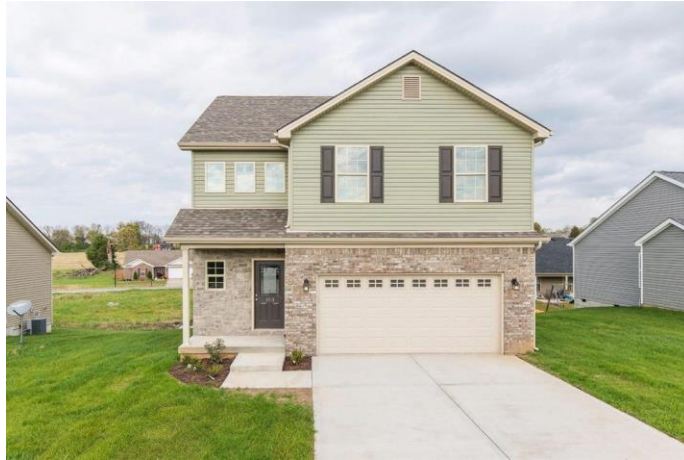
Photo 3: Finished house. (Photo property of KY FACE)

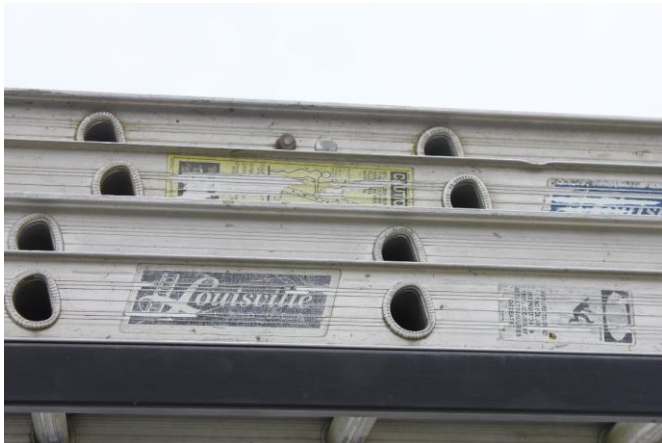
Photo 4: The two ladders used when the incident occurred.
(photo courtesy of KY OSHA)

On Friday morning, August 25, 2017, four gutter installation specialists arrived on the construction site of a new private residence for the purpose of installing gutters. This was their first day on the site. At approximately 11:00 am, the victim and a co-worker gathered two, 16 feet aluminum extension ladders and approached the front porch. The workers set up the first ladder on the side of the house in order to access the porch roof. The two then worked together to carry the second ladder up to the porch roof, where they positioned it in order to take measurements of the house roof. The victim ascended the second ladder while his coworker held the base of it in order to keep it in place. The victim took measurements and verbally communicated the results to the owner of the company who was located on the ground below. In an interview with the coworker who was holding the ladder, he stated that as the victim completed his measurements and began descending the ladder that was placed on the porch roof, the steep angle of the porch roof caused the base of the ladder to 'kick out' and strike the employee who was holding the ladder. This resulted in the victim, the coworker, and ladder all falling 10 feet 9 inches from the porch roof to the ground below.

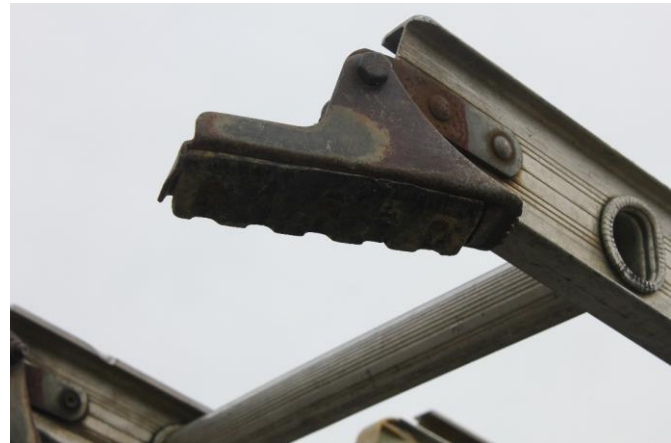
Photo 5: The base of the ladder from which the victim fell.
(photo courtesy of KY OSHA)

Discussion: At the time of the incident, the victim was descending a ladder whose base was being held in place by a coworker. The base of the ladder was positioned on the roof of the porch that had a measured pitch of 6:12. A roof’s pitch is measured by how many inches the roof rises for every 12 inches it moves inwards toward the peak (or ridge). A roof with a pitch of 6:12 would convert to an angle of 26.5°. According to 29 CFR 1053(b)(6): *Ladders shall be used only on stable and level surfaces unless secured to prevent accidental displacement.* Because of the slope of the roof upon which the ladder sat, precautions should have been taken by extending the ladder at least three feet above the point of support – in this case, the house roof – and secured there. If there was no feasible way to secure the top of the ladder to the house roof, efforts should have been made to secure the base of the ladder to the porch roof.

Recommendation #3: Ensure ladders are placed on sturdy, level ground or secured before use.

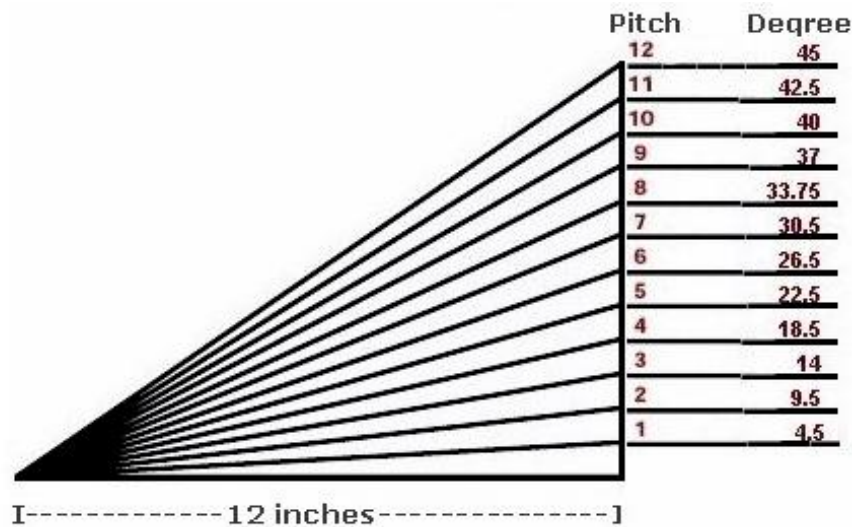
Photo 5: Chart showing the angle conversion of roof pitches
Stock image.
