REPORT#: 17KY057

REPORT DATE: 7-29-2019

Traffic Control Worker Struck and Killed by Vehicle While Setting up Cones on Interstate

State **FACE** Program

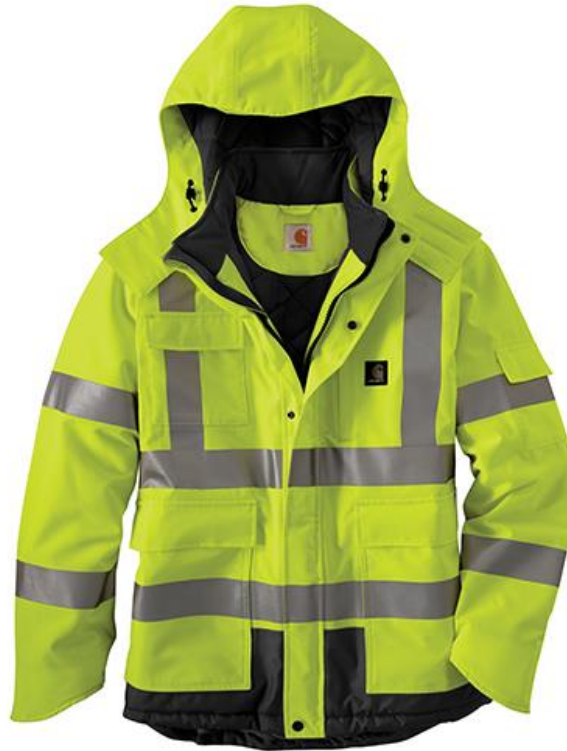
Photo 1. ANSI Approved class 3 jacket.
Stock image.

The victim was a 55 year old African American male who had been employed with the company since December of 2012. He was married and held an associate's degree. At the time of the incident, the victim and his two coworkers were all wearing ANSI-approved, class 3 high visibility jackets.

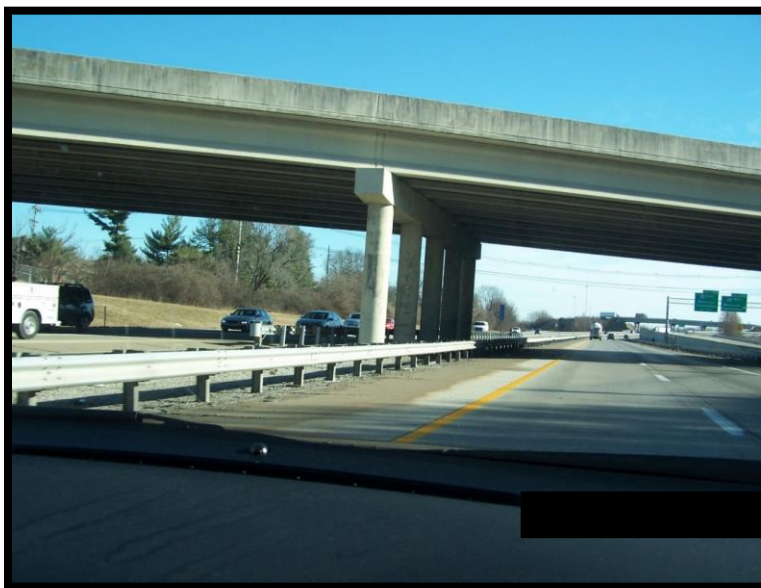
Photo 2. Street level view of the incident scene.
Photo property of KY FACE.

The incident occurred in the eastbound left lane of a major four-lane interstate near an underpass of a state highway. The victim was parked mostly on the shoulder, with a portion of the truck protruding into the left lane, preparing to place traffic cones in the left lane in order to close the lane leading to a construction zone.

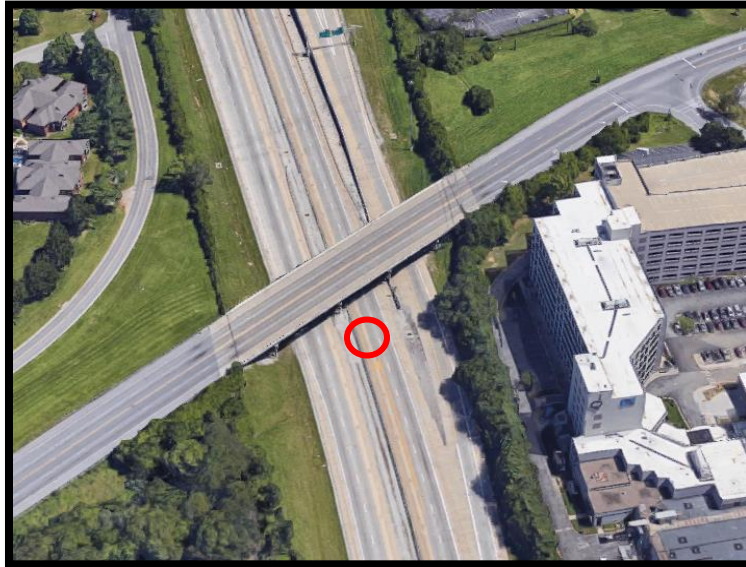
Photo 3. Aerial view of the incident scene. Red circle indicates where the collision occurred.
Photo courtesy of Google Maps.

As the victim’s co-worker was standing on the driver side of the truck, fully on the shoulder, the victim walked around to the rear passenger side of the truck. As he was preparing to brief the co-worker on their expected work activities, the victim was struck from behind by a compact SUV that was unable to merge into the middle lane in time to avoid the crash. The victim was crushed between the SUV and his work truck and then pushed under the work-truck.

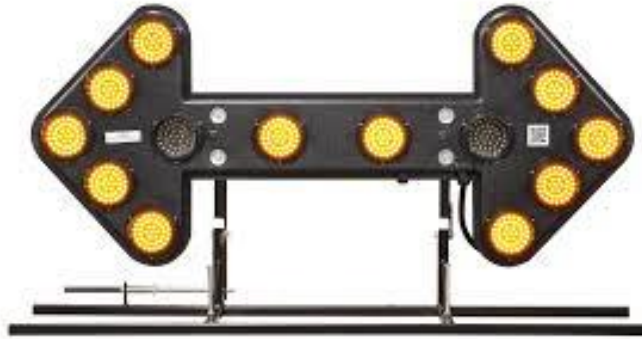
Photo 4: A 14-light vehicle mounted arrow board, similar to that found on the three work-trucks.
Stock image

At 8:00 pm, on Thursday, November 16, 2017, a traffic maintenance crew consisting of three employees were tasked with closing the eastbound left lane of a four-lane interstate in preparation of setting up a road construction site within a populous city. On the night of the incident, the three workers picked up traffic cones from the westbound lanes of the same interstate that had been placed several days before closing the left lane. The employees placed the cones in the beds of the three work trucks they were operating and drove to the left shoulder of the interstate travelling eastbound. Each work truck had operating brake lights, rotating strobe lights, and a 14-light split arrow Manual on Uniform Traffic Control Devices (MUTCD) type-D arrow board mounted on them. The arrows were all flashing to the right, indicating to oncoming traffic the need to merge before the lane ended.
