INCIDENT HIGHLIGHTS

REPORT#: 19KY013 REPORT DATE: 8/27/2019

IT Consultant Dies on Kentucky Interstate in Single Vehicle Collision.

Fatality Assessment and Control Evaluation (FACE) Program

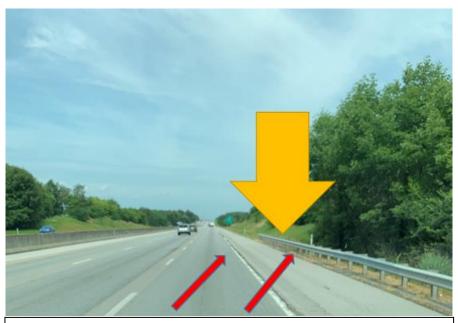
Photo 1. The **RED** arrows represent the initial path of the vehicle as it exited the travel portion of the roadway. The **YELLOW** arrow represents the first point of contact. (Vehicle vs. guardrail) Photo created by and property of KY FACE

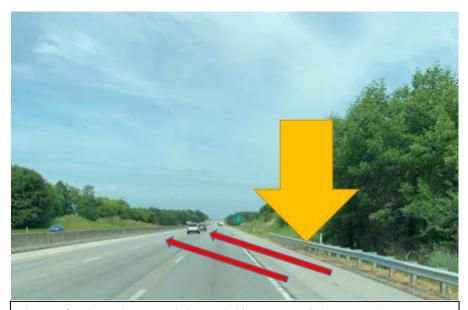
Photo 2. After the initial contact with the guardrail (YELLOW arrow), the victim took evasive action in an attempt to regain control. The victim overcorrected which resulted in the vehicle crossing all three lanes of traffic. (RED arrows) Photo created by and property of KY FACE

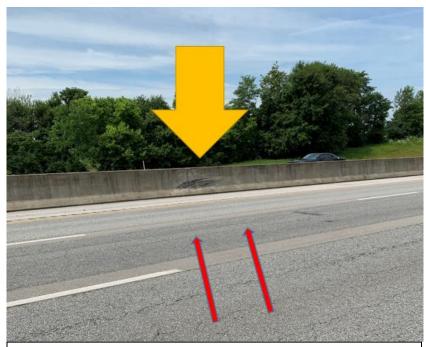
Photo 3. After crossing all three lanes of traffic (**RED** arrows), the victims vehicle struck the concrete divider (**YELLOW** arrow) where it came to final rest. Photo created by and property of KY FACE

struck the barrier on the front driver's side bumper where it came to final rest. No other vehicles were involved in the collision.

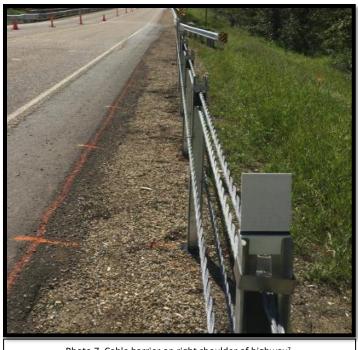
Photo 7. Cable barrier on right shoulder of highway7.

Recommendation #4: Replace W-beam highway guardrails with cable barriers.

Discussion: Studies support that the use of cable barriers greatly reduce the severity of injuries sustained during vehicle vs. barrier crashes when compared to W-beam and concrete barriers. According to the Minnesota Department of Transportation, when cable barriers are struck, posts break and cables flex to absorb the kinetic energy and redirect the vehicle along the barrier⁶. W-beam guardrails are more rigid, which increase the probability of a vehicle being forced back into the travel portion of the roadway leading to overcorrection and a secondary impact. In this case, the initial impact occurred with a W-beam guardrail on the right shoulder of the highway. The force of the initial impact, in addition to the driver overcorrecting, propelled the vehicle across all three travel lanes and into the concrete median barrier which separates east and west traffic flow. The secondary impact with the concrete barrier resulted in the fatal injuries the victim sustained.

The Kentucky highway department should consider installing cable barriers in place of W-beam guardrails in an attempt to reduce the severity of injuries sustained during motor vehicle vs. barrier collisions. In this case, the use of a cable barrier may have absorbed the force of the initial impact and redirected the path of the victim's vehicle in a straight line preventing it from crossing all three travel lanes and striking the concrete median barrier.
