**REPORT#:** 19KY034

## Gutter Installer Dies after Falling from Roof

### SUMMARY

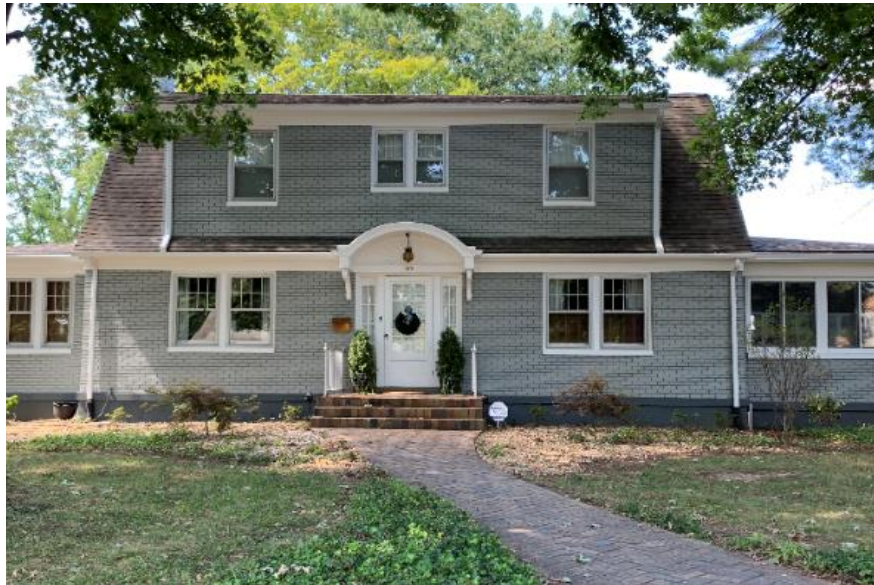
Photo 1. Front of the private residence where the incident occurred. Photo property of the Kentucky FACE Program.

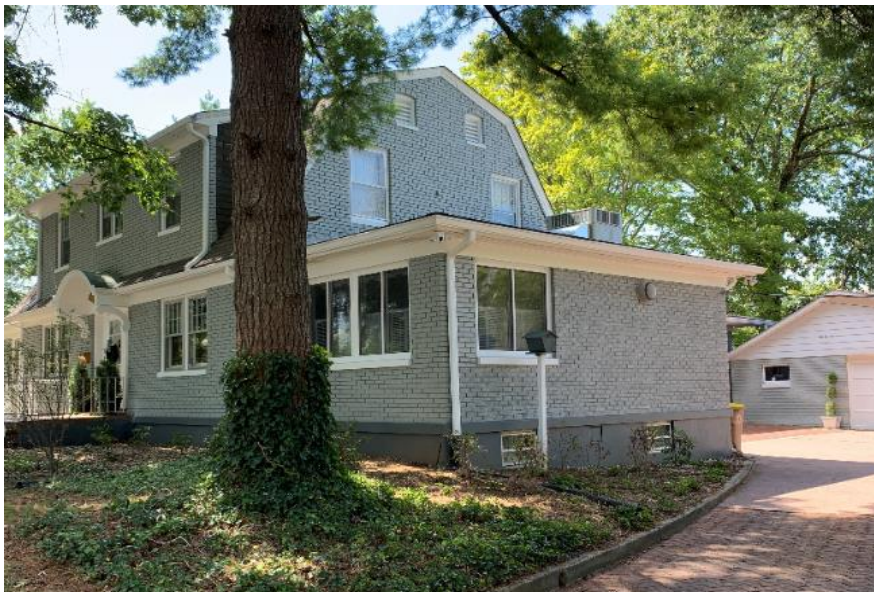
Photo 2. Rear of the private residence where the incident occurred. Photo property of the Kentucky FACE Program.

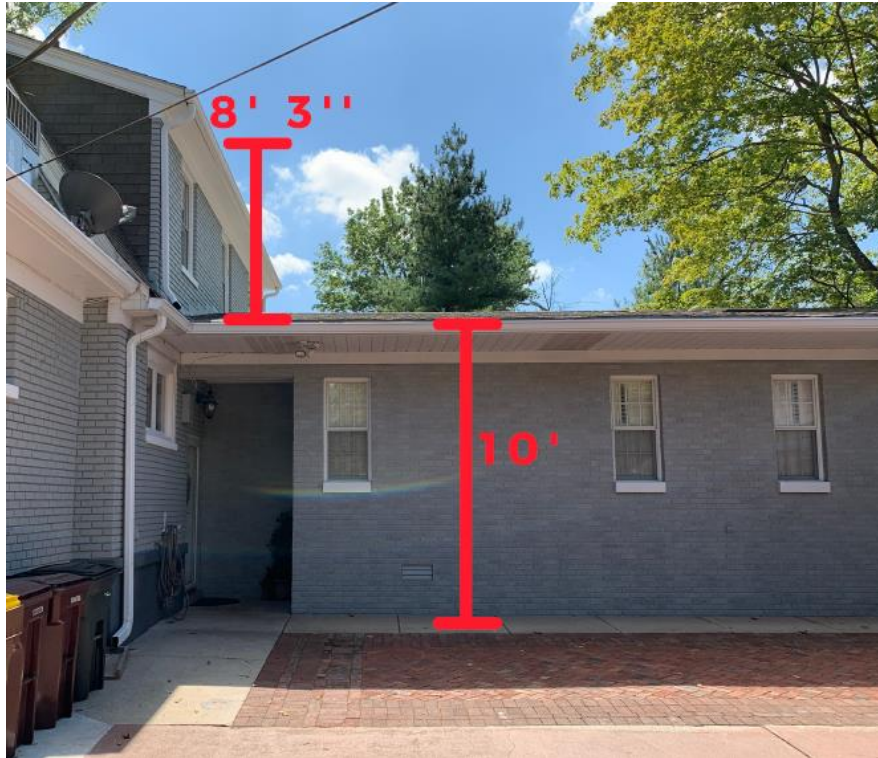
Photo 3. Roofs from which the victim fell. Photo property of the Kentucky FACE Program.

On Saturday, July 20, 2019, two employees, the owner of the company and the victim, arrived at a private residence to install gutter guards on the existing gutters of a two-story, single-family home. The first story is partially covered by a half-roof measuring 10 feet from the concrete driveway below. The second story roof covers the majority of the structure, and measures 8 feet 3 inches above the first story roof. The owner and the victim were working on the second story of the residence just prior to the incident occurring. The second

story roof has a pitch of 1:12, meaning the roof rises one inch for every 12 inches it moves towards the peak. A roof with a 1:12 pitch equates to an angle of approximately 45°. After working for approximately three hours, the owner exited the roof using a two-ladder system; one ladder resting on the first story roof extending to the second story and one ladder between the ground and the first story. The owner departed from the residence to pick up additional supplies needed to finish the job. As the owner was leaving, the victim's girlfriend was arriving at the residence. The owner stated he observed the victim sitting with his legs crossed on the second story roof, leaning forward to install the gutter guards as he pulled out of the driveway and left the premises. Within five minutes of leaving the residence, the owner of the company stated that he received a phone call at 10:30 AM from the victim's girlfriend, informing him that the victim had fallen from the second story roof, struck the first story roof, rolled off, and landed on the concrete driveway below. The owner immediately contacted 911 and returned to the residence. Upon his return, he observed the victim laying on the driveway unconscious, appearing to be suffering from a grand-mal seizure. A grand-mal seizure, also known as a tonic-clonic seizure, typically causes loss of consciousness and violent muscle contractions and is the result of abnormal electrical activity throughout the brain<sup>3</sup>. Emergency medical services arrived on the scene at 10:42 AM, and transported the victim to a local hospital. He was then airlifted to a larger metropolitan hospital where he was admitted in critical condition. The victim succumbed to his injuries seven days later on July 27, 2019.

### ***Recommendation #1. Train employees on and enforce the use of fall protection when working at heights above 6 feet.***

Companies who require employees to work at heights above 6 feet should train employees on fall protection, provide proper fall protection and enforce the use of fall protection in accordance to the associated OSHA standards.
