**REPORT#: 19KY045**

## Dump Truck Driver Dies on Kentucky Interstate in Single Vehicle Collision

#### Fatality Assessment and Control Evaluation (FACE) Program

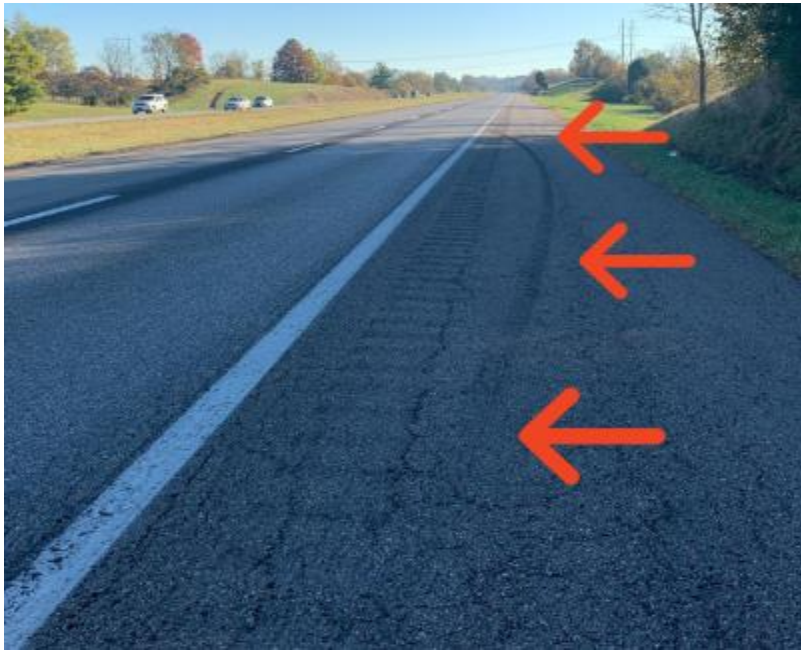
The incident initially began in the eastbound lanes of a major, four-lane interstate with a posted speed limit of 70 miles per hour. East and west-bound traffic is separated by a grassy median that measures 35 feet across; no barrier was present in the median. The involved vehicle, a 1981 Chevrolet, C-70 dump truck crossed the median, traveled across the westbound lanes, and struck an earth embankment head on, on the westbound right shoulder of the highway. The truck came to final rest positioned partially off of the shoulder with the front of the truck impacting the embankment.

Photo 1. Photo depicting the path traveled as the dump truck crossed the median and struck the earth embankment. Yaw marks were produced by the passengers' side front steer axle tire which resulted from the driver taking evasive action. Photo property of KY FACE.

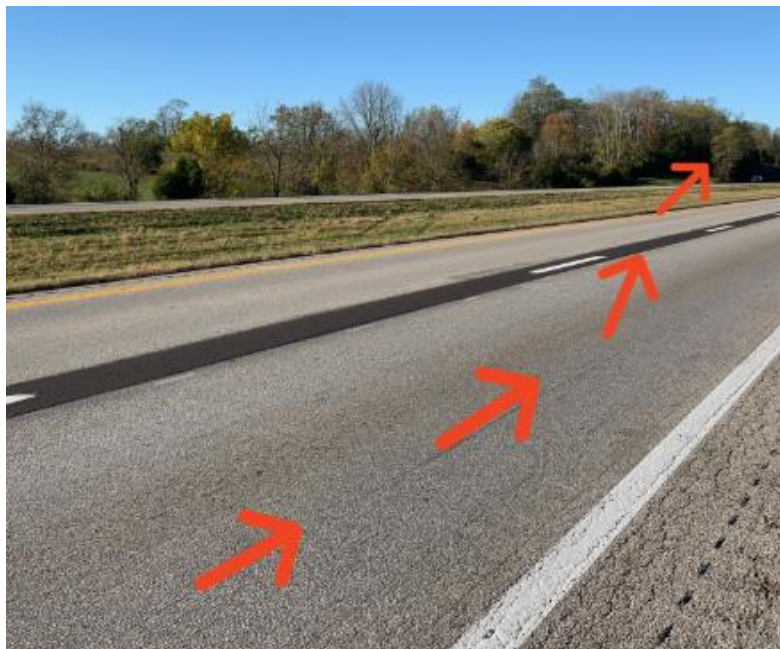
Photo 2. Photo representing the path the dump truck traveled as it left the roadway and crossed the median. Photo by and property of KY FACE.

Discussion: No type of median barrier was present at the scene; statistics prove that median cable barriers are an effective countermeasure in reducing the severity of collisions. According to a study conducted by the Michigan Department of Transportation (MDOT) in 2008, the installation of median cable barriers reduced cross-median collision by 87%. Furthermore, both severe injury and fatality collisions were decreased by 33% and rollover collisions reduced by 50% after the installation of median cable barriers<sup>10</sup>.

The Kentucky highway department should consider installing cable median barriers on all limited access highways and interstates to prevent median crossover collisions.

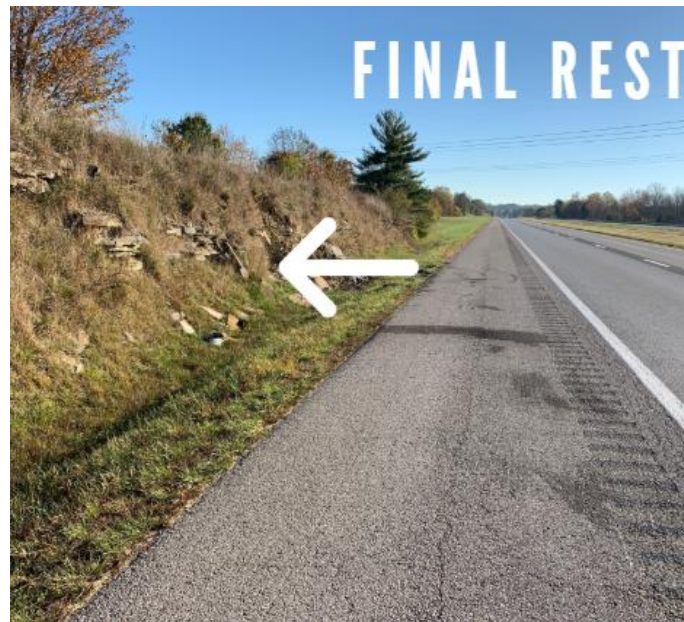
Photo 3. Photo representing the point in which the dump truck struck the earth embankment and came to final rest. Photo by and property of KY FACE.

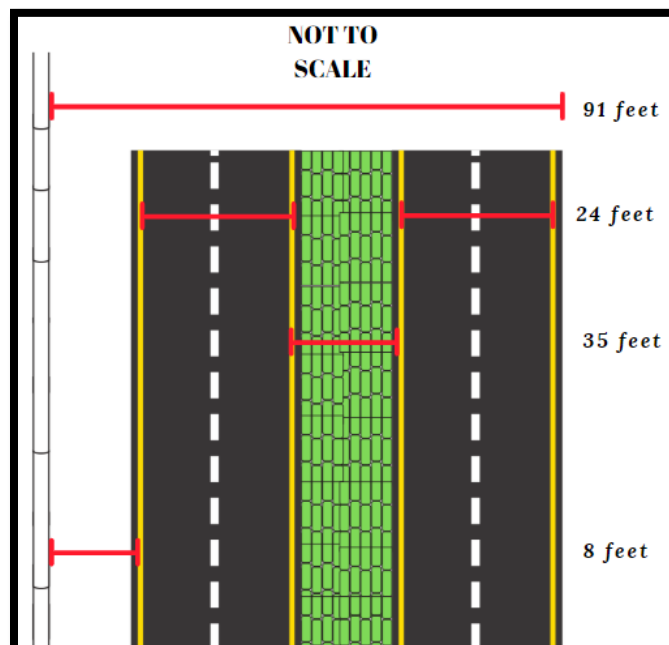
Diagram 1. Animation showing relevant measurements at the scene of the crash. Photo by and property of KY FACE.

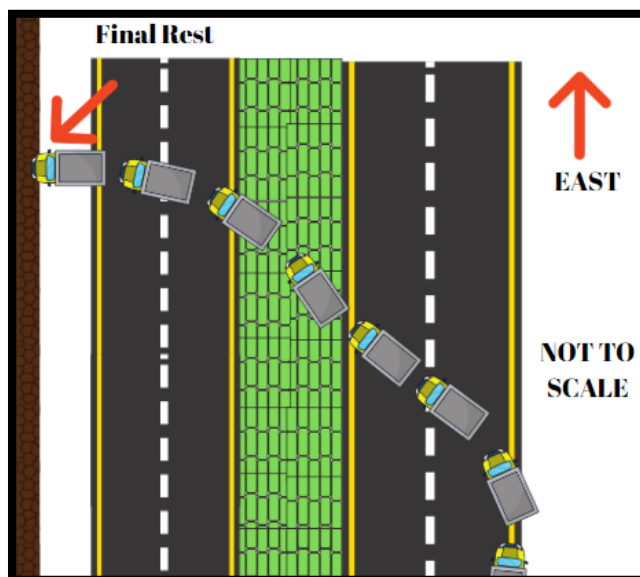
On Tuesday, August 20, 2019, a dump truck driver was operating a 1981 Chevrolet, C-70 dump truck eastbound on a major four-lane Kentucky interstate en route to the driver's place of business. The victim had just purchased the dump truck he was operating earlier that evening at an out-of-state auction. At 12:40 AM, the driver's side steer axle tire failed and disintegrated while the vehicle was traveling at an estimated speed of 70 mph. Yaw marks present on the right shoulder of the eastbound lanes suggest the driver attempted to oversteer to compensate for the blown tire, but was unable to maintain proper control of the vehicle. The dump truck exited the travel portion of the highway to the left and entered into the grassy median that separates the east and westbound lanes of traffic. Due to the absence of a barrier, the vehicle continued across the median and into the westbound traffic lanes. The truck traveled across the westbound traffic lanes and struck an earth embankment located on the right shoulder of the westbound lanes. The force associated with striking the earth embankment severely damaged the driver's portion of the cab. First responders arrived on the scene of the crash within ten minutes of the incident. Upon approaching the vehicle, it was determined that the driver had succumbed to the injuries sustained in the crash, and he was pronounced dead at the scene. Accident investigators determined the victim was not wearing a seat belt.

Diagram 2. Animation showing the path the dump truck traveled as it crossed the median and struck the earth embankment. Photo created by KY FACE.

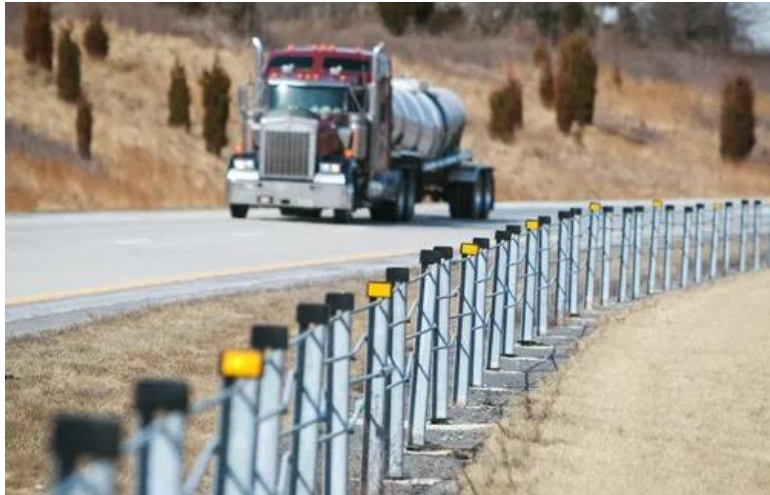
Photo 7. Photo depicting standard installation of median cable barriers on an interstate highway<sup>11</sup>.

***Recommendation #4: Install Median Cable Barriers.***
