REPORT#: 20KY010

REPORT DATE: 8/17/20

Semi-Truck Driver Dies in Single Vehicle Collision After Truck Overtakes

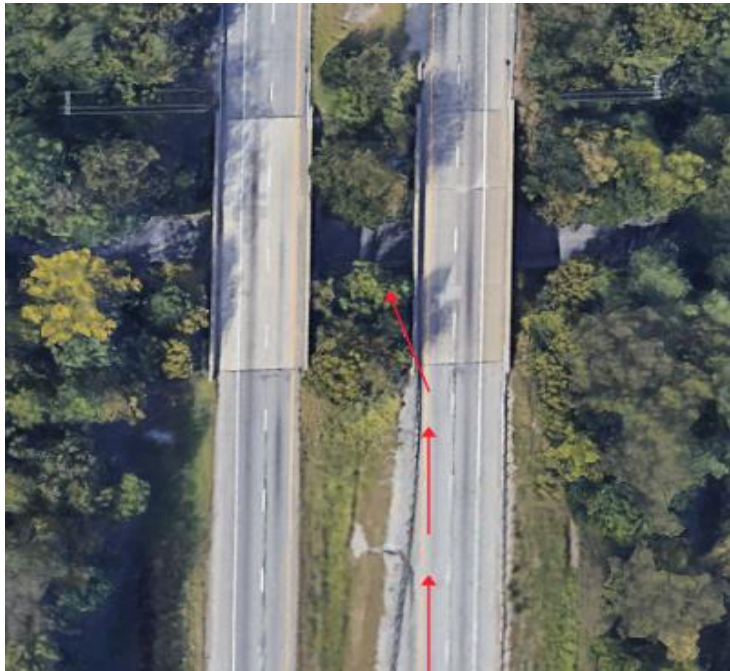
Photo 1. Google image of the location where the collision occurred.
"Kentucky Interstate," by Google, Digital Image.

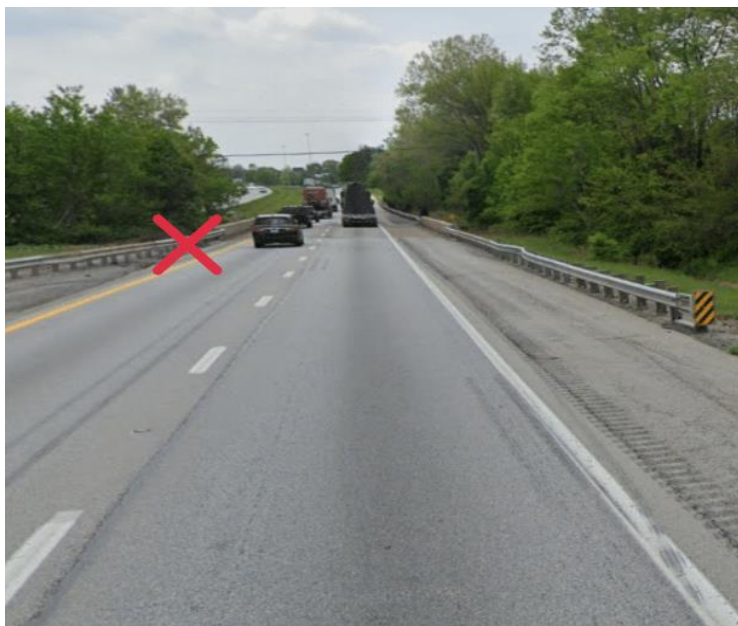
Photo 2. Google image of the location where the collision occurred.
"Kentucky Interstate," by Google, Digital Image.
