**REPORT#: 20KY030**

## Dump Truck Driver Dies in Multi-Vehicle Collision after Truck Overtakes

#### Fatality Assessment and Control Evaluation (FACE) Program

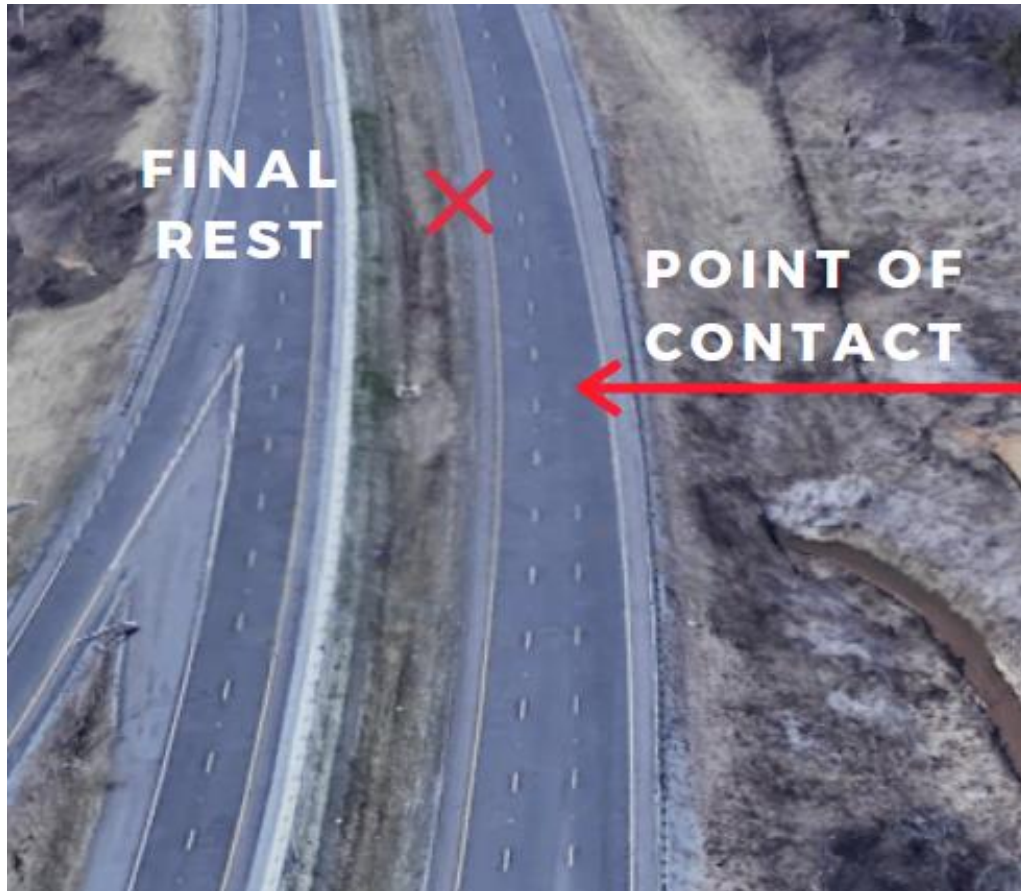
The incident initially began in the westbound lanes of a major, four-lane interstate highway with a posted speed limit of 70 miles per hour. Eastbound and westbound travel lanes are separated by a grassy median that measures 20 feet across. A cable barrier is present on the eastbound, left shoulder of the interstate. The point of first contact occurred in the right lane as a passenger vehicle was merging onto the interstate via an on-ramp, situated to the right of the interstate. The merging vehicle struck the passenger's side of the victim's vehicle, resulting in the victim losing control. After the victim's vehicle was struck, it veered left and struck a second passenger vehicle, also traveling next to the dump truck in the left lane. The dump truck began to rollover as it rotated 180 degrees and came to final rest overturned on the driver's side in the median.

Photo 1. Google image of the location where the collision occurred. "Kentucky Interstate," by Google, Digital Image.
