REPORT#: 20KY040

REPORT DATE: 1-21-2021

Truck Driver Killed After Vehicle Rollaway

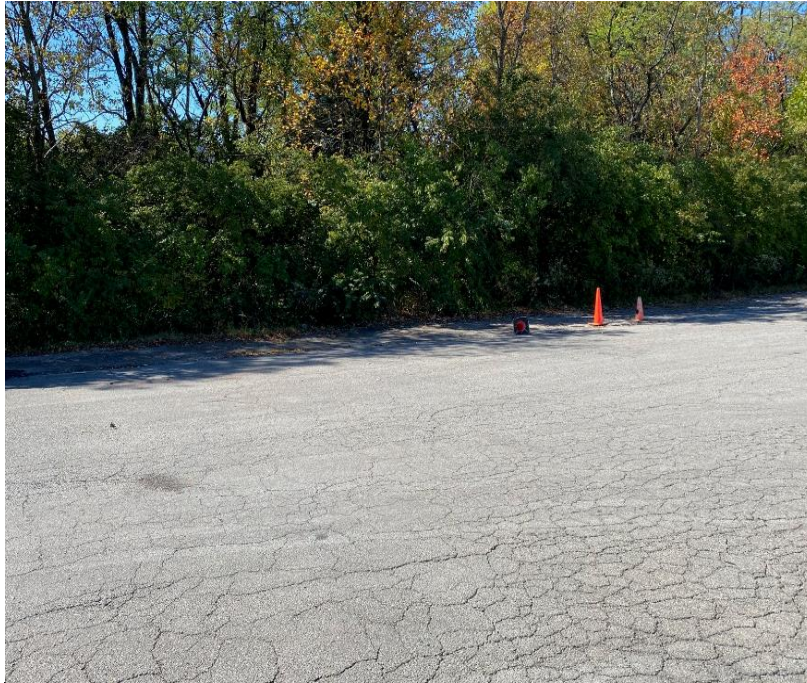
The incident occurred in a parking lot, near a manufacturer's facility. The victim had just finished loading freight from the business and had obtained a weight ticket from their on-site scale. The facility had just closed for the evening and the driver was attempting to park his vehicle overnight. The parking lot is generally level; however, the spot in which the driver chose to park had a descending grade of approximately 6%.

Photo 1. Picture of area where truck parked. Photo property of Kentucky FACE.

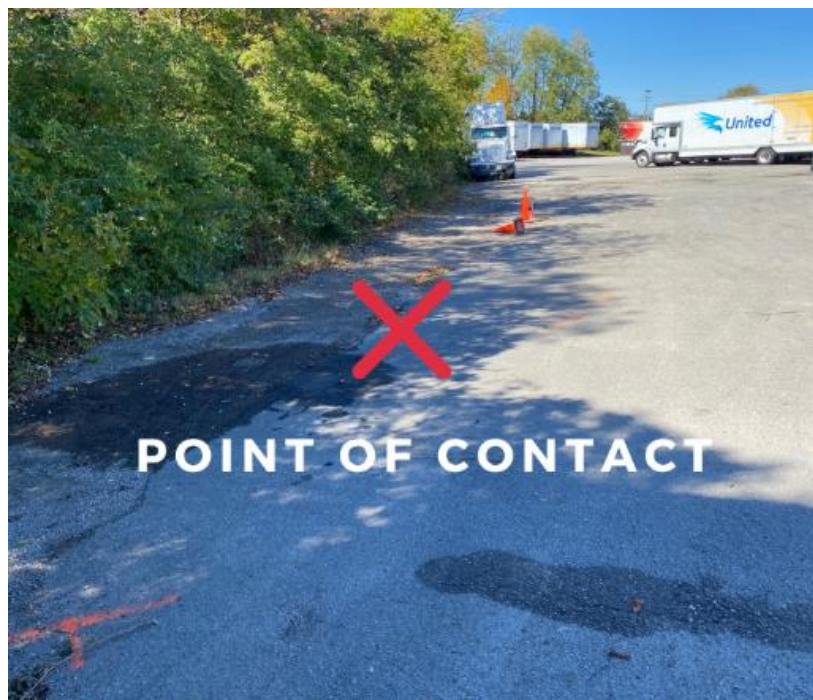
Photo 2. Picture depicting point of contact between the front of the involved truck and the victim. Photo property of Kentucky FACE.

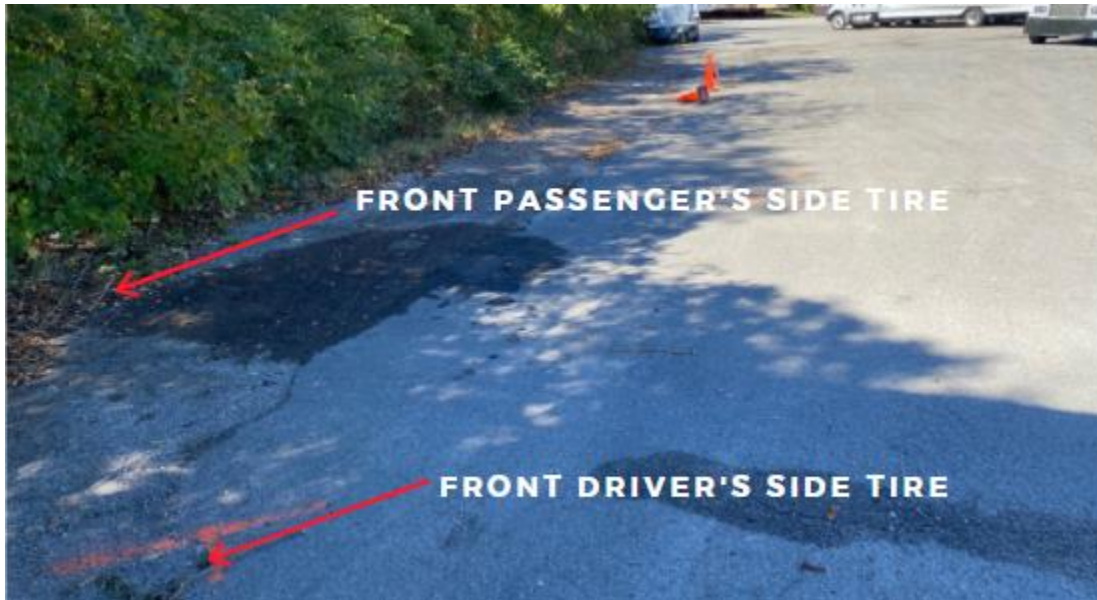
Photo 3. Picture depicting location of front steer axle tires at final rest. Photo property of Kentucky FACE.

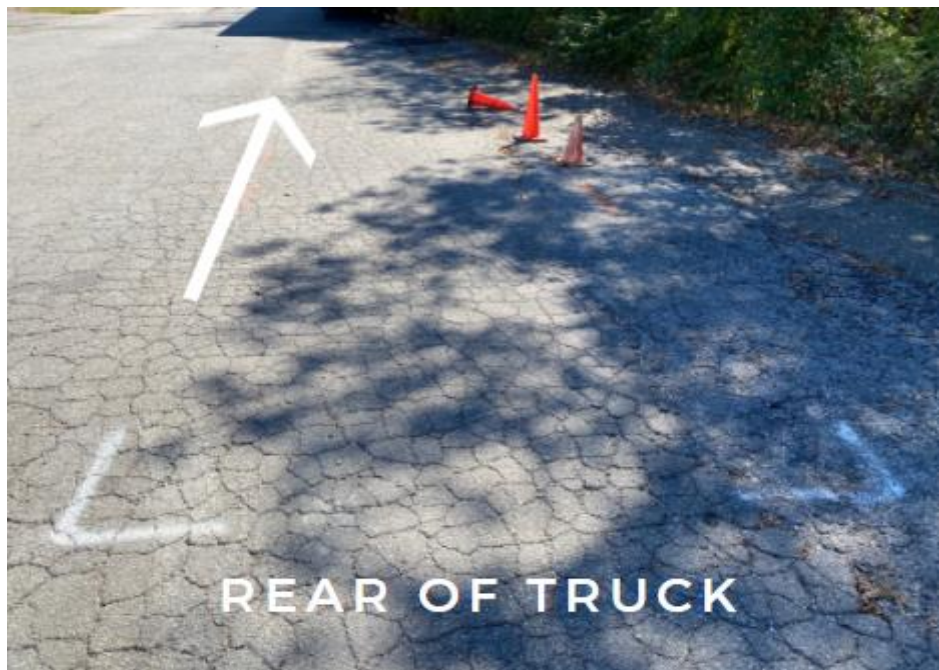
Photo 4. Picture depicting location of rear axle trailer tires at final rest. Photo property of Kentucky FACE.

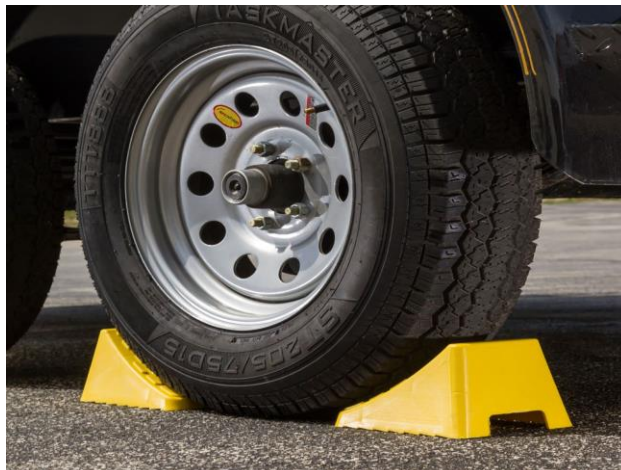
Photo 5. Picture depicting typical wheel chock configuration (Bing Image, 2020)

- Parking spot selection – When possible, drivers should select a parking spot that is level.
- Turn off the ignition
- Set truck parking brake and trailer parking brake
- Check mirrors
- Verify truck and trailer parking brakes are set
- Pause before exiting, observe for movement prior to exiting
- Exit truck and deploy wheel chocks

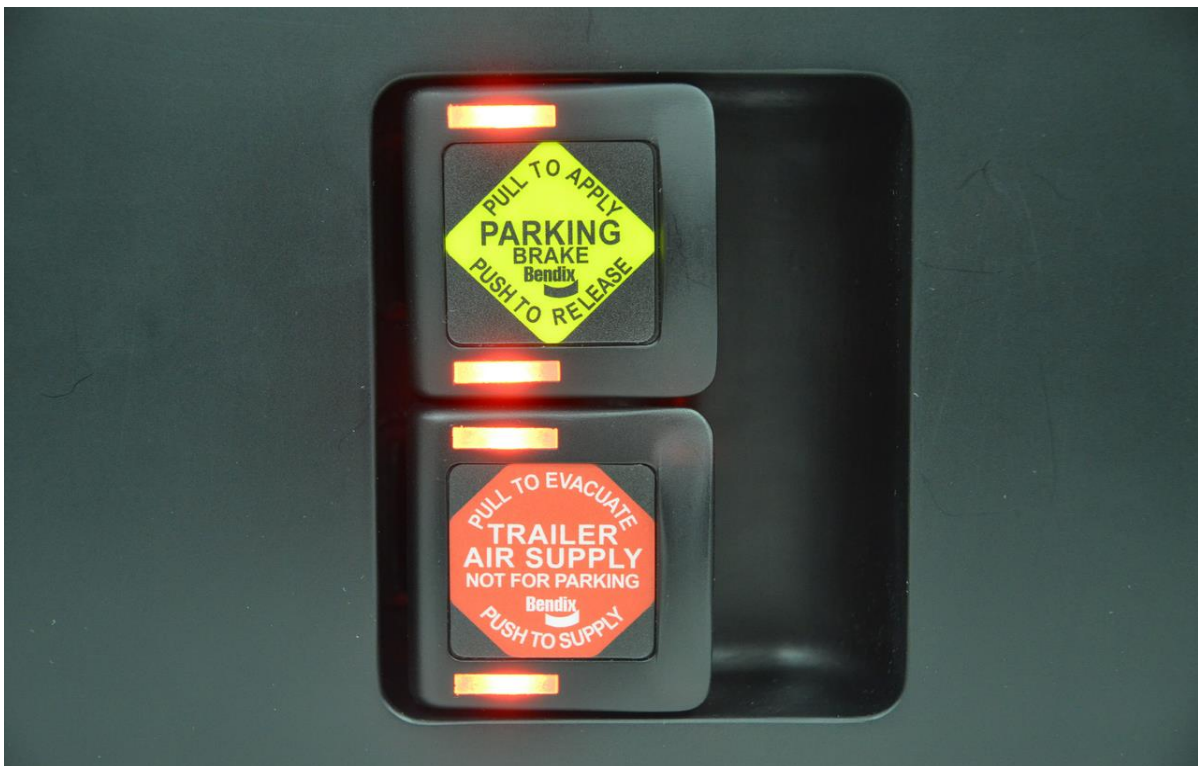
Picture 2. Picture of Bendix Intellipark LED brake interface. Retrieved from <https://www.oemoffhighway.com/drivetrains/brake-system/press-release/21060126/bendix-commercial-vehicle-systems-llc-bendix-pilot-testing-intellipark-electronic-parking-brake-with-fleets>

Discussion: Rollaway prevention technology exists to help drivers combat the dangers associated with failing to set the brakes. This technology works through a system of interlocks that are installed in critical areas, such as the seat, seat belt or cab door, and works by automatically engaging the parking brakes if the driver opens the door or exits the seat without doing so.

Heavy truck manufacturers are also offering add-on equipment features to notifying the driver if he or she fails to set the parking brakes before opening the door. Rather than applying the brakes for the driver, this system honks the horn if the driver opens the door without setting the brake. This audible tone would alert the driver immediately, drawing his attention to the fact he failed to set the brakes. Commercial carriers should equip company trucks with rollaway prevention technology to help prevent rollaway collisions from occurring.

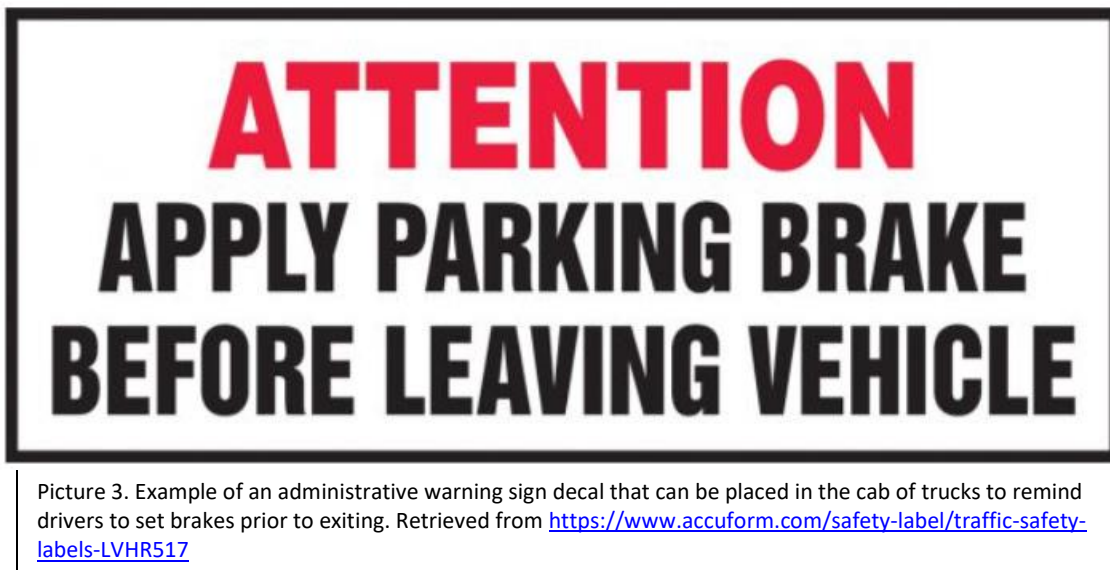
Discussion: Administrative controls, such as warning signs and postings can be an effective addition to any safety program by providing a visual reminder of a previously established policy or procedure. Administration controls, although 4th in the hierarchy of hazard controls, can further establish the desired muscle memory and application of a procedure. In this case, the victim exited the truck without first setting the parking brake. Commercial carriers should implement warning signs into the cab of their trucks to help remind drivers to set the parking brakes prior to exiting the vehicle. The warning signs should be in a clearly visible location, contrasting colors, easy to read and specific to the desired behavior.

Recommendation #3: Administrative controls, such as warning signs should be implemented to remind drivers to set brakes.
