REPORT#: 20KY065

REPORT DATE: 4/12/2021

Field Technician Dies after Contacting Downed Power Line

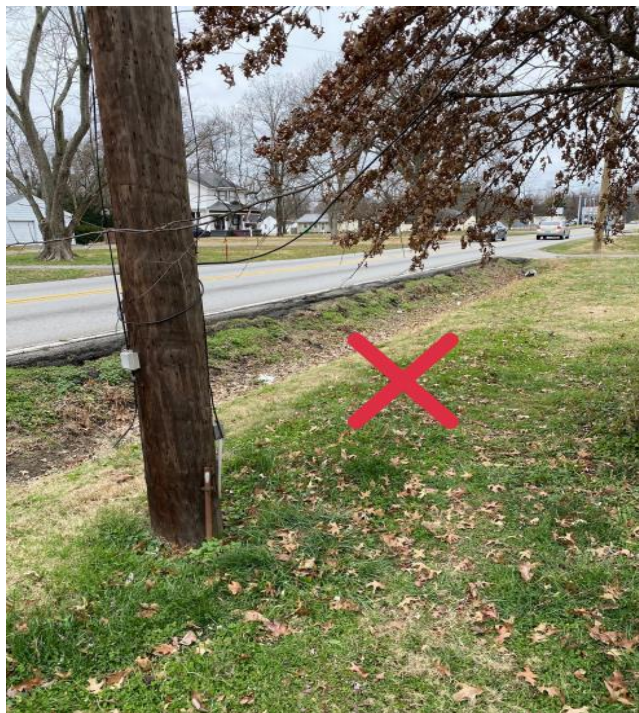
Photo 2. Picture which notates the location the victim was standing when he was electrocuted. Photo property of Kentucky FACE.

On November 4, 2020, a two-person crew departed their out-of-state place of business en route to a Kentucky metro area with the task of surveying power lines to develop future engineering plans. The job site was a residential area with homes located on each side of a two-lane highway. Due to the placement of the utility poles and their proximity to the highway, the job required them to work in the front yards of private residences. The employees worked their way from pole to pole, collecting data such as pole height, distance between poles, and each pole's proximity to the highway. The data collected would later be utilized to develop engineering plans for the installation of fiber optic cable. Throughout the course of their duties, the crew encountered a downed power line, which investigators determined was likely from a recent windstorm. According to a company representative, the downed power line was entangled in a nearby tree that sat approximately eight feet from the utility pole. The company representative stated that after the victim located the downed line, he worked to free it from the tree. Although the line was not initially energized, at some point in the process of untangling the wire, it became energized and delivered an electric shock to the victim, killing him instantly. As the victim maintained contact with the wire, his clothing caught fire, and his body was burned.

Recommendation #1: Employers should consider development of policies and procedures that specify the standard operating procedures for employees who encounter a downed power line.

To help avoid future similar events, employers should develop standard operating procedures that specify what actions employees are to take when a downed power line is encountered and restrict employees from engaging in activities in which they are not adequately trained to complete.

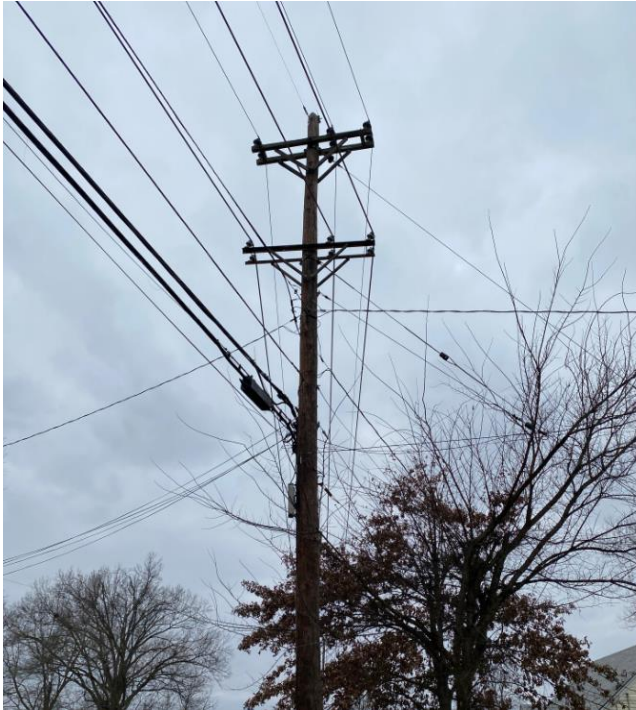
On Wednesday, November 4, 2020, a two-person crew was tasked with surveying utility pole placement in order to develop engineering plans. During the course of their duties, a downed power line was discovered that resulted from a recent windstorm. One of the employees, the victim, attempted to move the power line but discovered that it was tangled in a nearby tree. As the employee worked to remove the entangled power line, it became energized and electrocuted the victim as he held the wire.

Photo 3. Picture of utility pole which was being surveyed by the victim and his colleague. The pole pictured housed the wire which had broken loose and ultimately electrocuted the victim. Photo property of Kentucky FACE.
