# **Roofer Dies After Gust of Wind Knocks Him And A Co-Worker Off Roof**

**Incident Number: 13KY059**

## **Kentucky Fatality Assessment and Control Evaluation (FACE) Program**

**Subject: Roofer Dies After Gust of Wind Knocks Him And Co-worker off Roof**

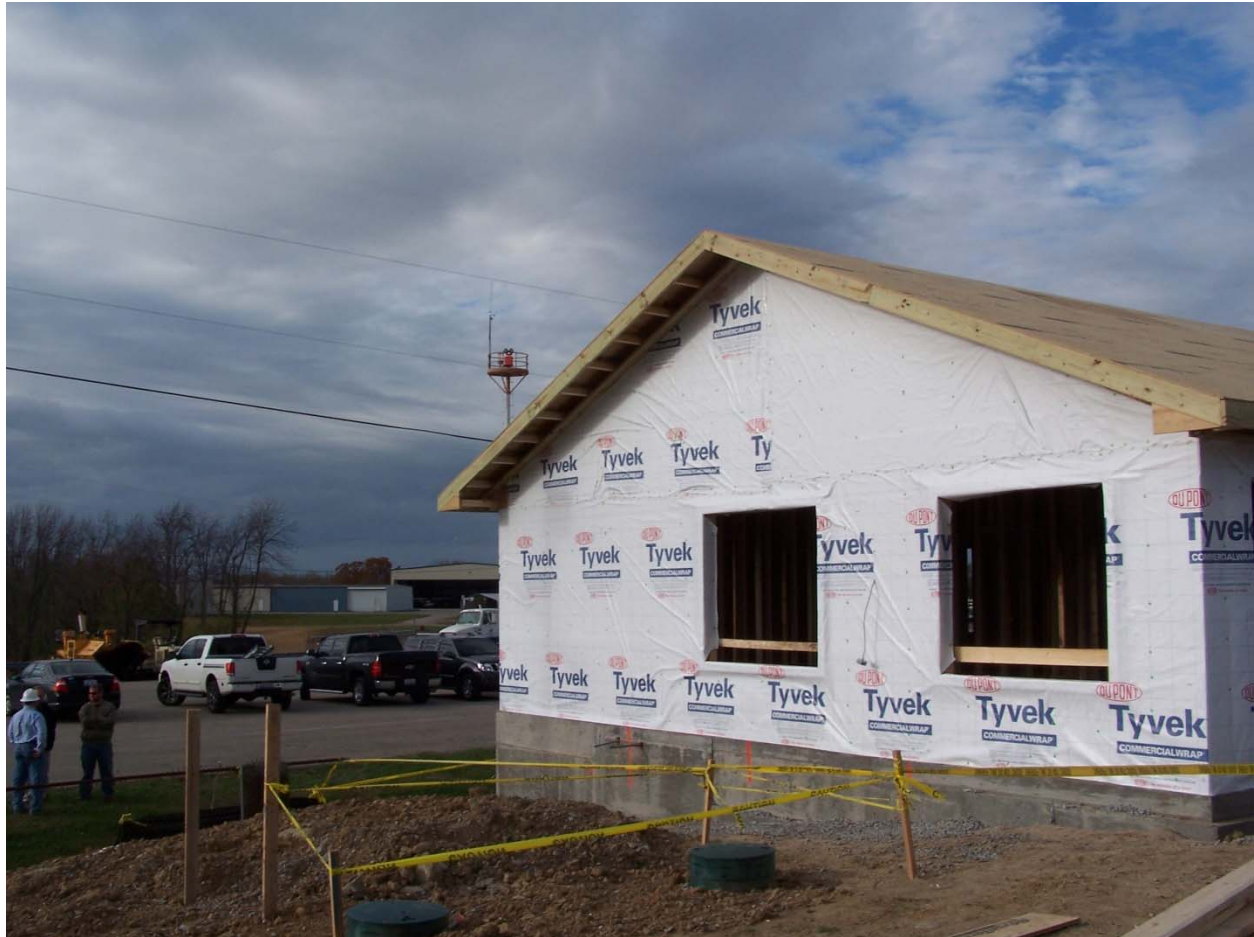
**The fall took place from this structure. Photograph property of KY FACE Program**

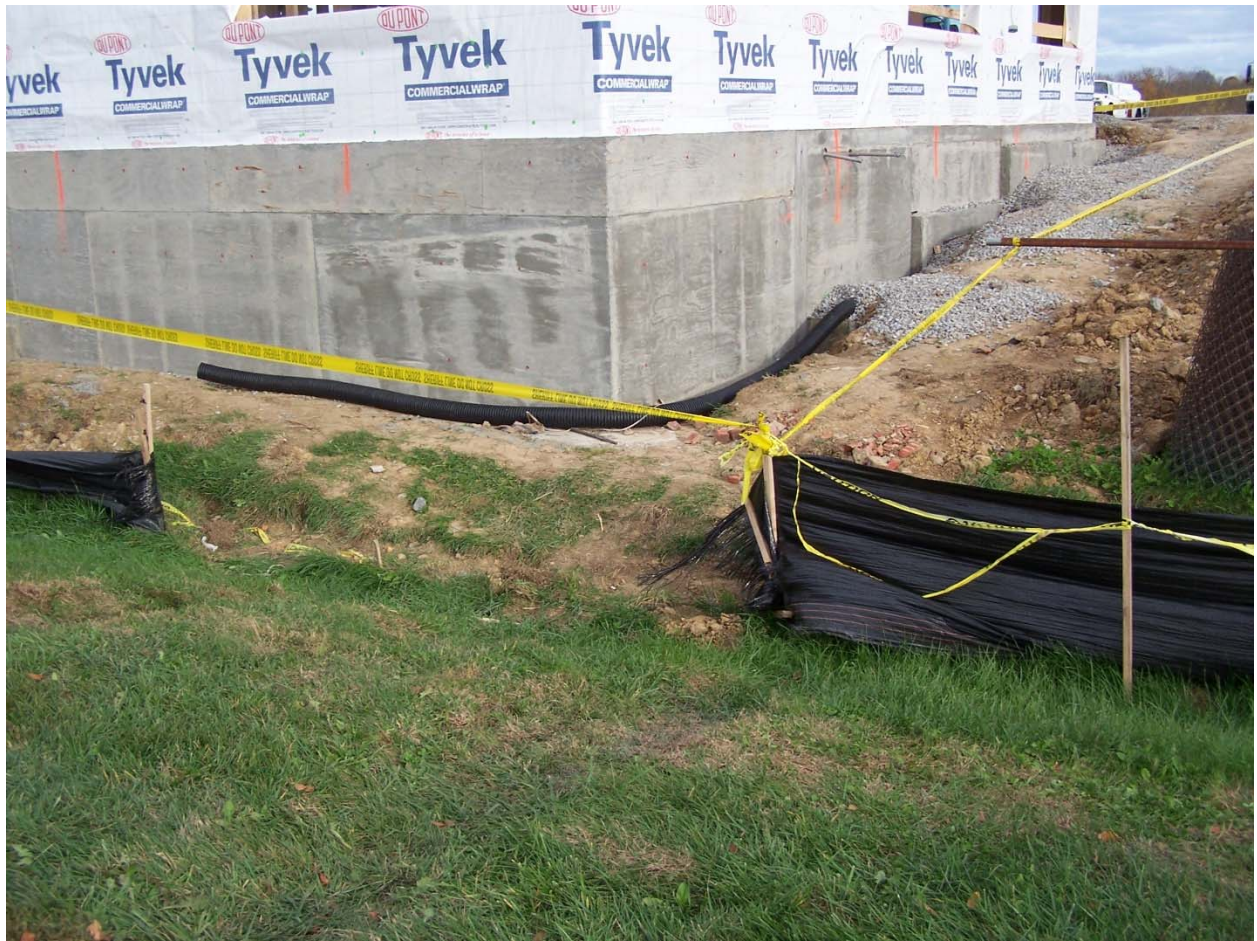
Around 11:00 a.m. on a windy fall day, a 73-year-old roofer and roofing coworker arrived at the commercial construction site to roof a newly constructed building. The two roofers climbed the extension ladder to access the roof of the one story commercial building, to decide where they were going to place their anchors to tie off. They had not yet put on their personal fall protection gear. While reviewing the backside of the commercial structure, a gust of wind around 33 m.p.h. made the two roofers lose their balance and fall from the roof. At 11:09 a.m., the 73-year-old roofer landed first and the second roofer landed on top of him. Both roofers fell 15 feet 6 inches and landed on a sloped grassy area next to the commercial building.

Area of impact where employees landed from fall. Photograph property of KY FACE Program
