Owner of Towing Company Dies When Struck by Box Truck

Incident Number: 12KY035

Kentucky Fatality Assessment and Control Evaluation (FACE) Program
Incident Number: 12KY035
Release Date: 2013
Subject: Owner of Towing Company Dies When Struck by Driver of a Box Truck

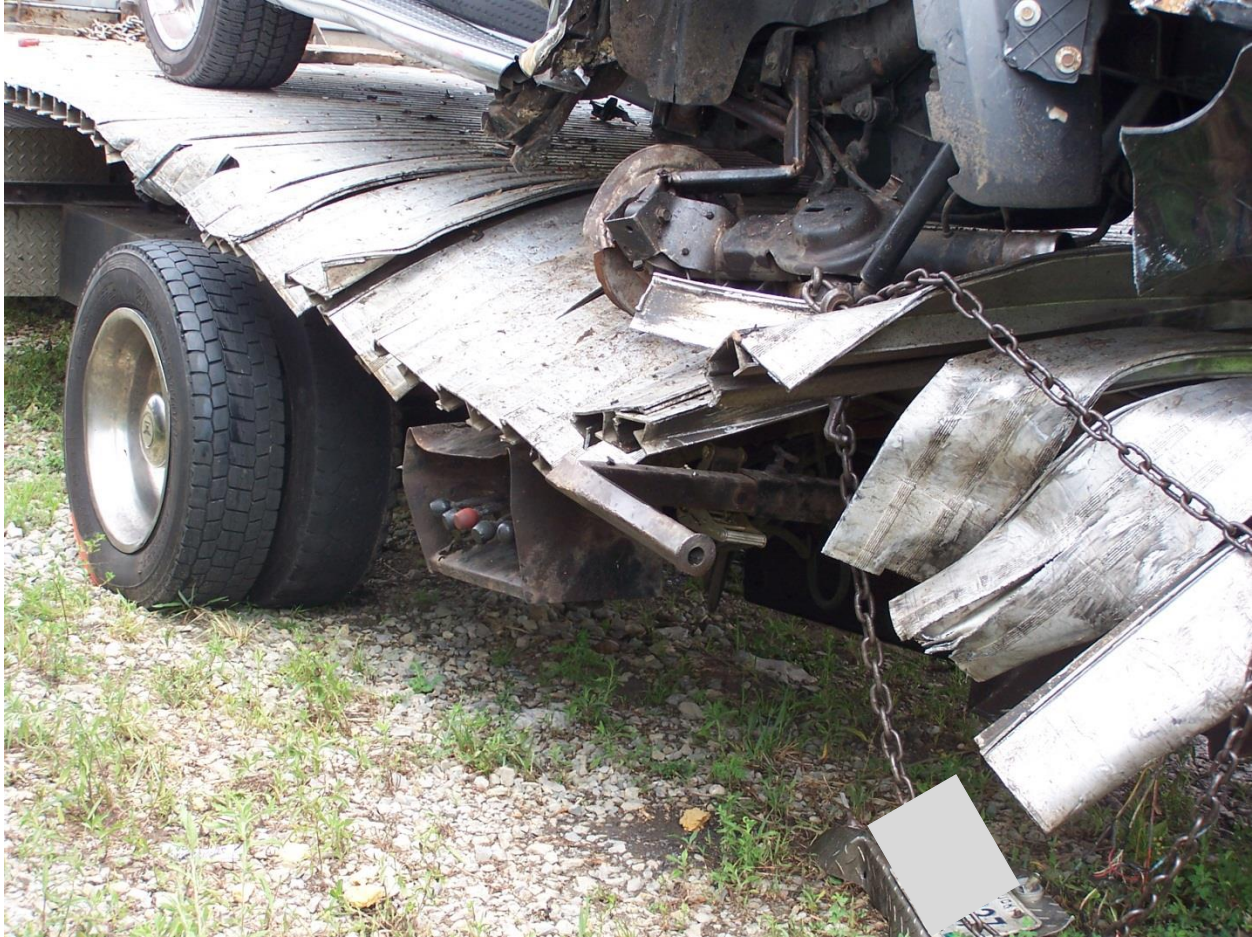
The tow truck struck by the box truck. Photos included in this report are property of Kentucky FACE.

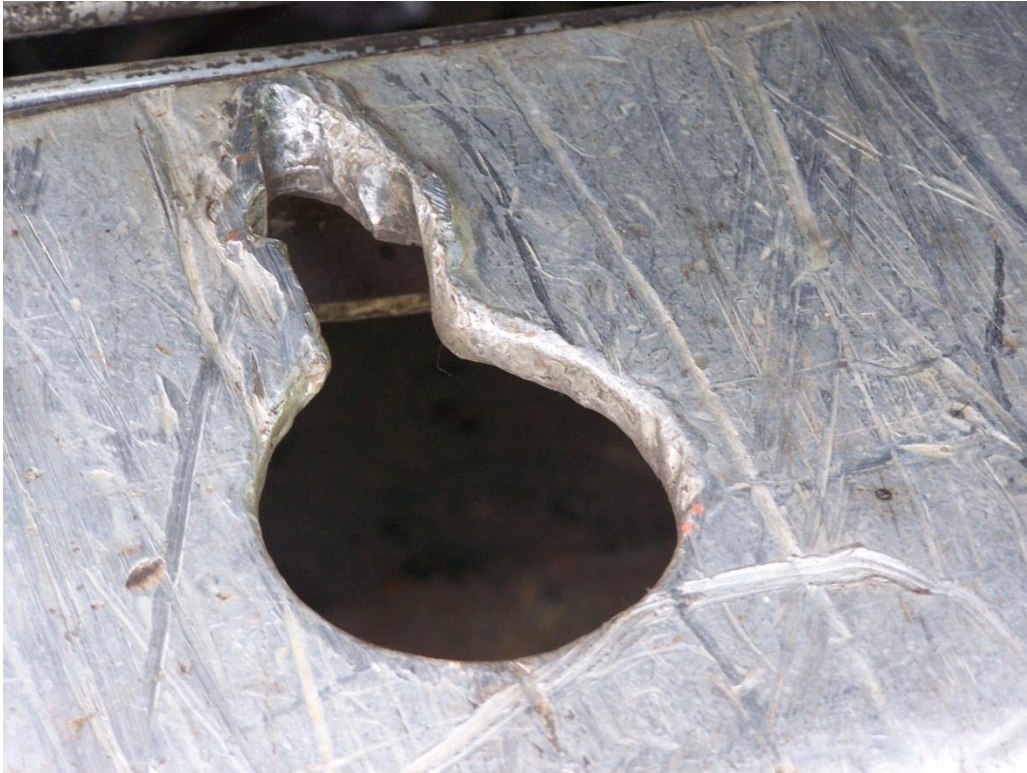
The securement sites on the tow truck were stretched beyond their original shape, suggesting the truck had carried loads beyond its maximum capacity. The excess weight of a load can cause a securement site to become warped and misshapen. This could have caused the load to shift back and forth while on the bed of the tow truck, causing it to feel unstable.

A worn securement site on the tow truck.

Recommendation No. 3: The maximum carrying capacity of a tow truck should not be exceeded.

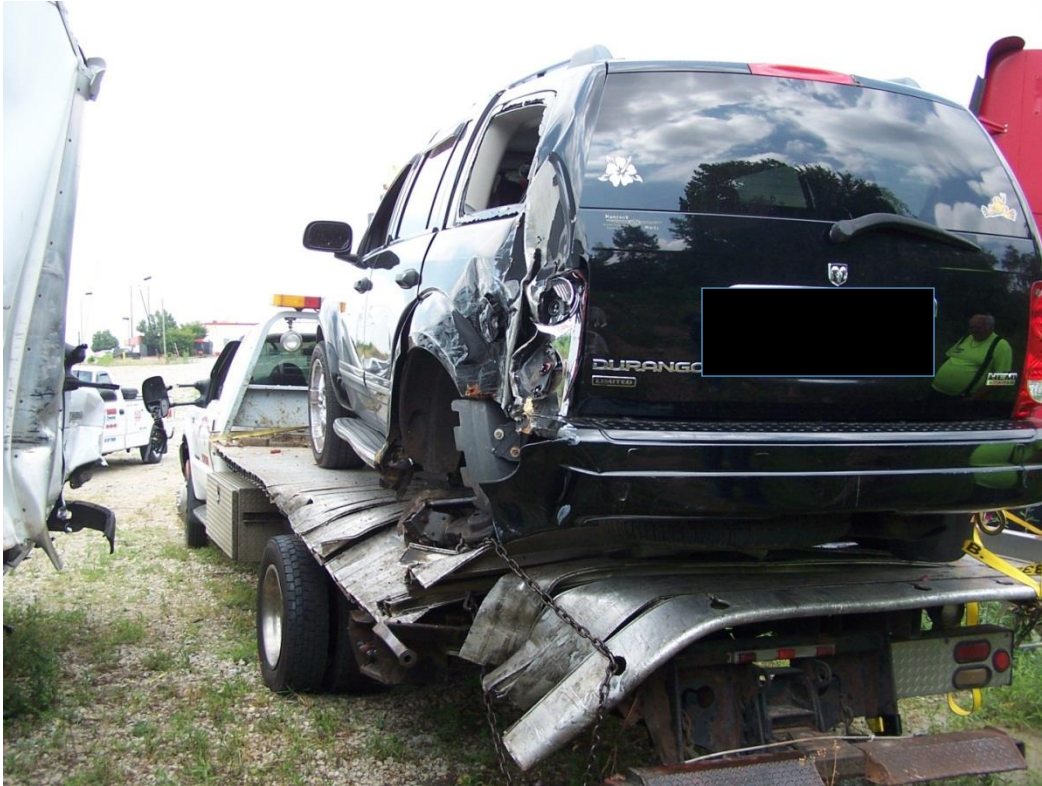
Upon arriving at their destination, the SUV was loaded onto the rollback using only three out of the four available anchoring points. The tow truck operator engaged the vehicle warning lights and he and his two sons headed north toward home, 225 miles away, and another 3 ½ hours.

The tow truck with SUV.

Recommendation No. 1: Four points of securement should be used when transporting a load.

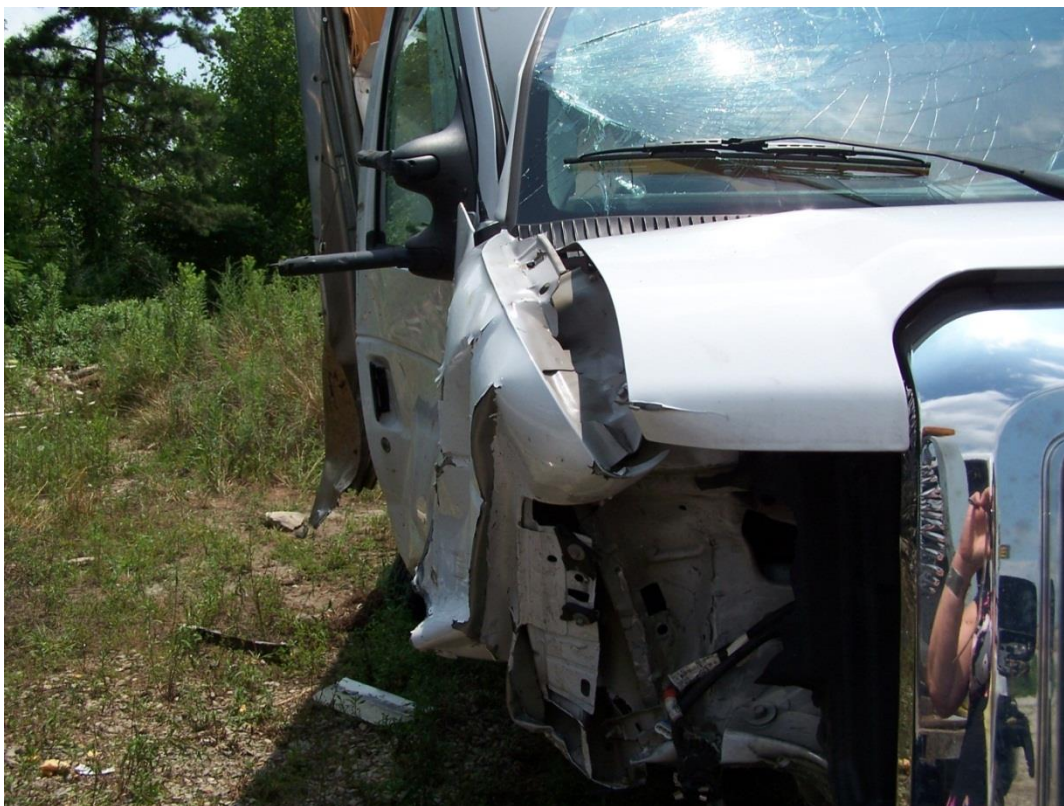
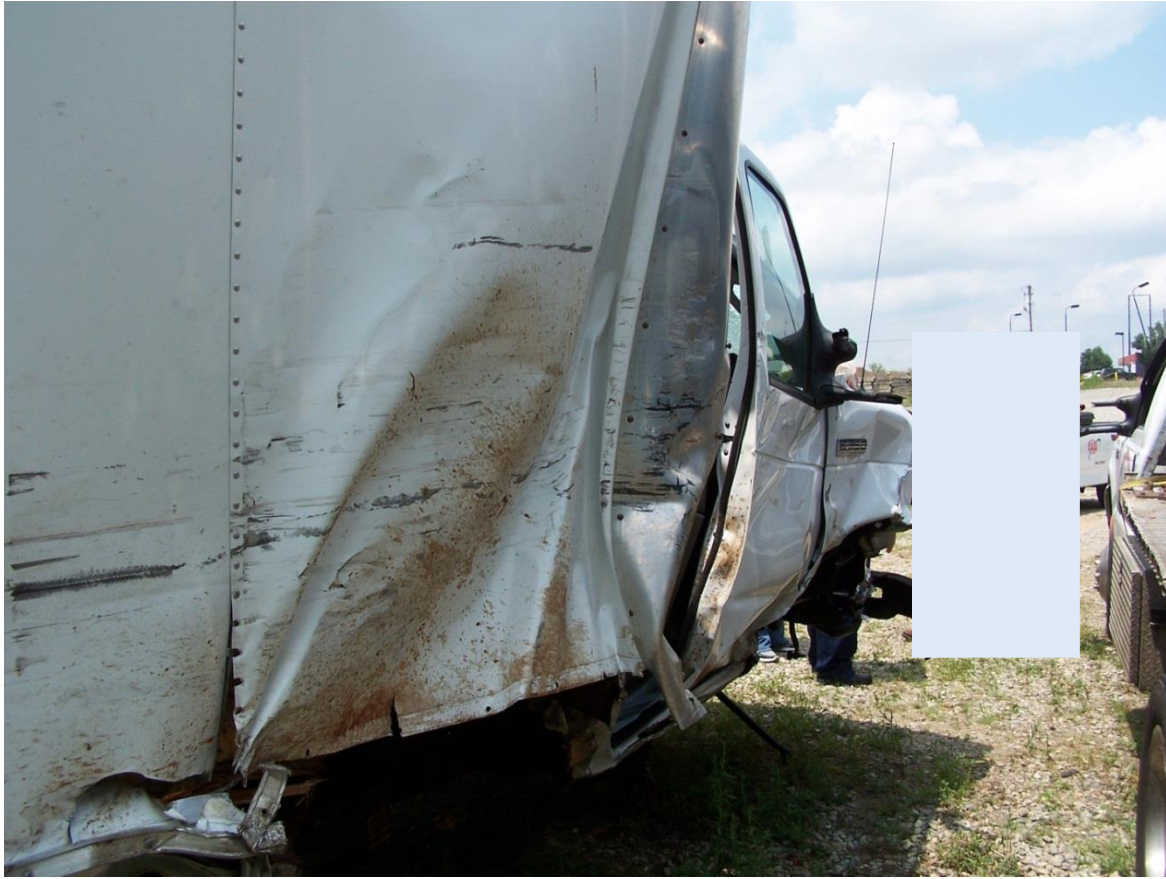
The box truck that struck the tow truck.
