REPORT#: 22KY00601

REPORT DATE: 08/01/2022

Delivery Driver Crushed by Granite Slab— Kentucky

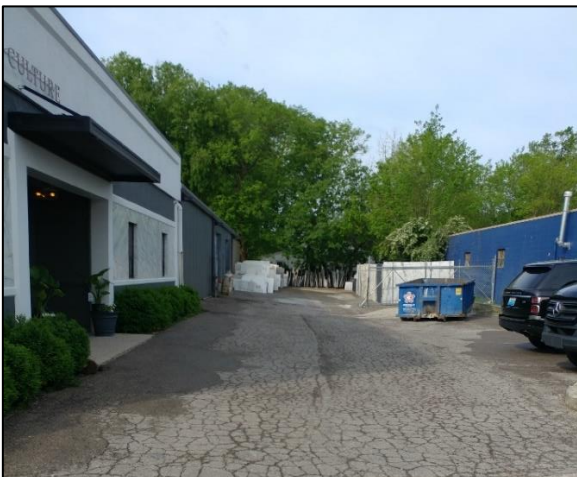
Photo 1. Parking Lot (Property of KYFACE Program)

The merchant's facility consisted of a retail showroom, offices, indoor workshop/production area, outdoor storage area, and parking lot. The incident occurred in the merchant's parking lot (Photo 1 and Photo 2). The parking lot provided a limited but sufficient amount of clearance for trucks to park for offloading. Although the parking lot was topped with asphalt, it was unevenly graded in some areas. Terrain is not considered to have been a factor in the incident.

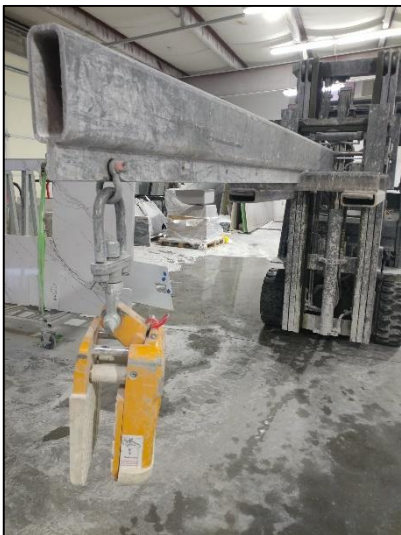
Photo 3. Forklift with Boom Attachment (Property of KYFACE Program)

The granite countertop wholesaler had secured granite slabs for transport on the flatbed trailer using a metal “A-frame” rack, which held multiple slabs in a near-vertical orientation. Stone slabs were off-loaded by the merchant’s employees using a forklift equipped with a boom attachment (Photo 3).

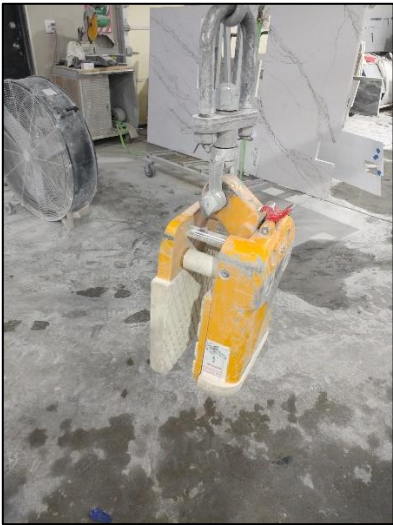
Photo 4. Abaco Little Giant Lifter, Model AFG50 (Property of KYFACE Program)

The boom attachment was equipped with a device designed to clamp onto an individual slab to allow it to be lifted, moved, and lowered. The device, referred to as a “slab clamp”, was an Abaco Little Giant Lifter, Model AFG50, manufactured by Abaco Machines (Photo 4).

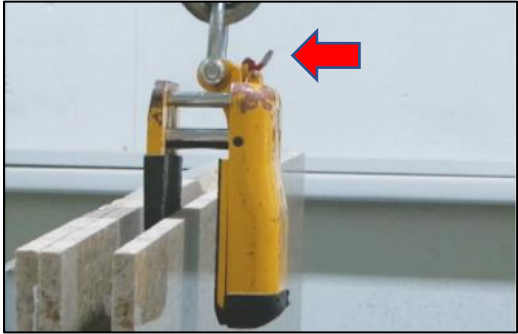
Photo 5. Positioning Lifting Device [Natural Stone Institute]

The incident occurred while the delivery driver was attaching the slab clamp device to a slab in the flatbed area of the trailer. The delivery driver separated the first slab from the others that were stacked on an A-frame to provide the necessary room to attach the slab clamp device over the slab. The slab clamp device was positioned in the center of the slab prior to securing so that the slab can be lifted from its center of balance, similar to that illustrated in Photo 5.

The forklift operator positioned the boom and slab clamp device above the approximate center of the slab, while the delivery driver separated the slab from the other slabs on the rack. Once the slab clamp device was positioned onto the slab, the delivery driver released the lifting device/slab clamp's locking latch to allow it to lock the slab, a process similar to that designated by the arrow in Photo 5.

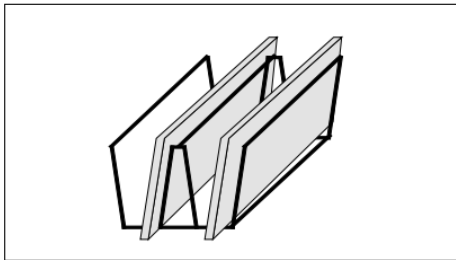
Image 1: W-Frame [FACE #96-NJ-080-01]

Employers should use engineered, heavy-duty stone slab storage racks with fixed support pins that form individual compartments, as shown in Images 1 and 2. Various designs of slab racks are available, such as the W-Frame rack below, which is essentially an A-Frame rack with individual compartments for each stone slab.

Recommendation #1: Employers should use stone slab storage racks engineered with individual compartments to support stone slabs.

Slab racks should be used for warehouse storage and for transport on flatbed and covered trailers. These types of racks can provide a positive means for preventing stone slabs from inadvertently falling onto employees during handling, which could result in serious crushing injuries and death.

Slab racks must be used according to the manufacturer's specifications regarding their safe carrying capacity. Overloading can deform the rack's components, reducing stability which could result in failure of the slab rack to keep slabs secure. Slab racks should be inspected prior to loading to look for: cracked welds, cracked or deformed structural members, other signs of damage or deterioration that could affect the structural integrity.

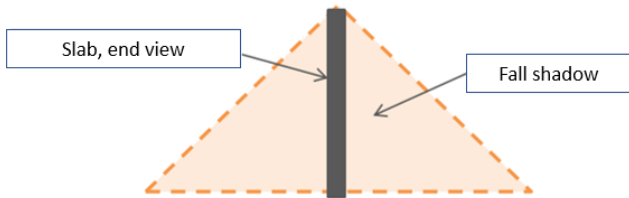
Figure 1: Fall Shadow

Slabs can weigh in excess of 1,000 pounds [Natural Stone Institute, pg. 7] and they are typically stored on slab racks such that they rest on their narrow long edge. A slab has the potential to fall when not actively secured from tipping beyond its absolute vertical alignment. A slab can also fall while being lifted and moved; if the rigging fails, the load becomes insecure, or the slab breaks. Locations where individuals could be struck, or crushed, are referred to as the fall shadow, as illustrated in Figure 1. The Natural Stone Institute has warned in its guidance, that employees must “Stay out of the shadow to reduce your risk of being crushed,” [2021, pg. 8].

Employers should identify slab fall shadow zones and restrict employees from placing themselves in the zones whenever a slab can fall.

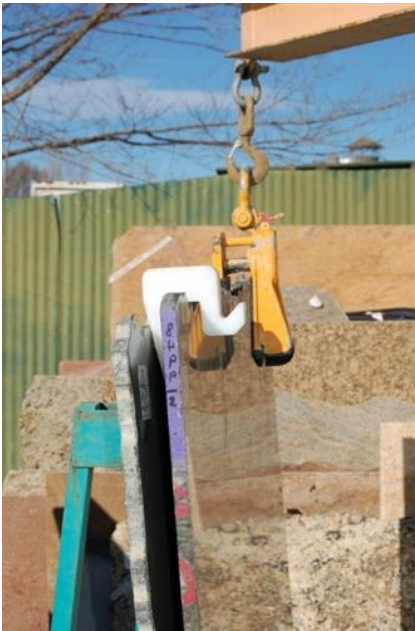
Photo 6: Positioning Relative to Rack [Wehausea.com]

When moving slabs to a near vertical position for rigging, employees should be positioned outside of the fall shadow. When preparing a slab for moving, a wedge tool is often used to separate a single slab from others so that a clamp lifter can be attached, Photo 6 illustrates an A-frame rack with wedge used to separate slabs enough to attach a clamp. Employees should be located outside the fall shadow when the wedge is inserted and for the remainder of the time the slab is being moved. Photo 7 depicts the location of the fall shadow and the correct position of the employee relative to slabs stored in a rack.

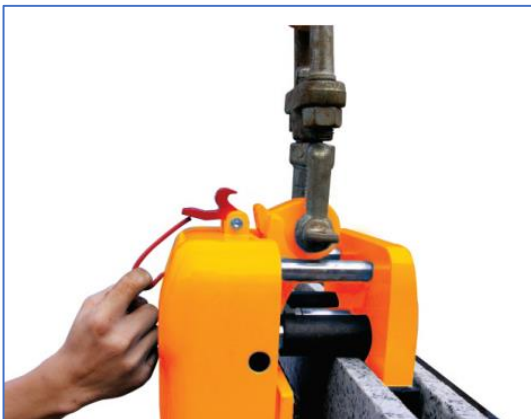
Photo 7. Unlocking of Latch of Lifting Device [ABACO Machines]

Safe work practices should be utilized which allow employees to remain outside the slab shadow. If using a slab clamp device, the device should be positioned at a slab's center using a push/pull pole device which is long enough to allow the employee to remain out of the fall shadow during rigging. When using slab clamp devices equipped with a manual unlocking latch as shown in Photo 7. Employees should remain out of the slab fall shadow by releasing the latch using a push/pull pole device. Alternative methods which would allow employees to remain outside the fall shadow include using more advanced lifting device equipment. These include the use of a clamp which has an automatic locking/unlocking mechanism, and clamp with an electronic remote-control latch.
