INCIDENT HIGHLIGHTS

REPORT#: 23KY096

Carpenter Dies After Fall from 6-Foot Ladder—Kentucky

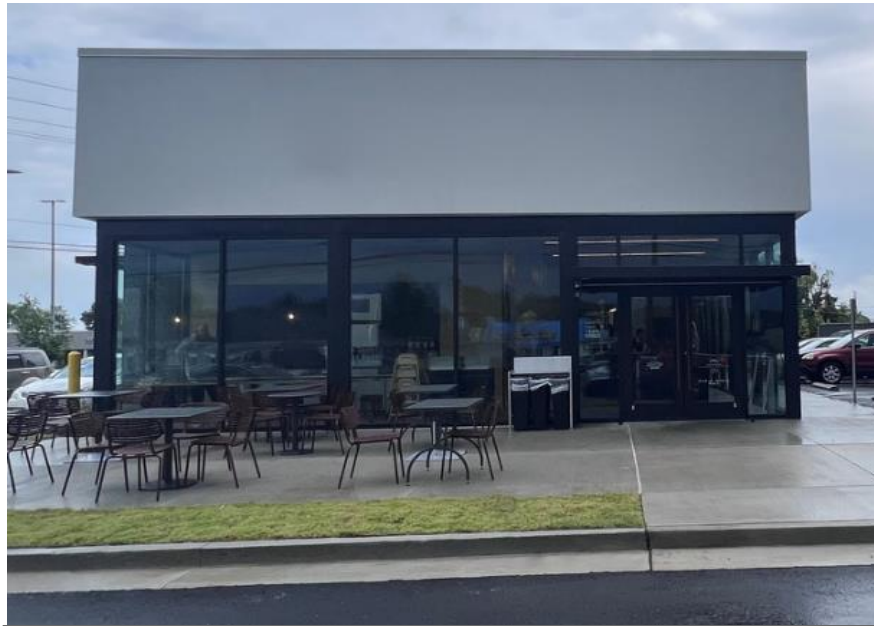
Photo 1. Exterior photo of the building where the incident occurred.

The incident occurred inside a newly erected commercial building that was still under construction at the time the incident occurred. The building is approximately 2,325 square feet and features 12-foot ceilings. The floor inside the building is constructed of polished concrete. Upon completion, the building will be utilized for a restaurant franchise (photos 1, 2, 3).

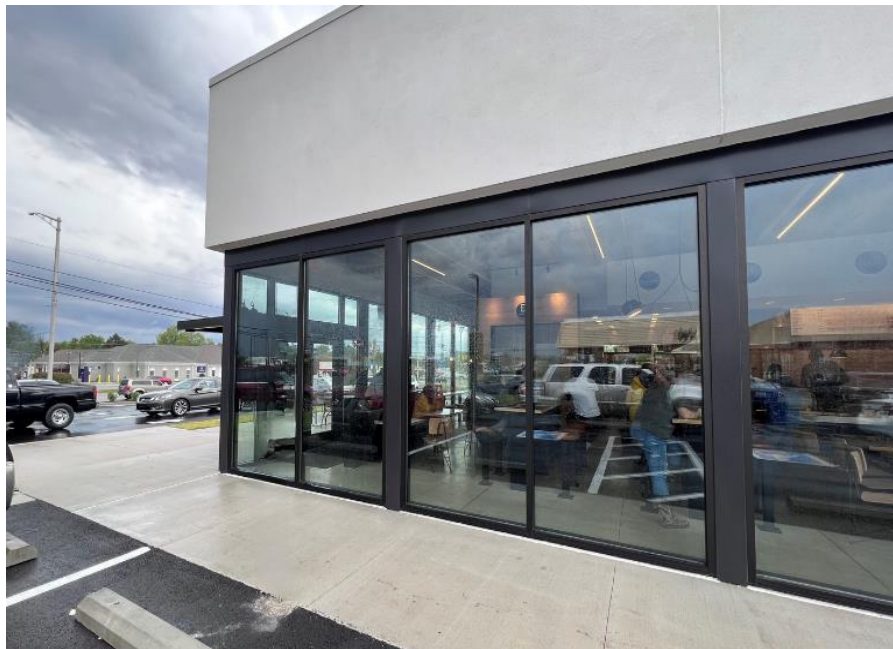
Photo 2. Exterior photo of the building where the incident occurred.

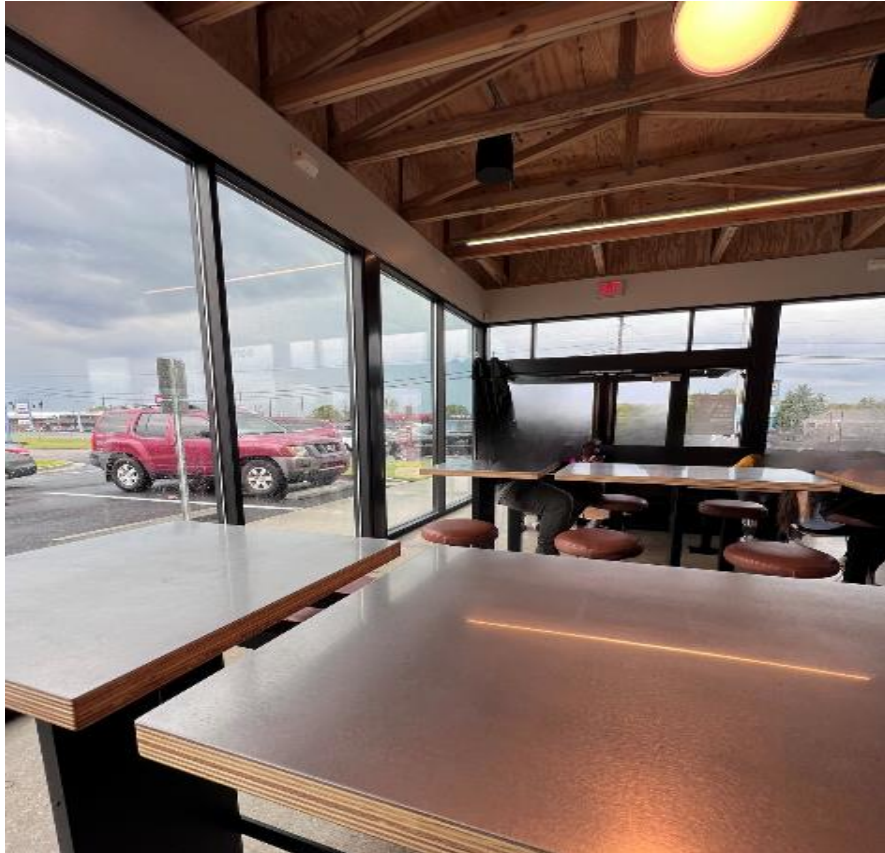
Photo 3. Interior photo of the location where the fall occurred (construction now finished). Photo also shows plywood ceiling panels that were being installed by the victim and his co-worker.

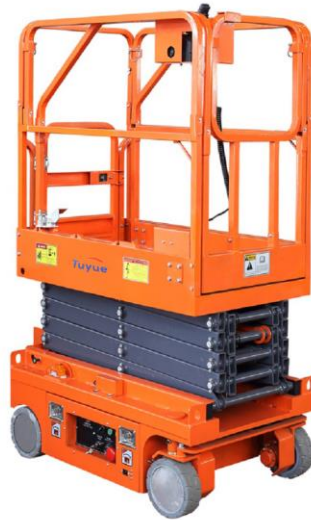
Photo 4. Stock photo depicting the type of scissor lifts that were available for use at the job site.

The rafters in which the plywood panels were being secured measured 11' 6" from the concrete floor below. As a result, both the victim and the co-worker were required to work at heights to perform the required job task. According to witnesses, several scissor lifts (photo 4) were available for use; however the victim opted to utilize a 6-ft. fiberglass step ladder (photo 5), while his co-worker utilized a 10-ft. fiberglass step ladder (photo 6).

The victim was utilizing a 6-ft. fiberglass step ladder at the time the incident occurred (photo 4). According to witnesses, scissor lifts were available and offered to the victim and his co-worker, but both declined. Although scissor lifts do not entirely alleviate the risk of falls from heights, they do offer additional protections over ladders. Scissor lifts are equipped with properly designed and maintained guardrail systems, which help reduce the risk of falling. The job site and work environment may not always allow for the utilization of a scissor lift; however, a properly conducted JHA can help employers determine the suitability. In this instance, scissor lifts were present, available for use, suitable for the

task being performed, and lowered the risk of fall. To reduce the risk of injury, employees should utilize equipment that best reduces the risk of injury.

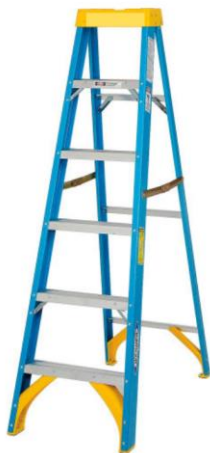
Photo 5. Stock photo depicting the type of ladder utilized by the victim at the time the incident occurred.

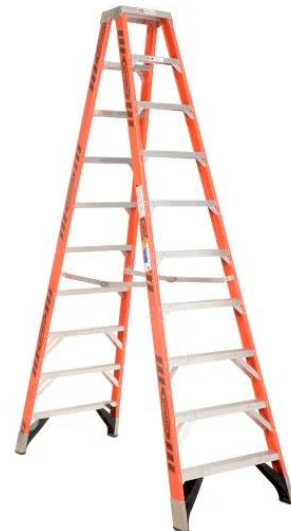
Photo 6. Stock photo depicting the type of ladder utilized by the victim's co-worker at the time the incident occurred.

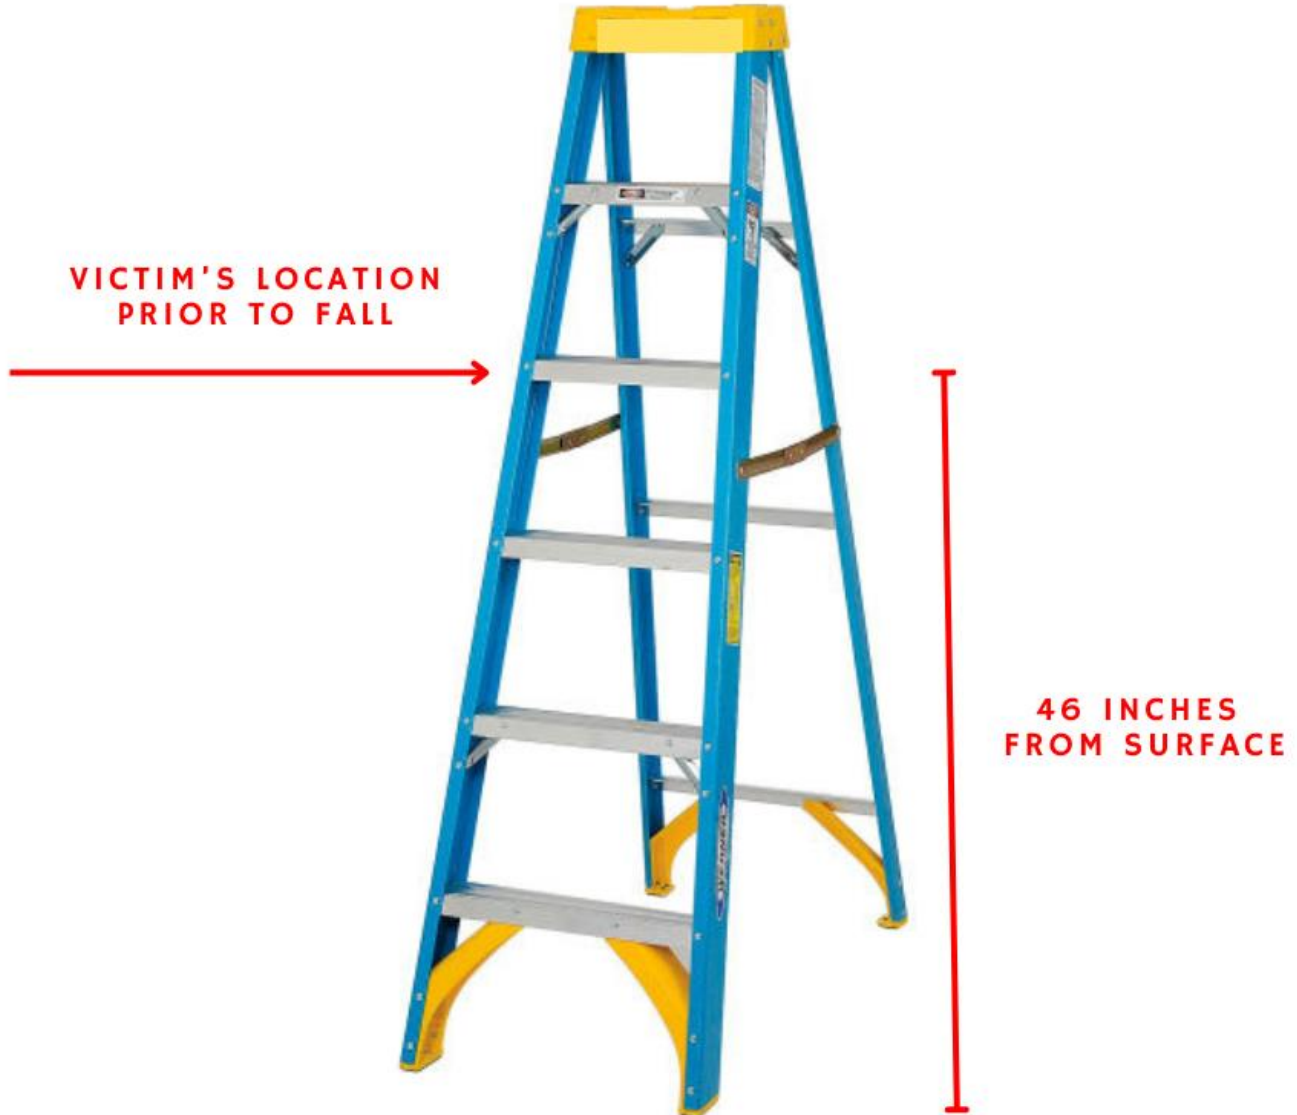
Tasks were being completed as planned without incident until approximately 2:45 p.m., 7 hours and 45 minutes after the workday began. The victim and his co-worker both ascended their ladders to obtain measurements for the next panel. According to the co-worker, the victim was standing on the fourth rung from the bottom of the ladder (diagram 1). The victim was holding one end of the measuring tape with his left hand and reaching beyond the ladder side rails to obtain the proper measurement. While doing so, the co-worker stated that the ladder began falling to the victim's left (diagram 2). The victim fell approximately 46 inches to the concrete surface below, landing on his head and neck (photo 7). The co-worker immediately descended the ladder, moved the victim's ladder from its original position to access the victim, and attempted to provide aid. The co-worker yelled for help, and a heating, ventilation, and air conditioning (HVAC) contractor who was also at the job site hurried to the victim's side and called emergency services (EMS) due to the victim being unconscious. While waiting for EMS to arrive, the co-worker repositioned the victim and elevated his head. EMS arrived a short time later, at approximately 3:00 p.m., rendered aid on site, and then transported the victim to an out-of-state hospital. The victim was later transported to a larger out-of-state university hospital but succumbed to the injuries sustained from the fall three days later on August 12, 2023, at 8:45 p.m.

Diagram 1. Diagram depicting the type of ladder utilized by the victim, the step he was standing on, and the distance the victim was from the surface. Diagram created by and property of Kentucky FACE.

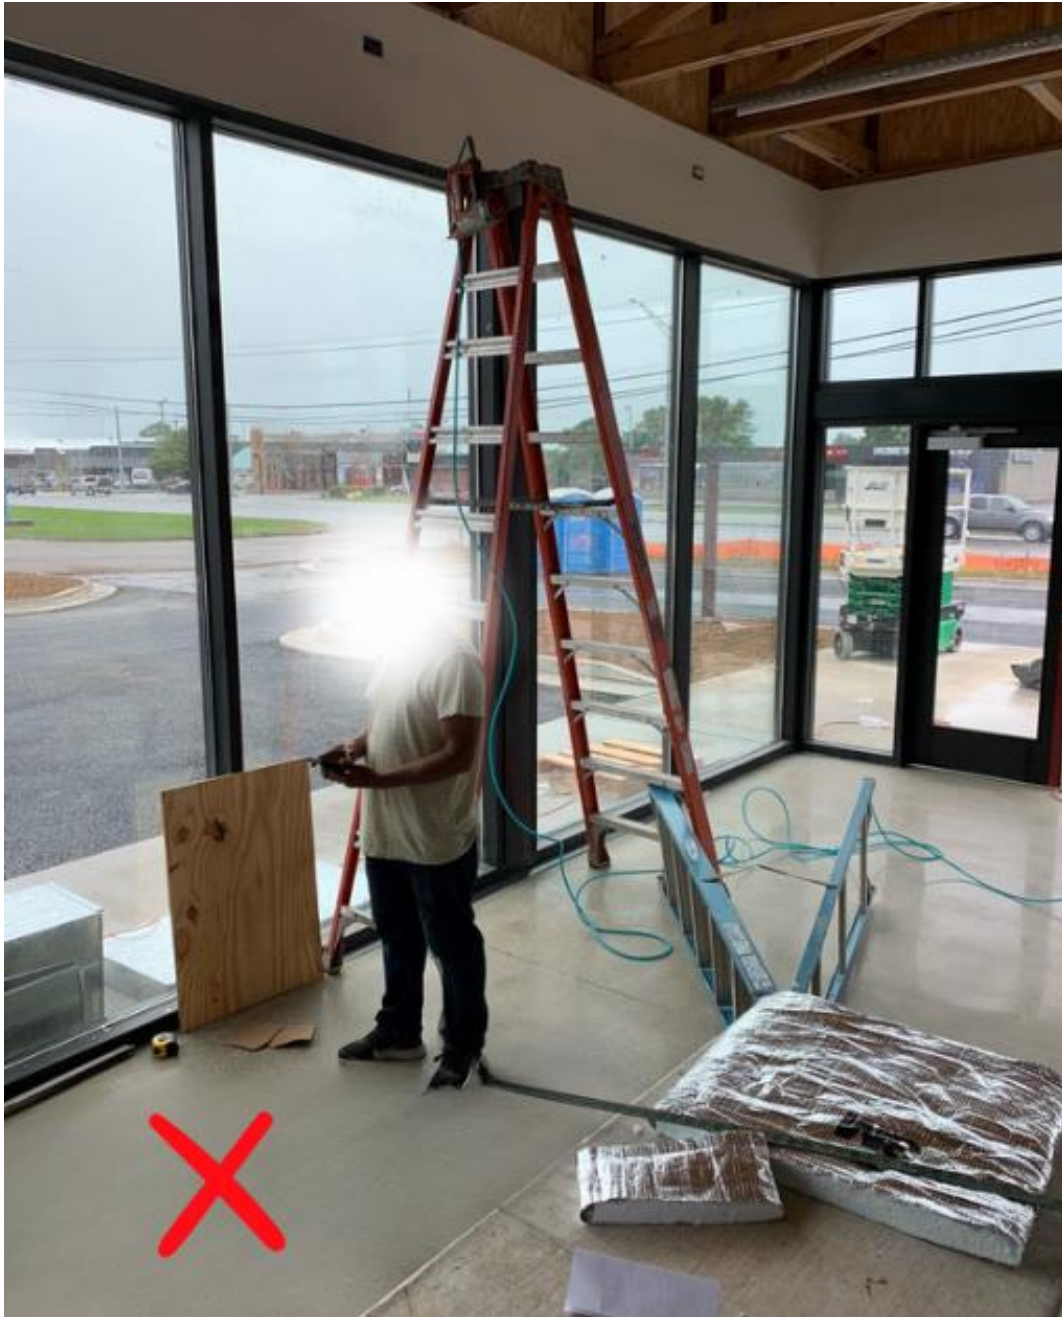
Photo 7. Photo of incident scene showing where the victim (red X) was lying unconscious prior to the arrival of EMS. Note: According to witnesses, the position of the victim's ladder (blue) and the victim are not the original positions. Both the victim and the ladder were moved to some degree post-incident.
