REPORT#: 23KY063

REPORT DATE: August 22, 2024

General Laborer Killed on Kentucky Interstate in Multi-Vehicle Collision

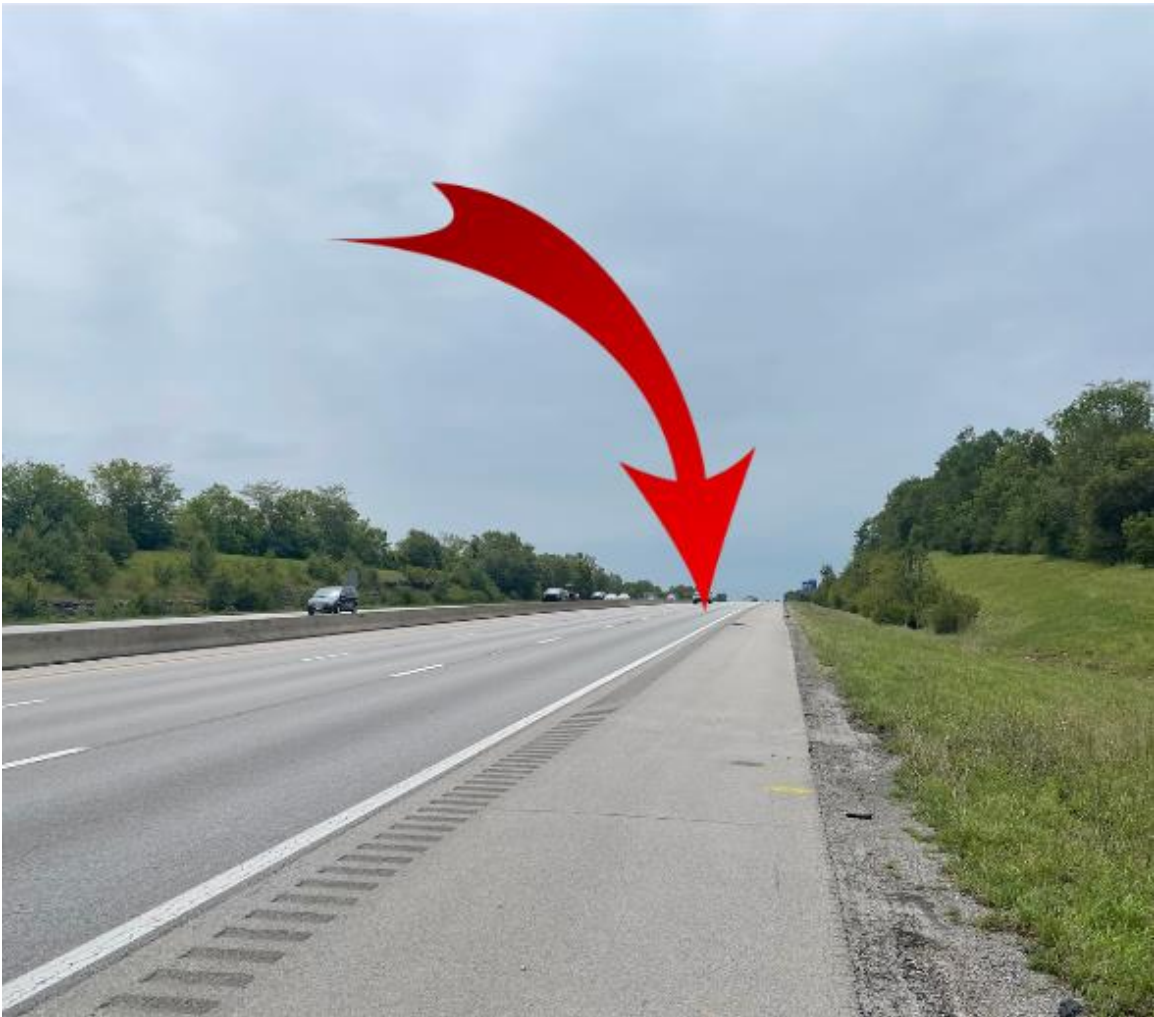
Photo 1. Photo of the incident scene where the crash occurred. Red arrow depicts location of crash. Photo property of Kentucky FACE.

The incident occurred in the southbound lanes of a major six-lane interstate with a posted speed limit of 70 miles per hour. North- and south-bound travel lanes are divided by a standard concrete barrier. The shoulder of the highway measures approximately 7 feet on either side of the highway. A grassy upward slope meets the edge of the shoulder and leads to a ditch and earth embankment on the southbound lanes where the incident occurred (photos 1–3).

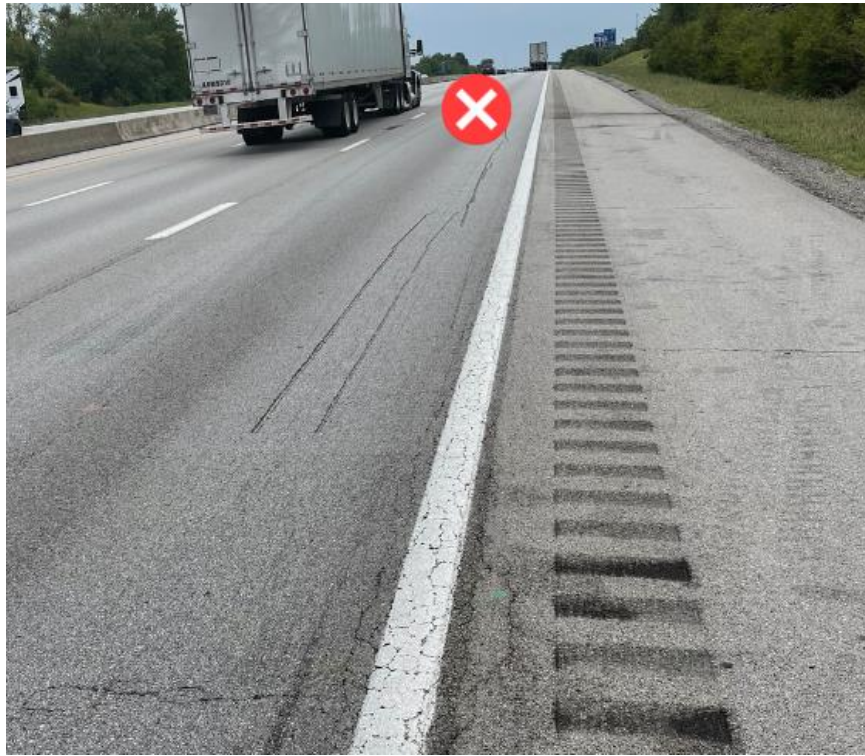
Photo 2. Photo of the incident scene where the crash occurred. Red X depicts location of crash. Photo property of Kentucky FACE.

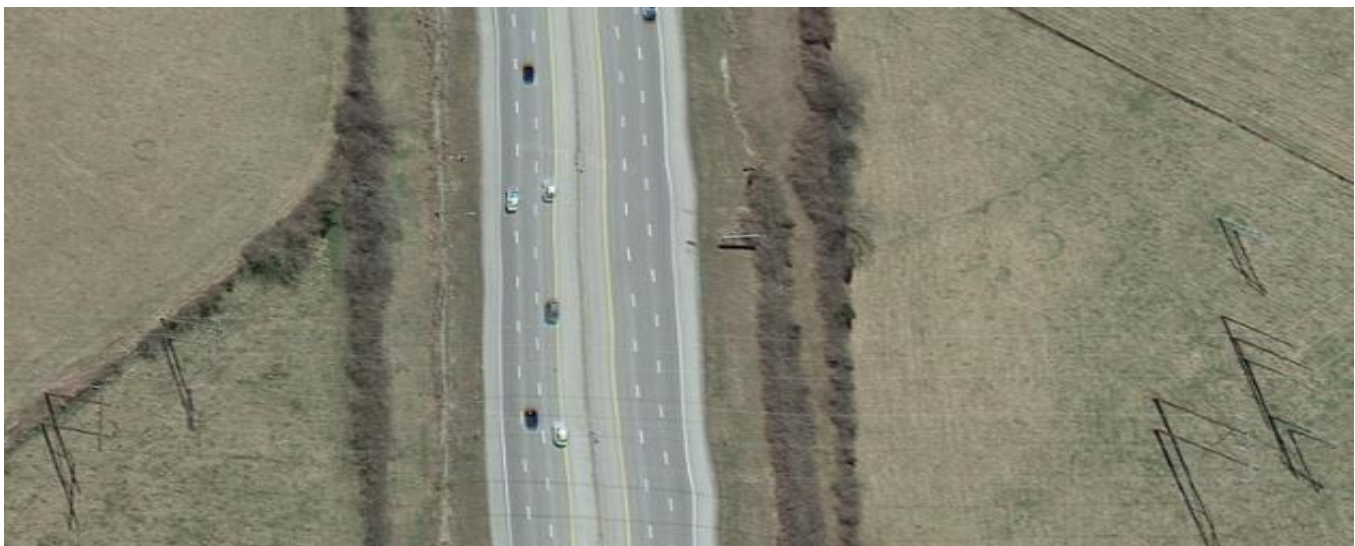
Photo 3. Google earth image of interstate highway showing the location where the crash occurred.

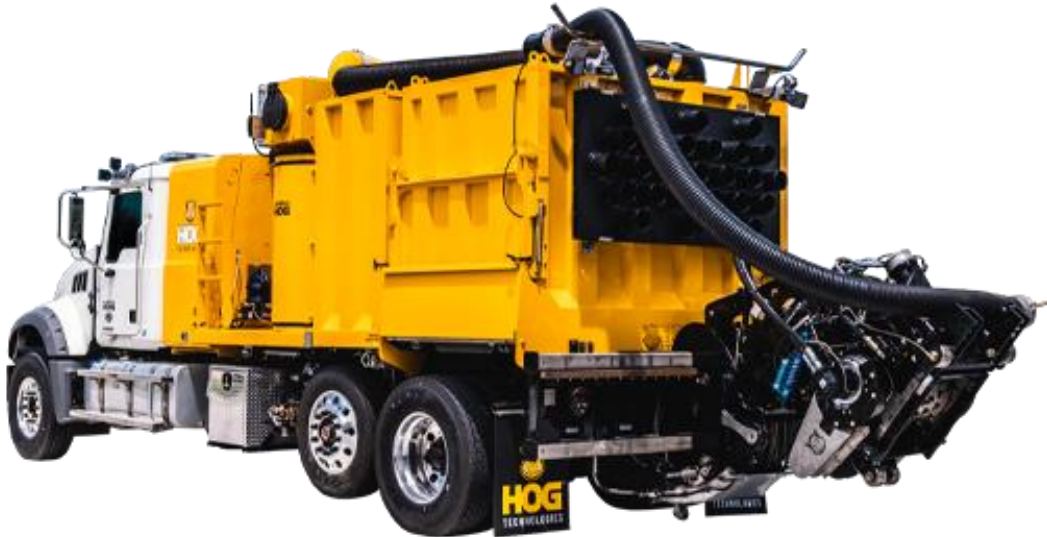
Photo 4. Stock photo of a Rumble Hog. Photo retrieved from and property of www.thehog.com.

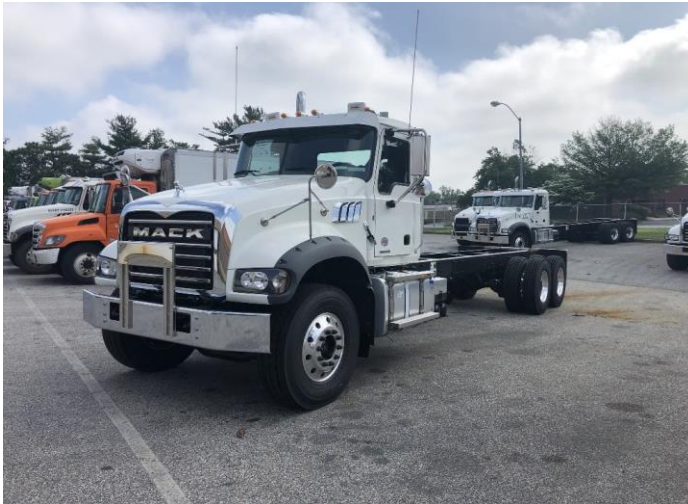
Photo 5. Google image depicting make and model of the truck driven by the victim that was involved in the collision.

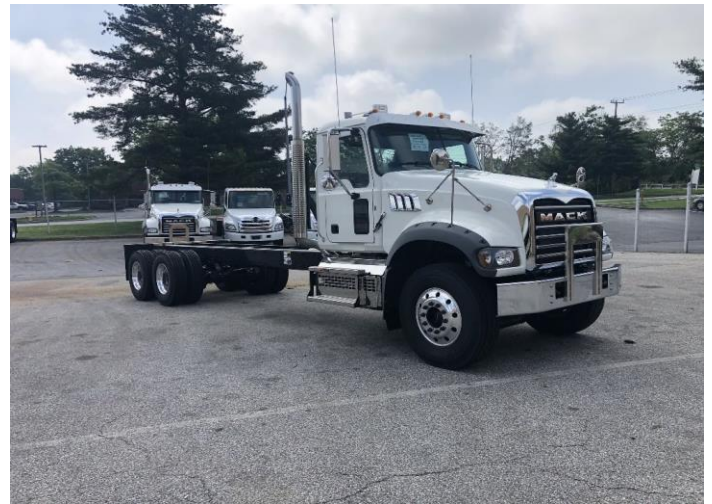
Photo 6. Google image depicting make and model of the truck driven by the victim that was involved in the collision.

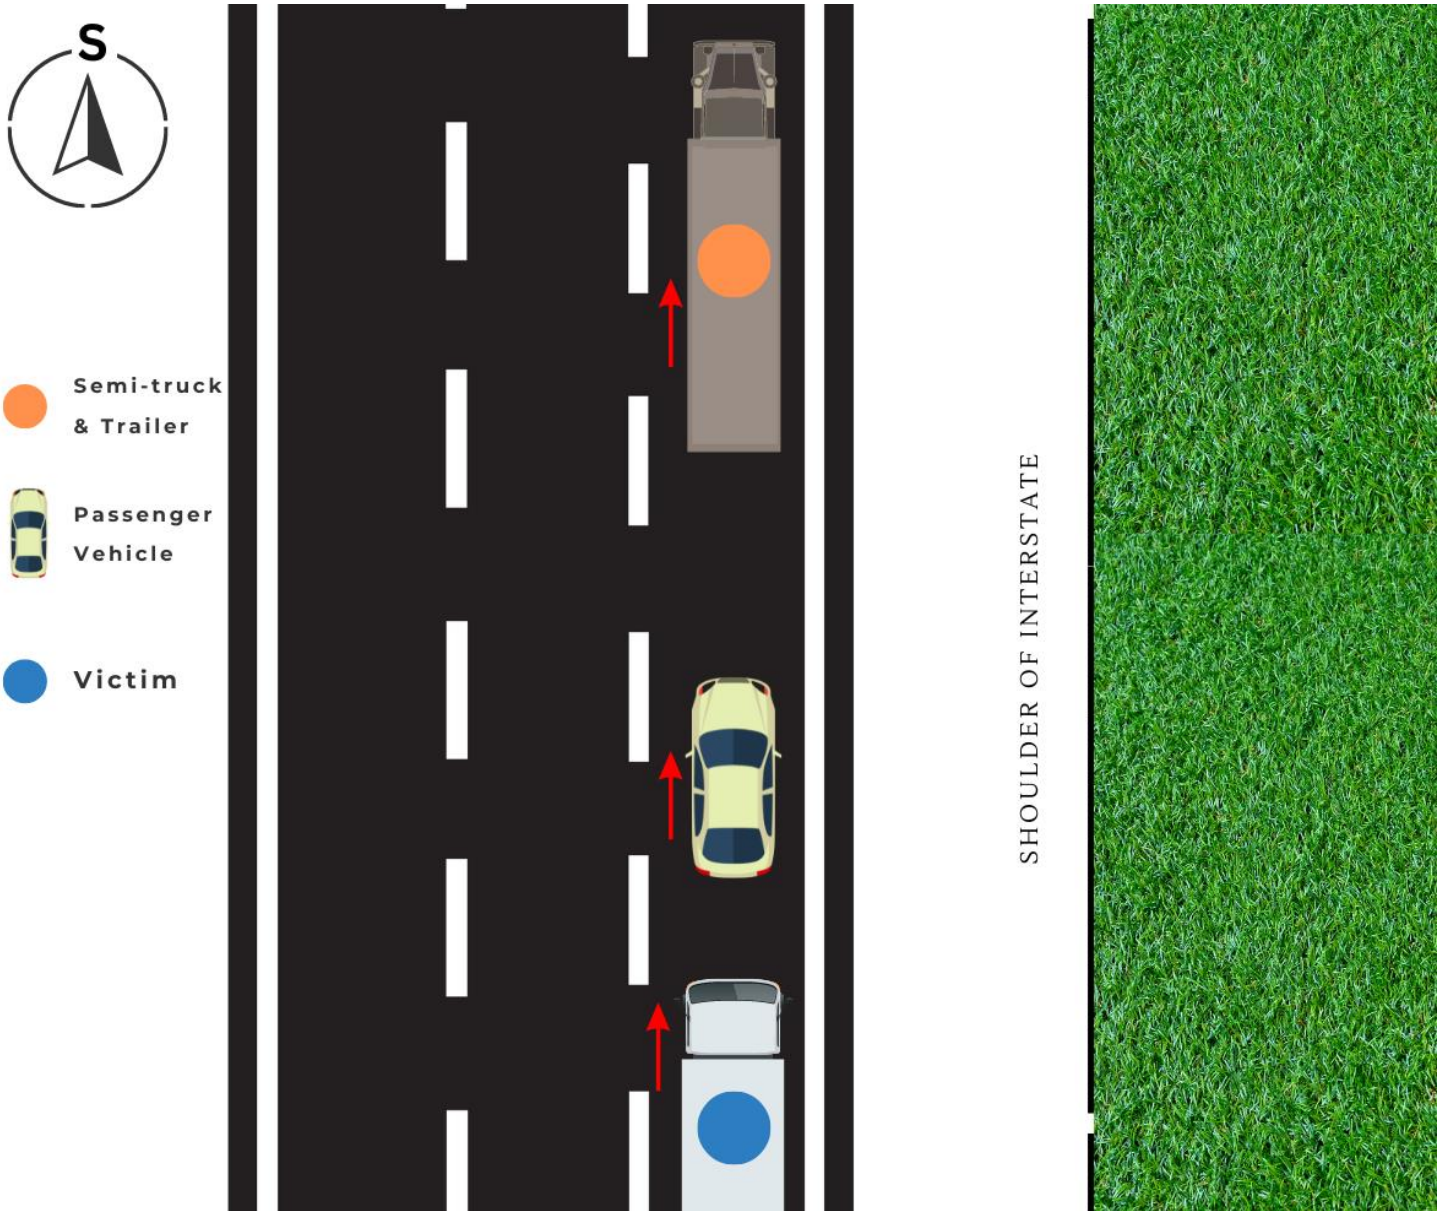
Diagram 1. Diagram depicting original arrangement of the three involved vehicles prior to the occurrence of the vehicle collision. Diagram property of Kentucky FACE.

Just after daylight, at 7:15 a.m., 1 hour and 15 minutes into the trip, the victim was involved in a fatal motor vehicle collision. According to the involved company, three total vehicles were involved, all of which were traveling south in the right lane of a major six-lane Kentucky interstate. Witnesses at the scene state the victim was initially following a passenger vehicle, and the passenger vehicle was following the involved semi-truck and trailer (diagram 1).

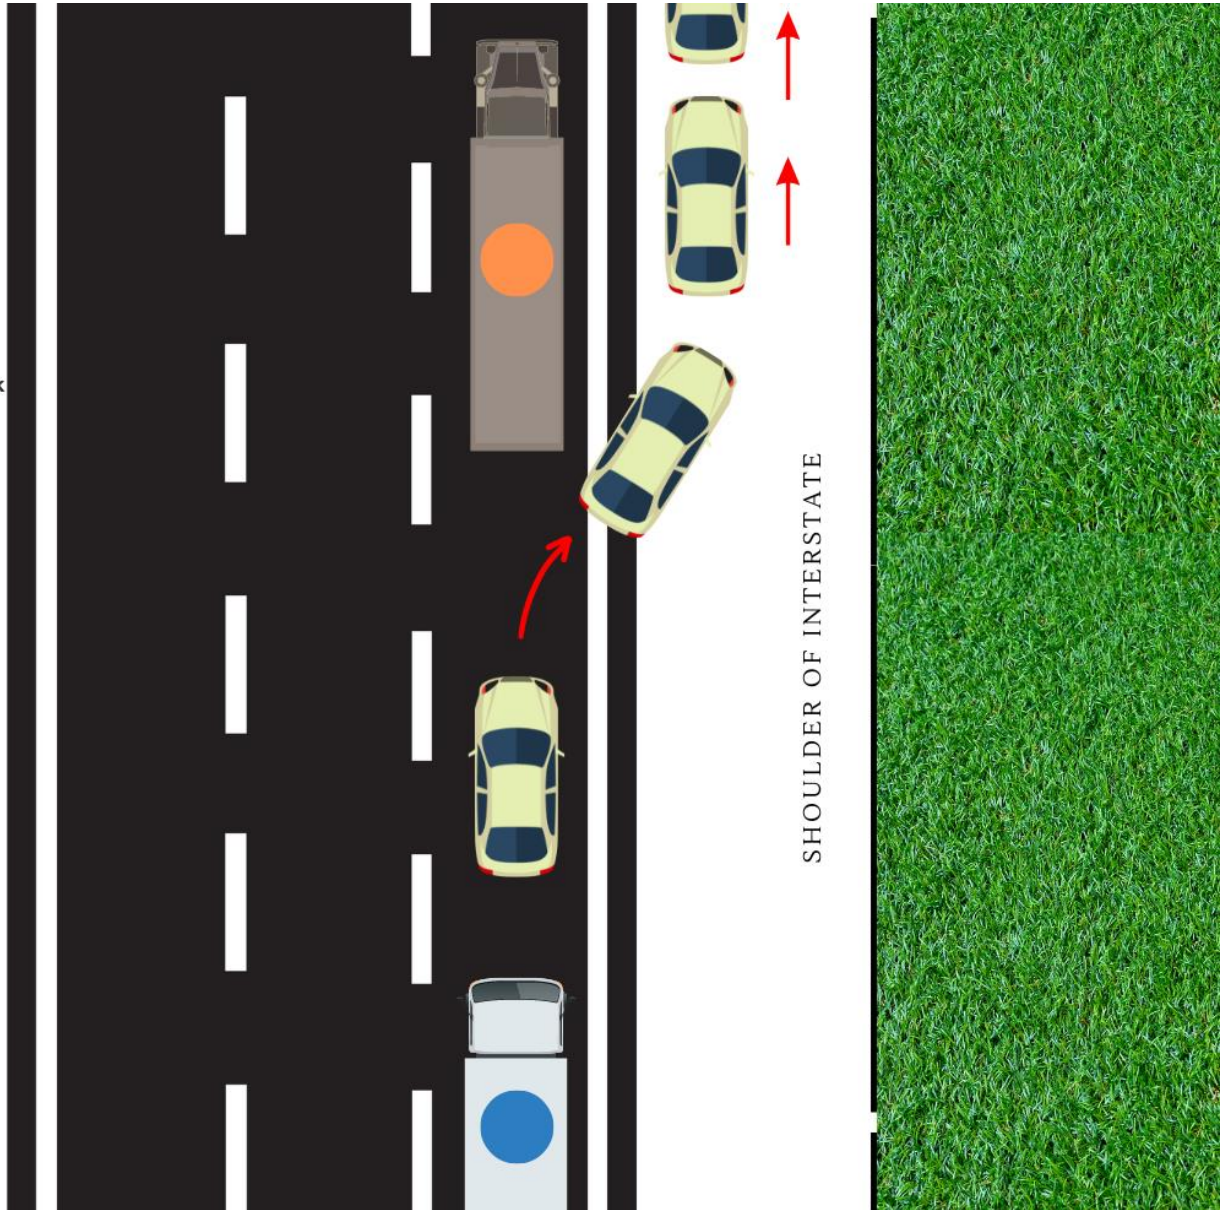
Diagram 2. Diagram depicting the evasive maneuver executed by the driver of the involved passenger vehicle to avoid striking the semi-truck and trailer. Diagram property of Kentucky FACE.

The involved semi-truck and trailer was traveling at approximately 15 mph due to mechanical issues. The passenger vehicle approached the semi-truck and trailer rapidly, due to the semi's low speed of travel, and made an evasive maneuver to the right shoulder to avoid striking the semi-truck and trailer (diagram 2).

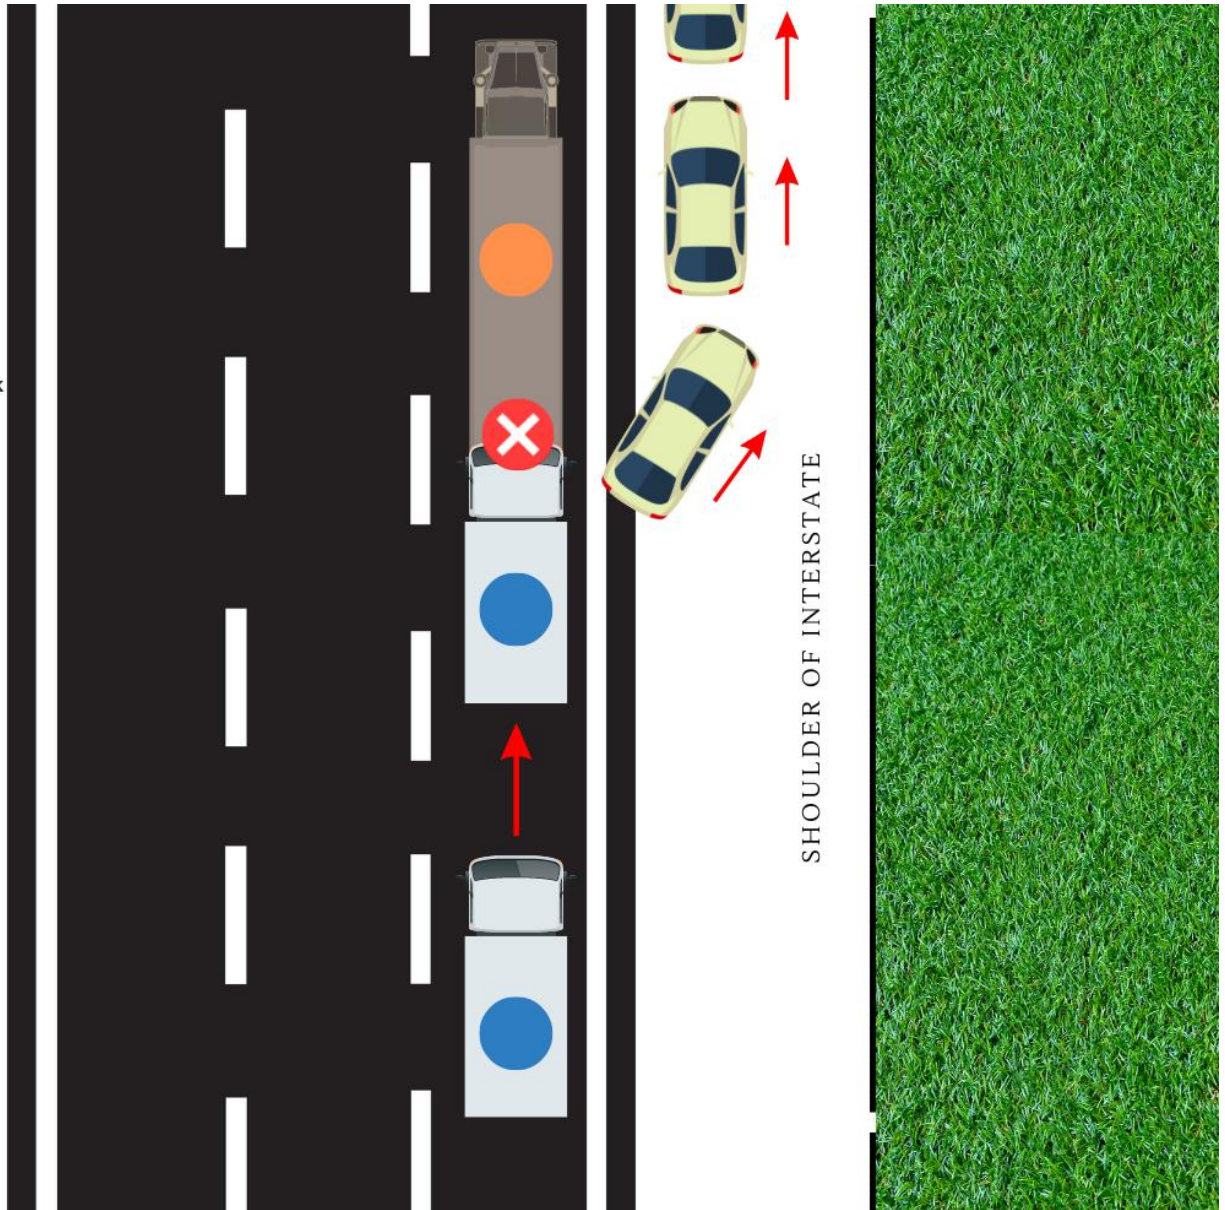
Diagram 3. Diagram depicting the continued path of the victim's vehicle and point of contact with the involved semi-truck and trailer. Diagram property of Kentucky FACE.

Also approaching the semi-truck and trailer rapidly, the victim was unable to stop and struck the semi-truck and trailer in the rear bumper at an estimated speed of 70 mph (diagram 3). Witnesses contacted emergency services, who arrived 7 minutes after the collision occurred. The local coroner pronounced the victim deceased at the scene of the incident; the victim was wearing a seatbelt.
