**REPORT#:** 24KY020

**REPORT DATE:** August 23, 2024

## Machine Operator Pulled into Machine, Succumbs to Injuries

On March 20, 2024, a 33-year-old female machine operator was pulled into the wire weaving machine she was operating, by her hair, while she was attempting to clean excess cutting fluid off the wire weaving machine. The victim succumbed to her injuries at the scene of the incident.

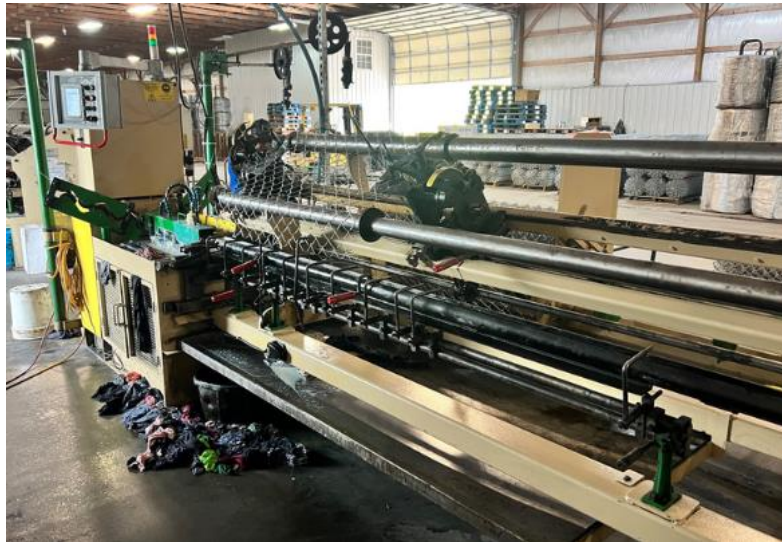
Photo 1. Photo of Bergandi A500 wire weaving machine involved in the incident. Photo property of Kentucky FACE.

The involved machine was a Bergandi A500 wire weaving machine. The machine takes coiled wire and weaves it into fence panels (photo 1). Upon completion, the panels measure 50 feet long and 4 feet wide. After the production of the panel is complete, the machine rolls and binds the newly created panels for shipping (photos 2 and 3).

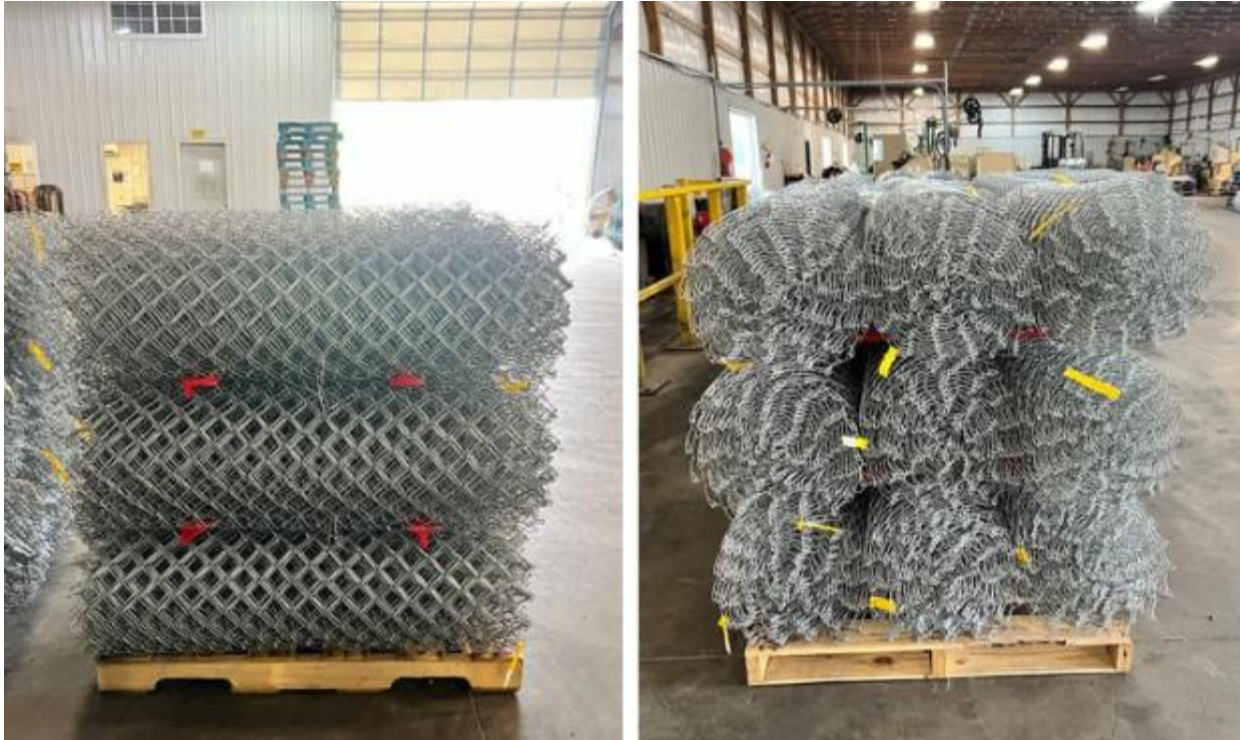
Photos 2 and 3. Photos of finished panels measuring 50 feet long by 4 feet wide. Photo property of Kentucky FACE.

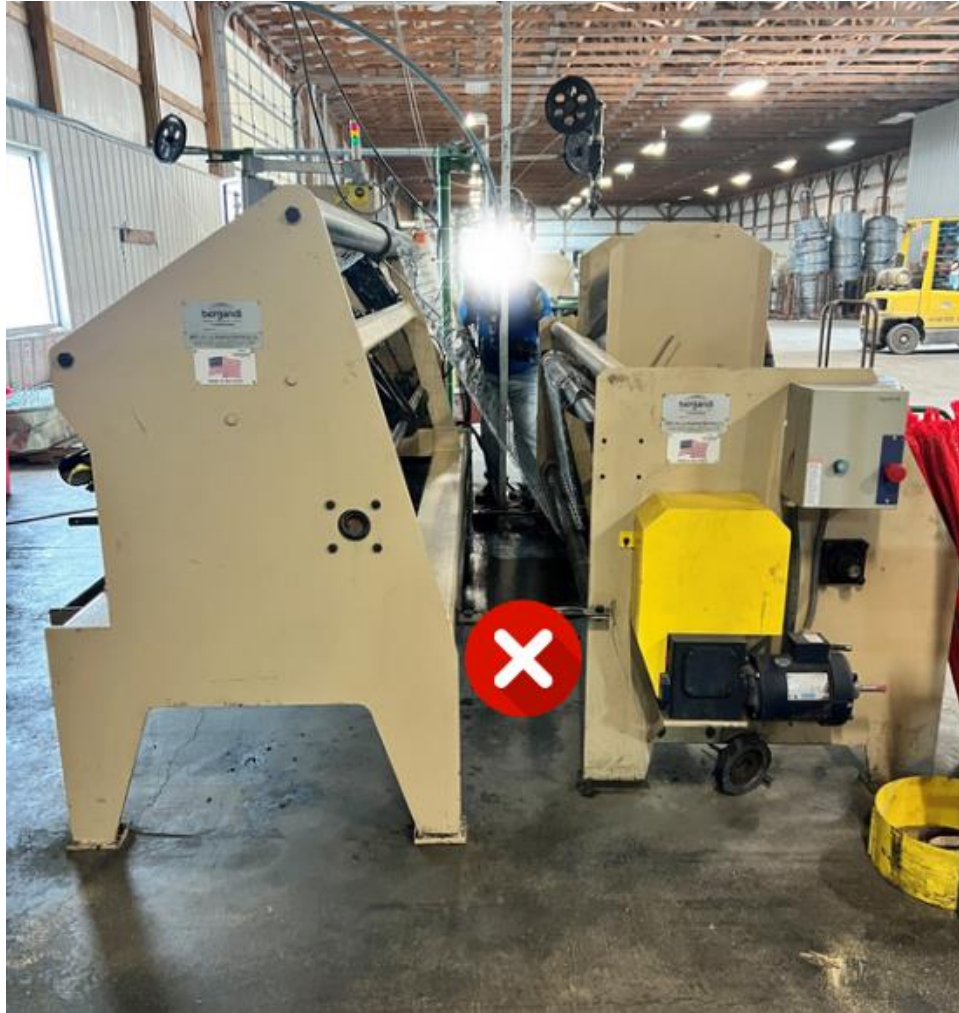
Photo 4. Photo of machine and general area where the incident occurred (red X). Photo property of Kentucky FACE.

The incident occurred on the shop floor of a 30,000-square-foot building that was erected in 2017. The building is utilized to produce wire fencing and gates. This building houses specialized machinery, is in a mostly rural area, and is constructed of metal (photo 4).

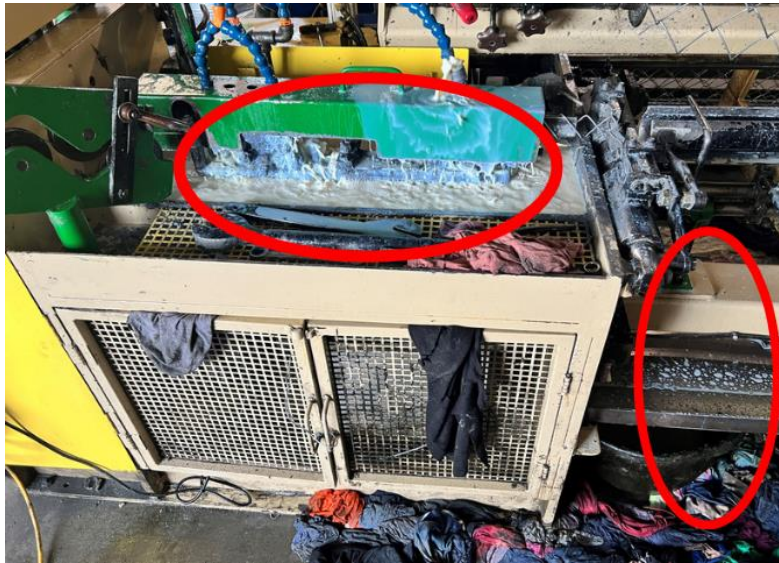
The Bergandi A500 wire weaving machine weaves wire into panels. A lubricant is utilized to keep the wire at a normal operating temperature. The lubricant often spills onto the exterior of the machine and the floor, creating a slipping hazard (photo 5). The victim was described as having a meticulous cleaning behavior and being one of the best employees at the company. She performed her job exceedingly well. The victim frequently cleaned the front of her machine and work area with the provided shop towels and brake cleaner. Cleaning the front of the machine was an employer-approved task; employees were required to power off the machine prior to cleaning.

Photo 5. Photo showing lubricant used in the manufacturing process and towels utilized for cleaning. Photo property of Kentucky FACE.

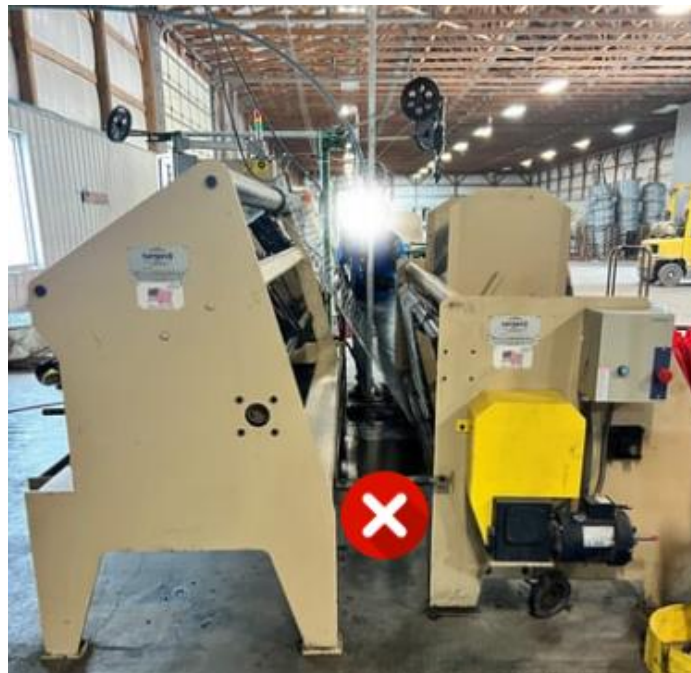
After the incident, the company conducted an internal investigation of the death. The shop floor was equipped with video surveillance cameras, but the camera placement did not directly capture the incident. However, the machine's red indicator light was visible in the video footage. The red light was illuminated at 11:21 a.m., which indicated that the machine experienced an error and stopped. This is suspected to be the time in which the victim was pulled into the machine. The floor supervisor noticed the light 11 minutes later and came to investigate. A can of brake cleaner was found behind the machine, in addition to cleaning towels. The investigation concluded that the victim had attempted to clean the rear of the machine, which is a prohibited area, while the machine was powered on and in operation (photo 6). While doing so the victim's hair (ponytail) became entangled in a horizontal shaft, known as the knuckler shaft (photos 7 and 8). This resulted in the victim's head/upper body being pulled into the machine by the hair until the machine jammed. All factory guarding was in place and functional; the machine was relatively new (2020 model). The horizontal shaft itself was not guarded since it is in an area not designed for employee interaction.

Photo 6. Red X indicates prohibited area where the employee entered and the fatal event occurred. Photo property of Kentucky FACE.

To reduce the likelihood of future occurrences, employers should install physical barriers to prevent employees’ entry into dangerous areas. The physical barriers should be marked with applicable signage to warn of the associated hazard (photos 9, 10, and 11). Once in place, employers should train employees appropriately on their application.

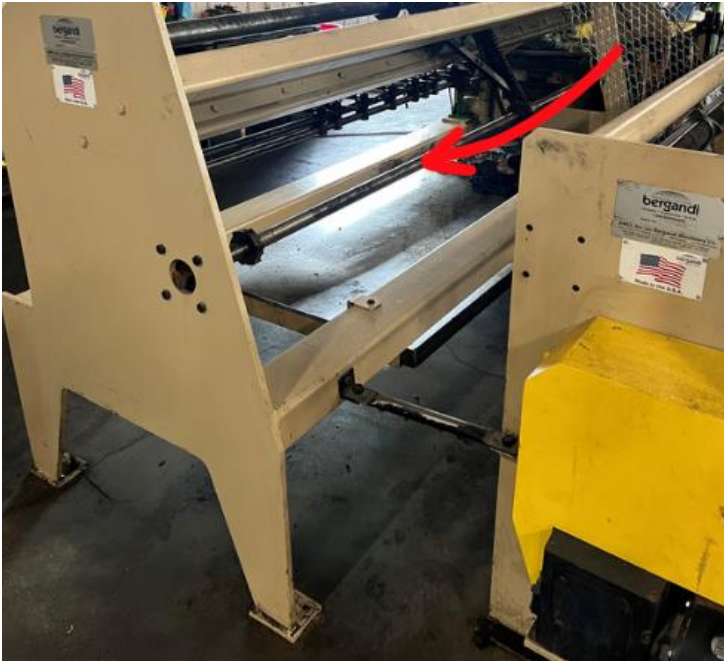
Photo 7. Red arrow indicating the horizontal shaft in which the victim's hair was entangled. Photo property of Kentucky FACE.

Discussion: According to a company representative, the victim's ponytail became entangled in a horizontal shaft known as the knuckler shaft located at the rear of the machine. Wearing loose fit clothing and having long, unsecured hair can present a grave risk when operating machines with moving parts. These risks may increase based on the season, weather, and temperature, as employees are more likely to utilize long sleeve jackets and shirts to stay warm. Other items such as beards, necklaces, and jewelry can also pose a similar risk. The involved company has a policy in place that reads as follows: *loose clothing, jewelry, and hair must not be worn around machinery*. However, the policy was not followed on the day the incident occurred.

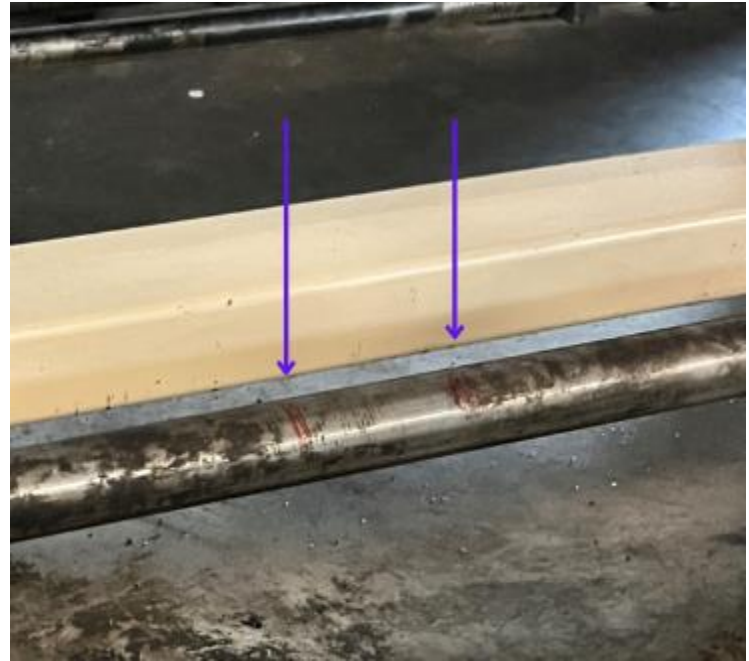
Photo 8. Purple arrows point to red marks drawn on shaft that indicate exact spot the victim's hair wrapped around the shaft. Photo property of Kentucky FACE.

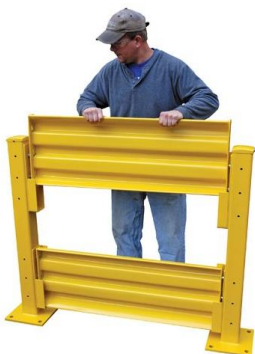
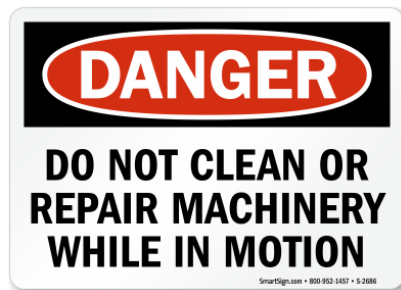
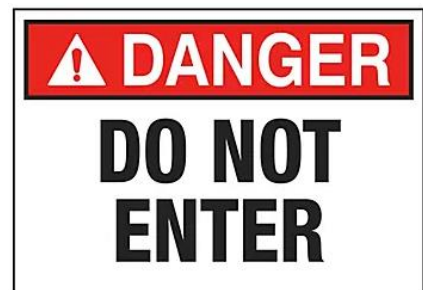
Photos 9, 10, and 11. Photos depicting examples of physical barrier and signage that could be utilized to prevent entry and warn employees of associated hazards. Stock photos obtained from Google.
