**REPORT#:** 23KY115

## Hotel Employee Drowns in Swimming Pool

### SUMMARY

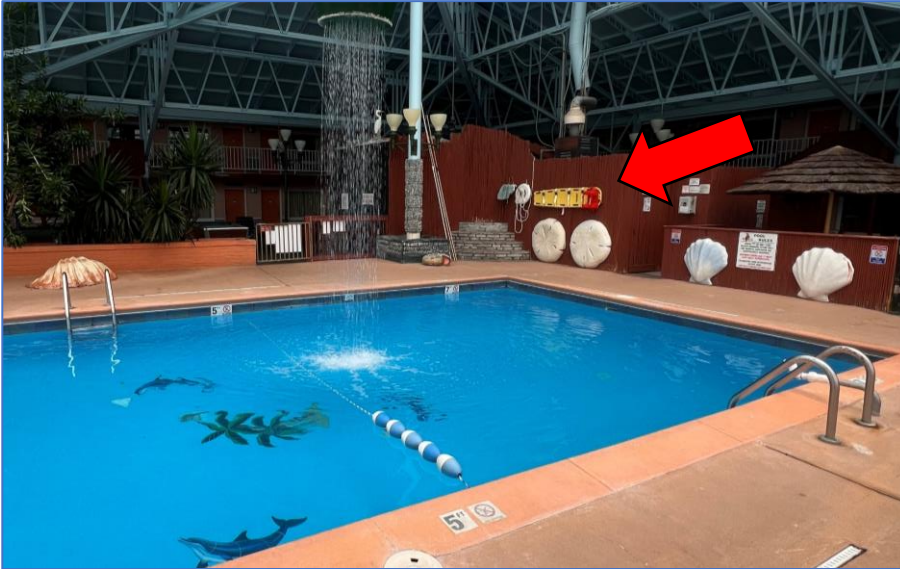
The pool was equipped with entry steps and a ladder in the shallow end and another ladder in the deep end. Water safety equipment including a ring buoy with throwline, rescue pole, and backboard were located in the pool area. Pool maintenance equipment such as poles and skimmer bag attachment were also available in the pool area. Equipment is indicated by a red arrow in photo 1.

Photo 1. Equipment in pool area. Photo property of KYFACE program.

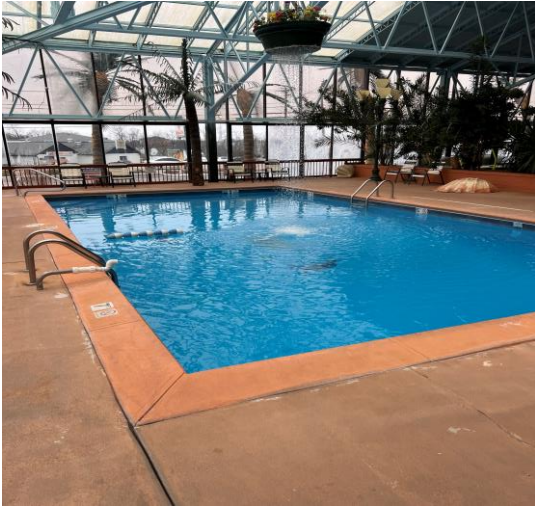
The scene was an indoor pool housed in a large atrium that contained mature trees and plants. It included billiards and shuffleboard areas and was bordered on the northeast and southeast sides by guest rooms on two levels. The northwest and southwest sides of the atrium and portions of the ceiling were constructed of glass, as shown in photos 2 and 3. The pool area was located adjacent to the hotel's front desk area, accessed through a short hallway separated by glass doors. The pool area was monitored by a security camera that could be monitored by employees at the front desk.

Photo 3. Northwest view of pool area. Photo property of KYFACE program.

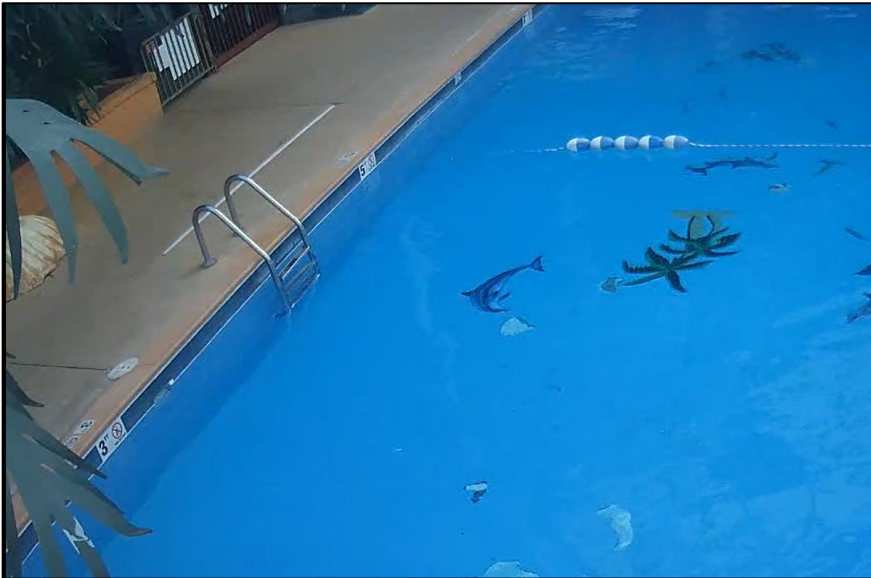
While there were no eyewitnesses, the employer's security camera system recorded most of the incident. KYFACE was able to obtain the video from the local emergency response agency. The video began at 11:04 a.m. with the worker having already entered the shallow end of the pool, at a depth of approximately 3 feet. Pool depths were indicated by signage on the pool deck and inside pool walls and are visible in photo 4. It should be noted that the security camera footage and photos taken by KYFACE show that the buoys of the pool's rope and float line were not evenly spaced. Buoys should be kept secured so that they do not slide or bunch (Texas, 2024).

Photo 4. Video capture of pool depth signage. Video courtesy of local EMS agency.

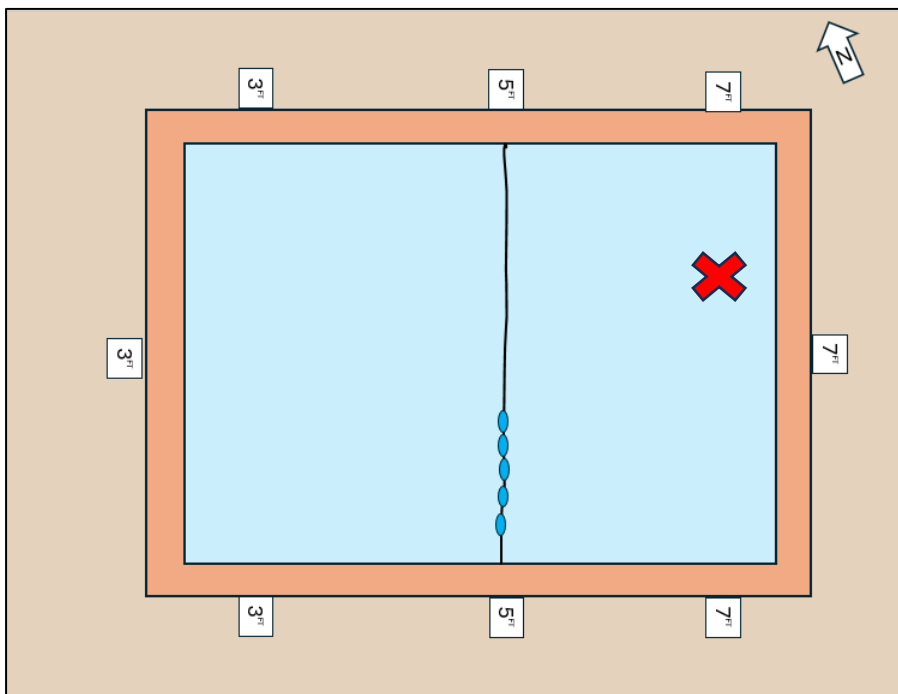
At 11:08 a.m., the worker then climbed out of the pool near the 5 foot depth mark and walked to the deep end of the pool, indicated to be 7 feet deep. At 11:09 a.m., he re-entered the pool at the southern corner and moved to the center of the deep end by holding on to the poolside. The security camera video footage suggests that he was looking at additional trash and he pushed himself down to the bottom to retrieve it. The worker then experienced trouble returning to the edge of the pool, which appeared to be just out of his reach. He struggled to remain afloat, submerging and coming to the surface several times. He submerged for the last time and appeared to lose consciousness at approximately 11:11 a.m., sinking to the bottom in an area indicated by a red "X" in diagram 1.

Diagram 1. Pool area.

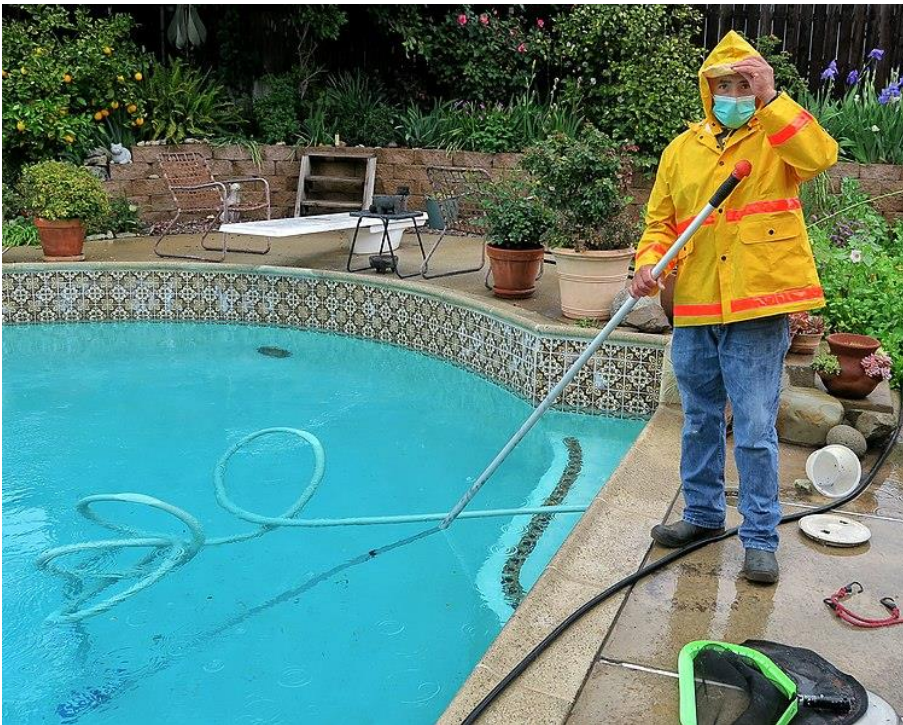
Photo 6. Example of non-entry. Photo courtesy of Russ Allison Loar.

***Recommendation #4: Employers who have a swimming pool should establish a safe work practice that directs employees to perform work tasks without entering the pool.***

Discussion: Safe work practices are a form of administrative hazard control. The National Institute for Occupational Safety and Health ([NIOSH, 2023](#)) notes that, “Administrative controls establish work practices that reduce the duration, frequency, or intensity of exposure to hazards,” by methods such as limiting access to hazardous areas. A safe work practice that directs employees to clean the pool without entering, such as using a pole with skimmer bag, similar to the work practice shown in photo 6, could be implemented.
