REPORT#: 24KY001 REPORT DATE: November 19, 2024

Employee Dies by Suicide

Kentucky FACE Program

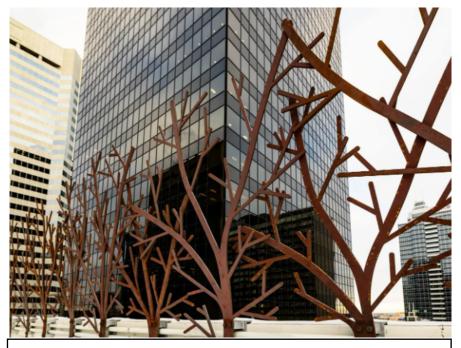
Photo 2. Photo showing physical barrier installed on top of a high rise building to combat suicide by jumping.³

Physical barriers on high rise buildings: Physical barriers can be an effective method of means prevention to combat suicide by jumping. Physical barriers on a building's roof prevent and/or increase the difficulty of jumping (photos 2 & 3). Physical barriers can be included in new building construction plans or retrofitted to existing structures.
