**REPORT #:** 24KY072

# Wash Bay Attendant Engulfed by Fire Dies from Injuries

#### Fatality Assessment and Control Evaluation (FACE) Program

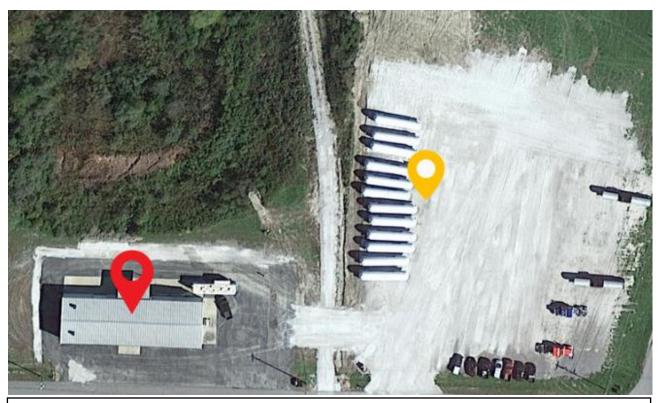
The incident occurred in a gravel parking lot at the company's Kentucky location. The property houses a large metal building that is utilized as an equipment maintenance facility and employee offices. Both trucks and trailers park around the perimeter of the property (photo 1).

Photo 1. Google Earth photo showing overhead view of the location where the incident occurred. The yellow location marker represents the approximate location of the incident. The red location marker identifies the dual-purpose office and maintenance building occupied by the involved company.

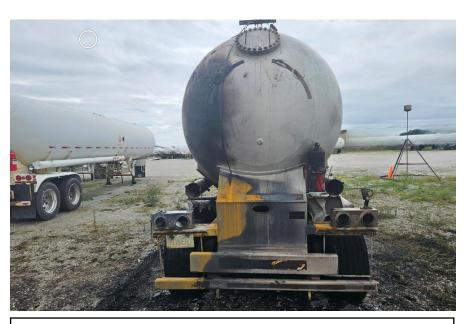
that the brakes on the trailer were seized. As a result, the trailer could not be moved. Concurrently, the employee also observed 75 lbs of pressure on the trailer gauge, concluding that the trailer still contained compressed butane gas.

Photo 3. Photo of LPG trailer involved in the incident.
