INCIDENT HIGHLIGHTS

REPORT#: 25KY001

Truck Driver Dies after Truck Overturns

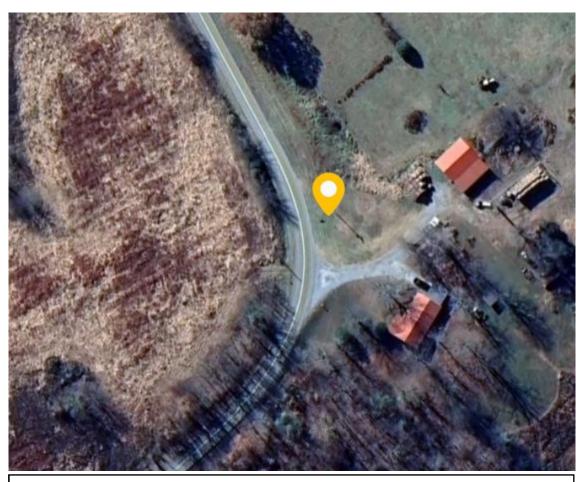
The incident occurred on a rural two-lane Kentucky highway. Travel lanes are separated by a double yellow line, which indicates that passing is not authorized. The speed limit is 55 mph, and no guardrails are present at the scene. The road, which runs from east to west, has several prominent curves and grade changes (photo 1). The road was dry at the time the incident occurred.

Photo 1. Overhead view of the location where the incident occurred. The yellow location marker represents the approximate location where the truck came to a stop. (Google Earth)

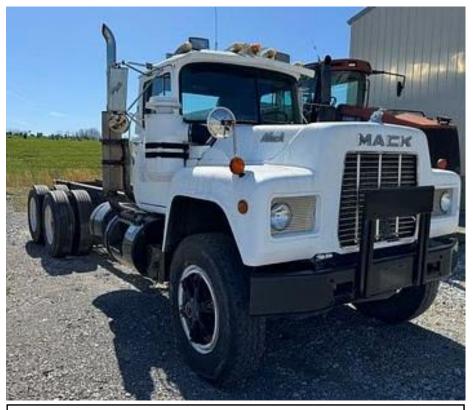
Photo 2. Photo of a 1986 Mack RD semi-truck, similar to the type of truck involved in the incident. Image found via Google search.

On the day the incident occurred, the victim was operating a 1986 Mack RD semi-truck (photo 2) with a 32-foot Dickerson flatbed trailer in tow (photo 3). The task of the day was to deliver 22 wooden mats to a Kentucky-based job site; the weight of the truck, trailer, and wooden mats was approximately 75,000 lbs. This trip was not the first time the victim had delivered to this job site; he had successfully completed two deliveries to the same location the day prior.

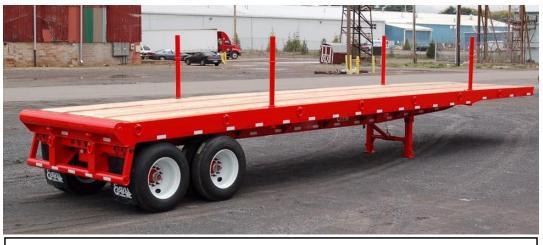
Photo 3. Photo showing type of trailer similar to that involved in the incident. Image obtained via Google search.

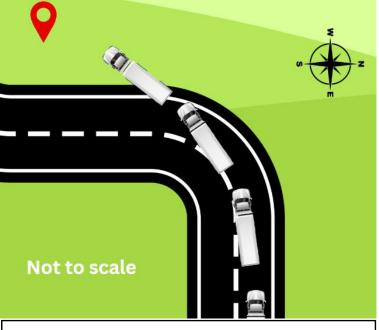
Approximately two hours into the victim's workday, at 8:52 a.m., the victim was involved in a single vehicle fatal collision. According to the crash report, the victim was traveling westbound on a rural two-lane Kentucky highway when he attempted to navigate a 90-degree turn. Although the speed of travel was not listed on the crash report, crash investigators determined that the speed at which the truck entered the curve was too fast for the victim to maintain proper control of the vehicle. Braking marks present on the roadway suggest that the victim attempted to brake upon realizing the vehicle was traveling too quickly to navigate the turn. The braking attempt was unsuccessful, which led to the semi-truck and trailer exiting the travel portion of the cargo to shift, which resulted in the trailer overturning. As the trailer overturned, the semi-truck followed, overturning and coming to a final rest on its top (diagram 1, photo 4).

Diagram 1. Diagram depicting the approximate path traveled by the involved semi-truck and trailer. The red location marker indicates the approximate location where the vehicle came to a final rest on its top. Diagram property of Kentucky FACE.

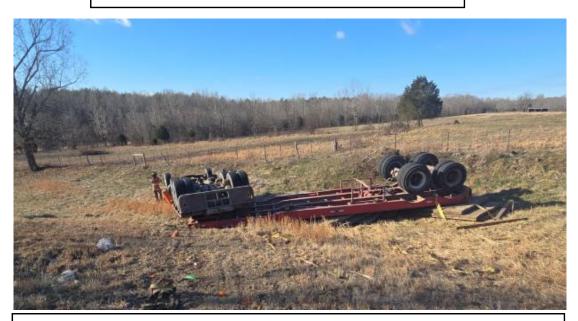
Photo 4. Scene of incident captured by responding officer's body camera. Photo obtained via Kentucky open records request.

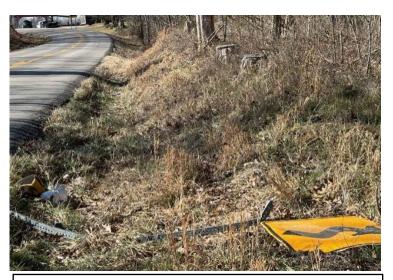
Discussion: According to the company involved, a static W1-3 reverse turn sign (photos 4 & 5) was damaged and down prior to the collision. Although the police report does not mention the missing sign, and FACE investigators cannot be certain, the absence of tire tracks on the shoulder of the road does suggest that the vehicle involved did not strike the sign.

Although the impact of the missing sign cannot be accurately assessed, the presence of the sign may have helped provide advance warning of the sharp curve ahead.

Photo 5. Photo of W1-3 reverse turn sign located at the scene of the crash. Photo provided by the involved company.

To aid in the prevention of similar incidents, the Kentucky Transportation Cabinet Department of Highways should ensure that highway warning signs are free of damage, legible, and properly placed to adequately warn drivers of hazards.
