**REPORT#:** 25KY009

## Fencing Laborer Deceased after Skid Steer Attachment Fails

# KENTUCKY

### Fatality Assessment & Control Evaluation

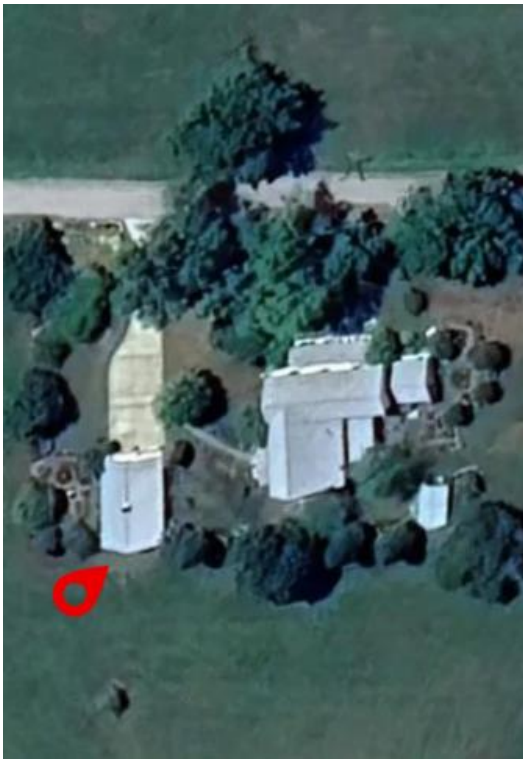
Photo 1. Google Earth photo showing overhead view of the residential location where the incident occurred. Red location marker identifies location on the property where the incident occurred.

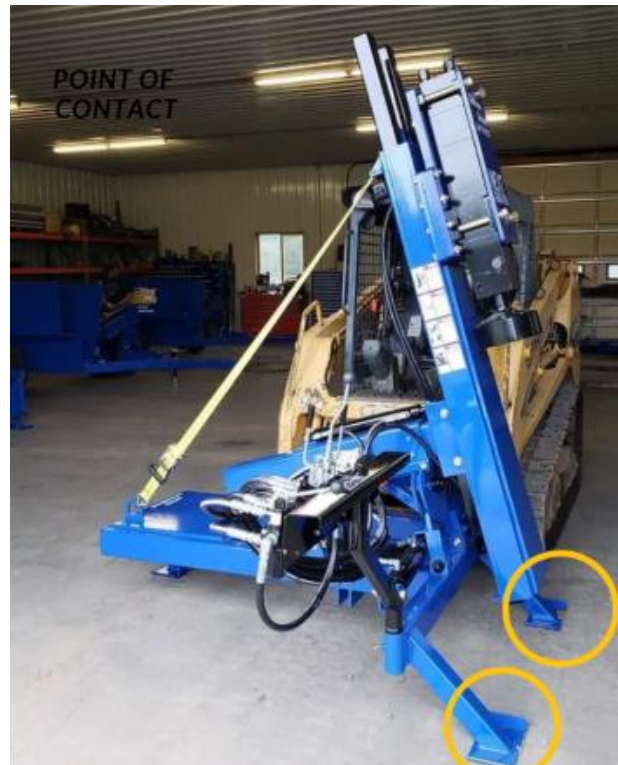
The company involved was operating a skid steer mounted, single slide "Next Generation" model post-driver manufactured by [Extreme Post Drivers](#). (Photo 2). Once attached to the skid steer, the post driver utilizes a hydraulically controlled hammer to drive posts. Support arms on the driver's attachment (photo 2) help stabilize the driver during operation. The driver arm can be tilted to meet the needs of the post and terrain in which the post is being installed. The post driver specifications, according to the manufacturer's website, are as follows:

Photo 2. Photo showing type of skid steer mounted post-driver utilized in the incident. The yellow circles show the driver support arms. Photo obtained via Google image search.

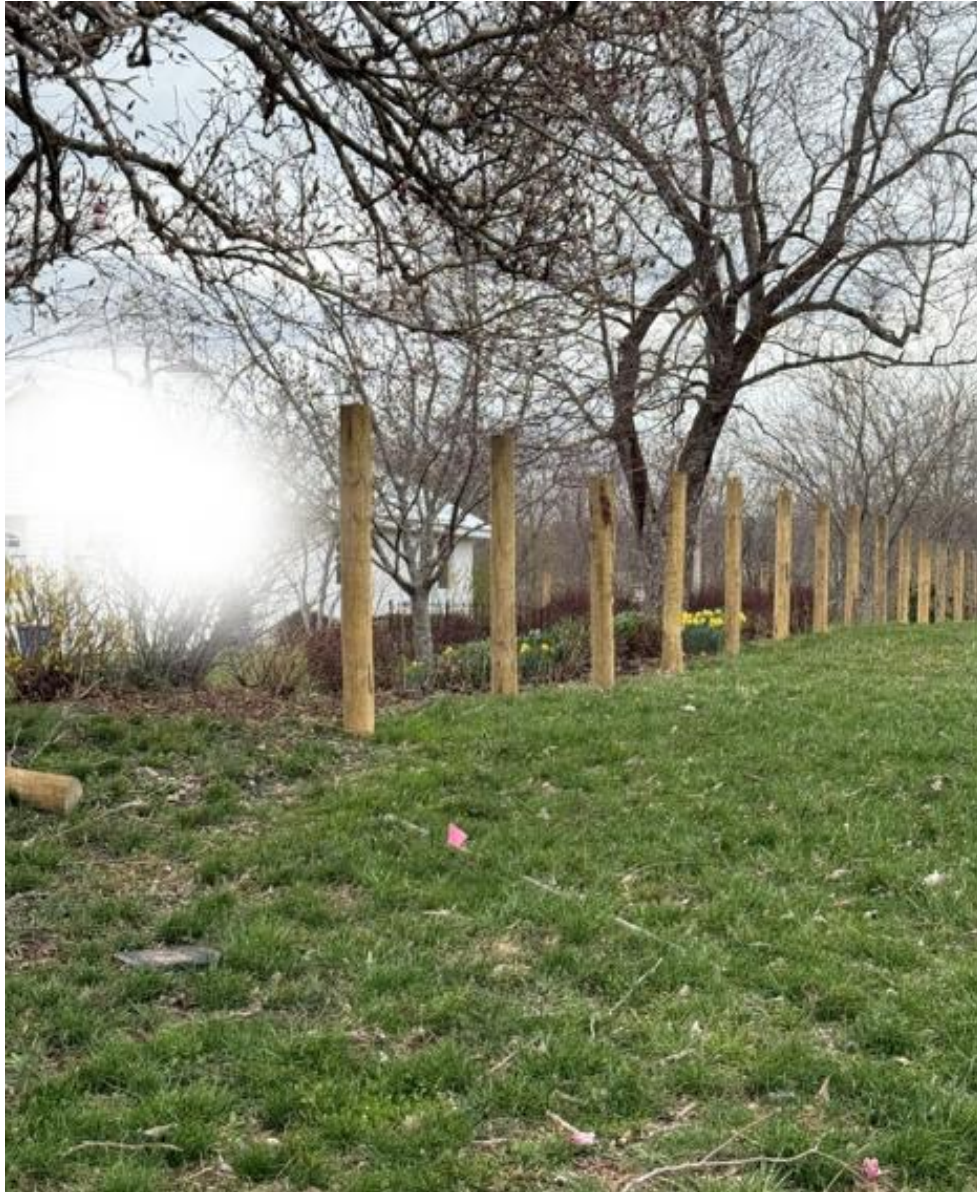
Photo 3. Photo showing posts that were being installed when the incident occurred. Photo property of Kentucky FACE.

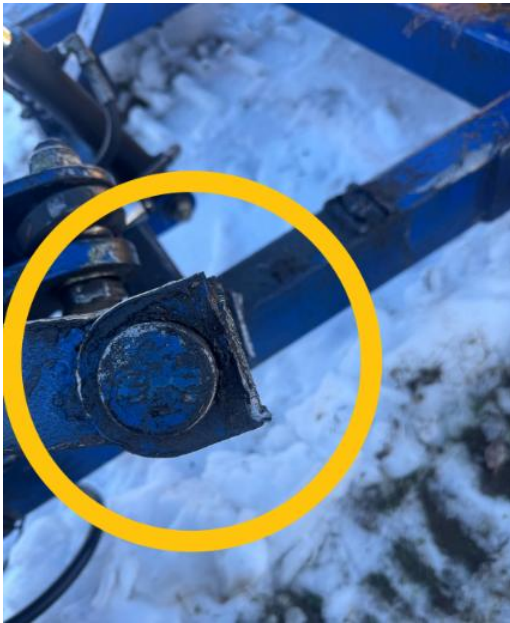
Throughout the course of this repetitive task, at approximately 11:30 am, four hours after arriving at the job site, the post-driver suffered a catastrophic failure while driving a wooden post into the ground. For unknown reasons, the driver arm and head broke away from its mounting point while attempting to drive a wooden post (Photo 4 & 5). As a result, the hydraulic arm sheared off (Photo 6).

Photo 4. Photo showing post-driver attachment point and point of break. Photo provided by involved company.

- Examine attachment for cracks, visible signs of wear, damage or malfunction.
- Examine connection points to ensure connections are free of damage.
- Inspect hydraulic hoses and connections for leaks, cracks or other damage.
- Ensure hydraulic hoses are free of obstruction.

- Inspect and ensure all fasteners, bolts, and nuts are tightened and properly secured.
- Visually inspect for missing fasteners, bolts and nuts.
- Visually inspect any safety features, such as locks, guarding, and warning labels.
- Verifying all moving parts are properly lubricated.
- Conduct a functionality test to ensure proper safe operation prior to beginning work.
- Any issues observed should be properly addressed prior to utilizing the machine.

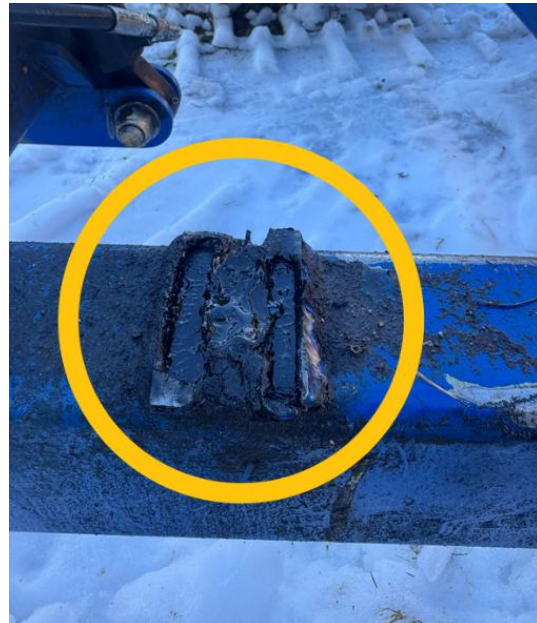
Photo 5. Photo showing post-driver attachment point and point of break. Photo provided by involved company.

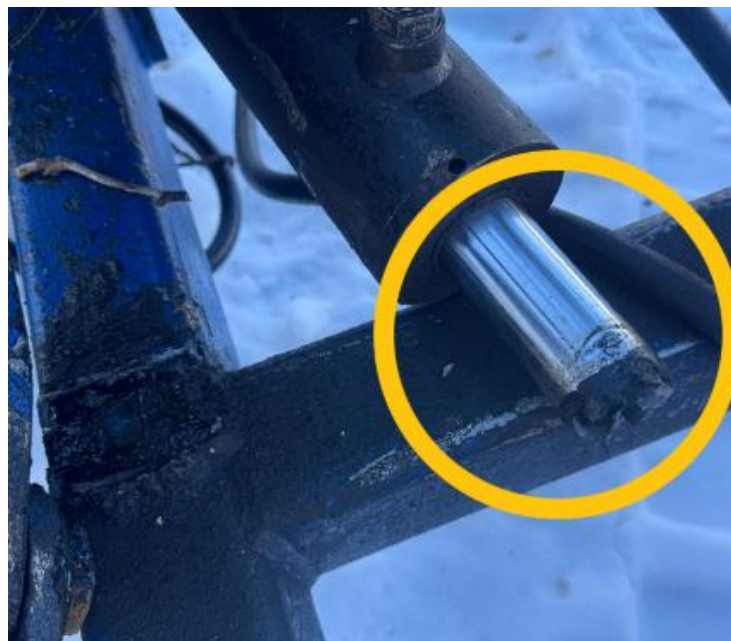
Photo 6. Photo showing post-driver hydraulic arm that was sheared off. Photo provided by involved company.

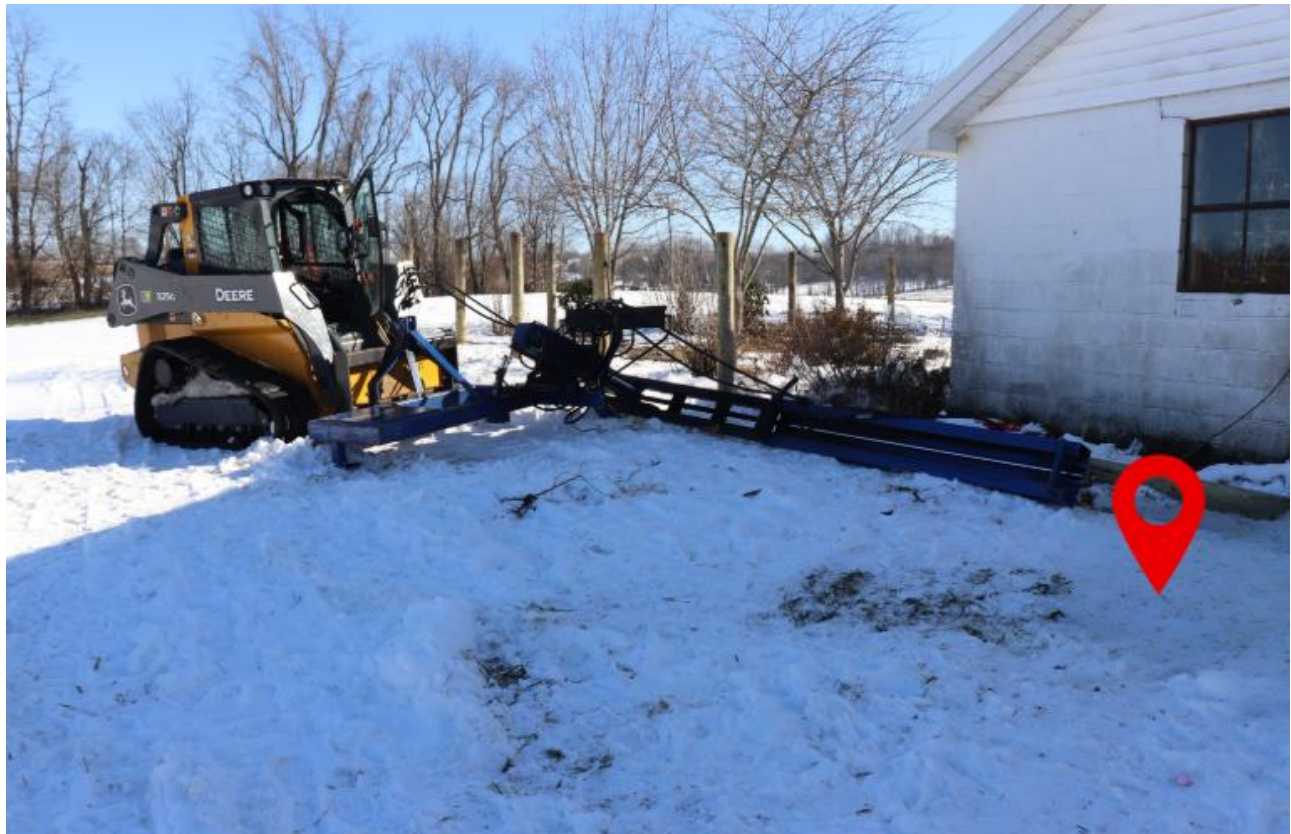
The broken arm and driver-head fell, striking the victim, who was approximately 10 feet from the equipment, in the back and upper left shoulder (Photo 7, 8, Diagram 1). The victim was reportedly on his cell phone with his back turned to the equipment, holding the next post to be installed, when he was struck. The strike knocked the victim forward and to the ground, bending him at the waist. The arm and driver-head remained on the victim after the strike, and in the bent position his head and torso were touching the front of his legs. The owner and two other crew members who witnessed the incident rushed to the victim, who was unconscious, to lift the arm and driver-head off the victim. Once removed, the owner contacted 911 while a crew member attempted to perform cardiopulmonary resuscitation (CPR).

Photo 7. Photo showing failed post driver at the scene of the incident at final rest. Red location marker indicates location of the victim. Photo obtained via Kentucky open records request.

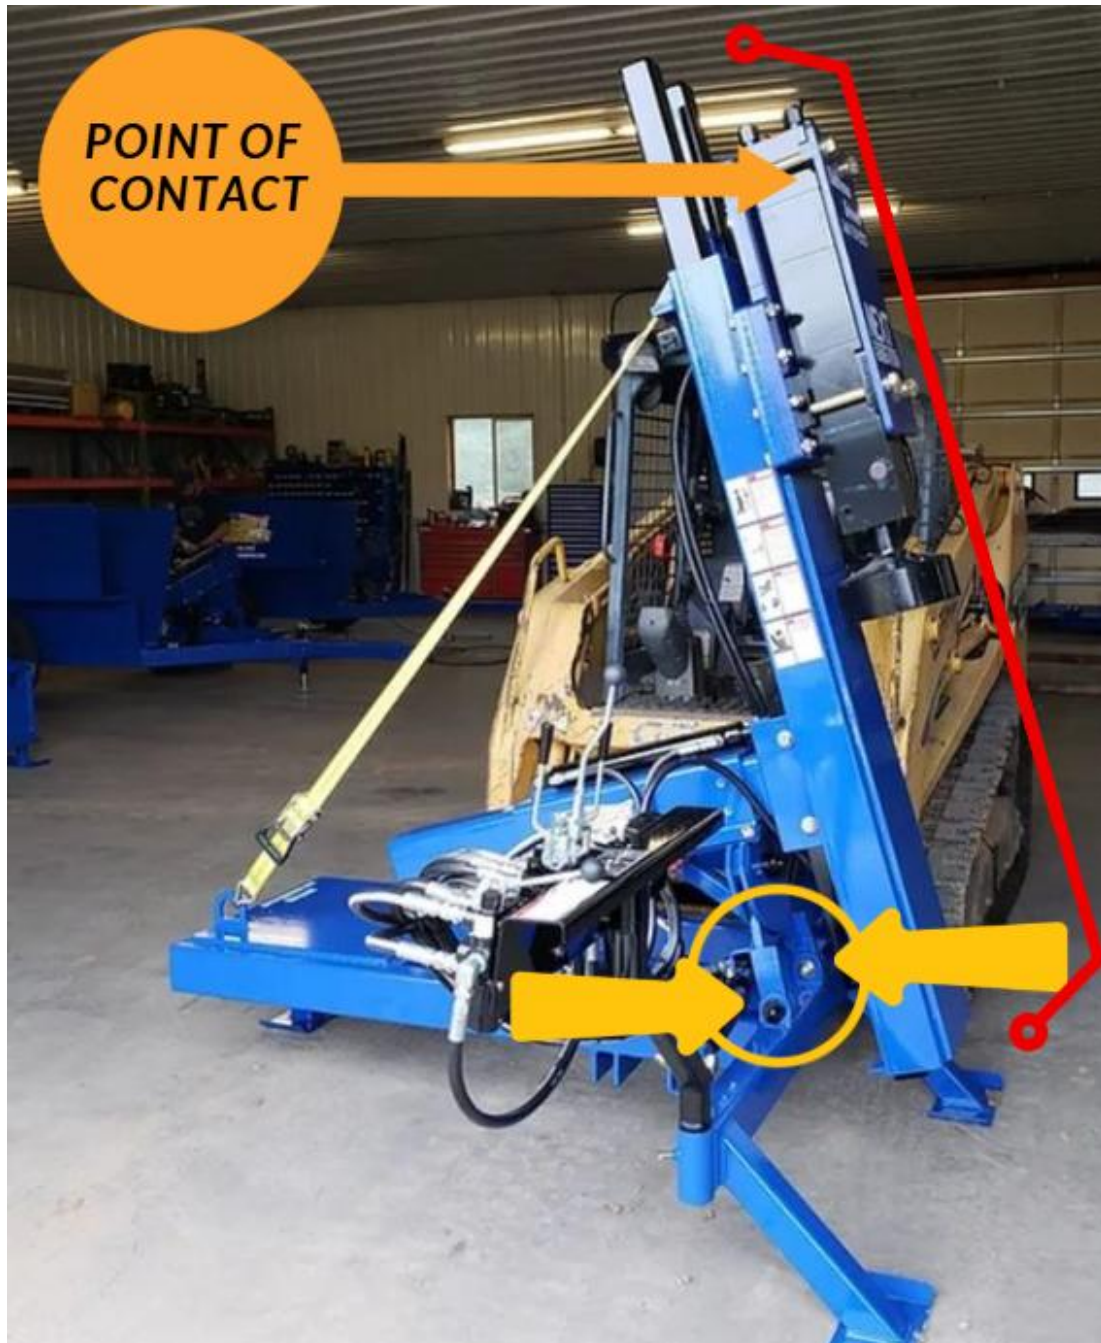
Photo 8. Photo showing a similar post-driver. Yellow arrows depict points where machine broke from base. Red lines show the driver arm and head which fell towards the victim. Orange arrow indicates the point of contact with the victim's back/shoulder area. Photo obtained via Google search, modified to aid in investigation.
