**REPORT#: 25KY032    REPORT DATE: 05/01/2026**

## Electrician Trainee Fatally Electrocuted at Commercial Job Site

### SUMMARY

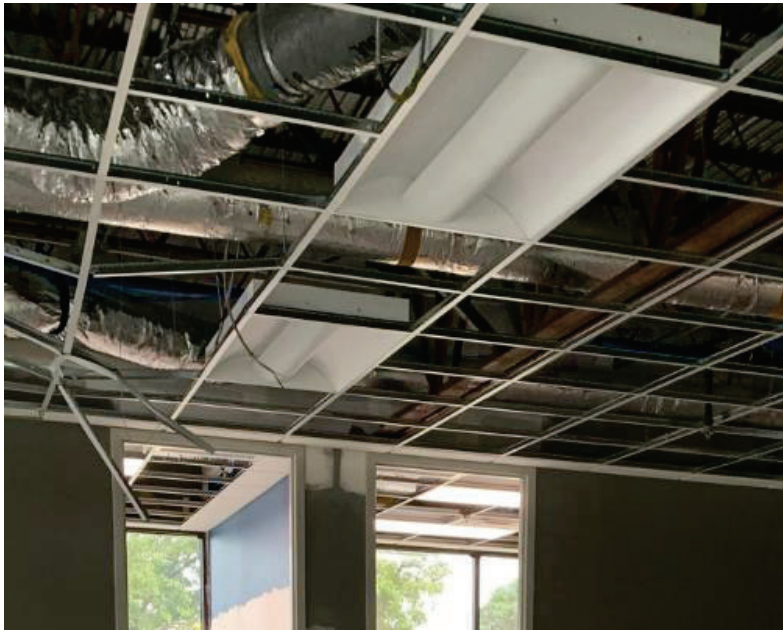
Photo 2: Troffer style lights in the incident. Photo obtained via open records request.

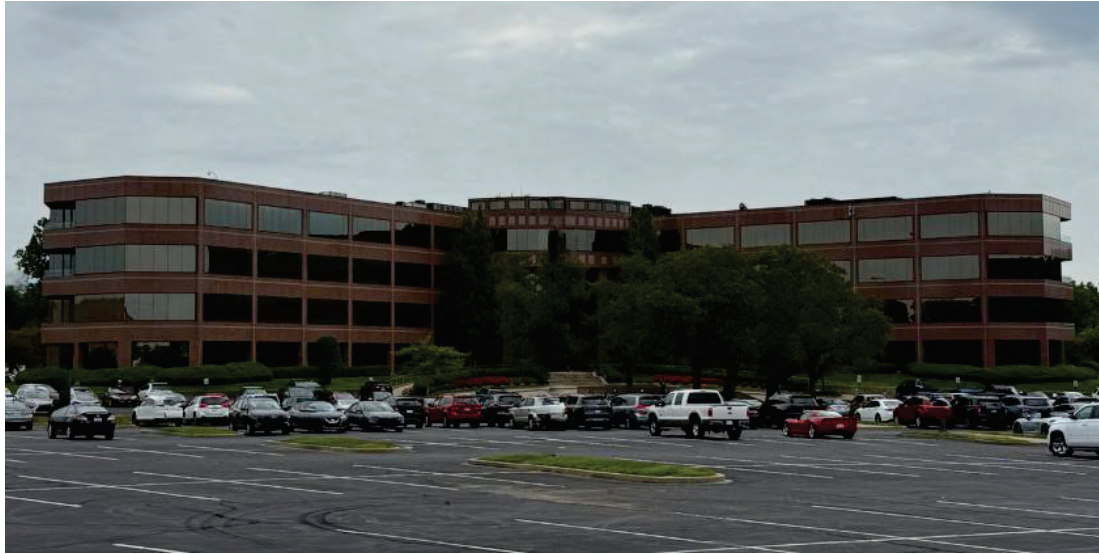
The incident occurred inside a 134,000-square-foot, four-story commercial office building (photo 4). The building, which was erected in 1989, is constructed of brick and hosts multiple business suites on each floor. The incident took place in a suite that was being renovated (photo 5). The victim and his supervisor were working within the same room; however they did not have a clear line of sight due to the L-shaped design of the room. The victim was working around a corner, on the shorter side of the L-shaped room, while the supervisor was on the opposite end completing a task when the incident occurred.

Photo 4. The building in which the incident occurred. Photo property of Kentucky FACE.

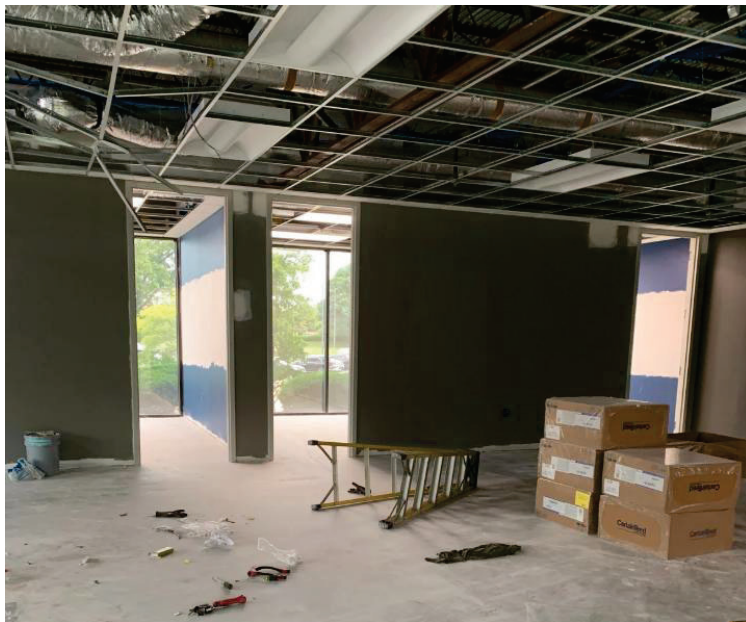
Photo 5: The scene of the incident. Photo obtained via open records request.

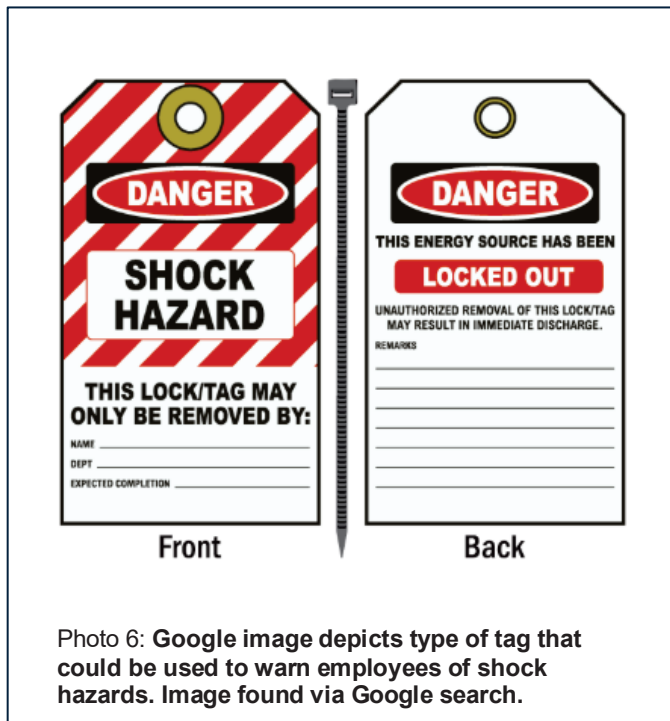
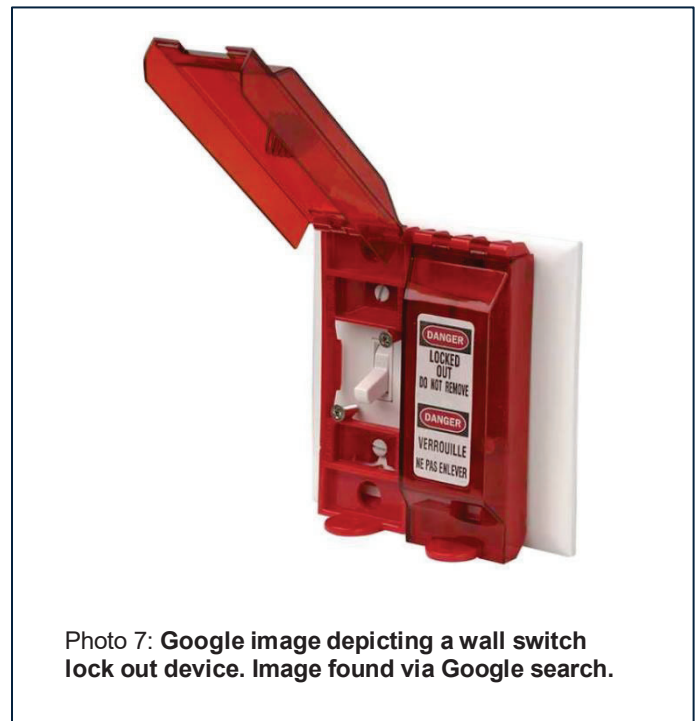
A lockout/tagout program could be beneficial in removing the risk of electrical shock in similar scenarios. Even if lockout is not possible, a tagging system (photo 6) can warn employees of electrical shock risk, helping the employee mitigate the exposure.

To help prevent similar incidents, Kentucky FACE investigators suggest that employers implement, train, and adhere to a formal energy-control program, which includes lockout/tagout procedures.
