Traffic Technician Dies From Fall While Changing Traffic Signal Bulb

Incident Number: 03KY028

Kentucky Fatality Assessment and Control Evaluation (FACE) Program

**Subject: Traffic Technician Dies From Fall While Changing
Traffic Signal Bulb**

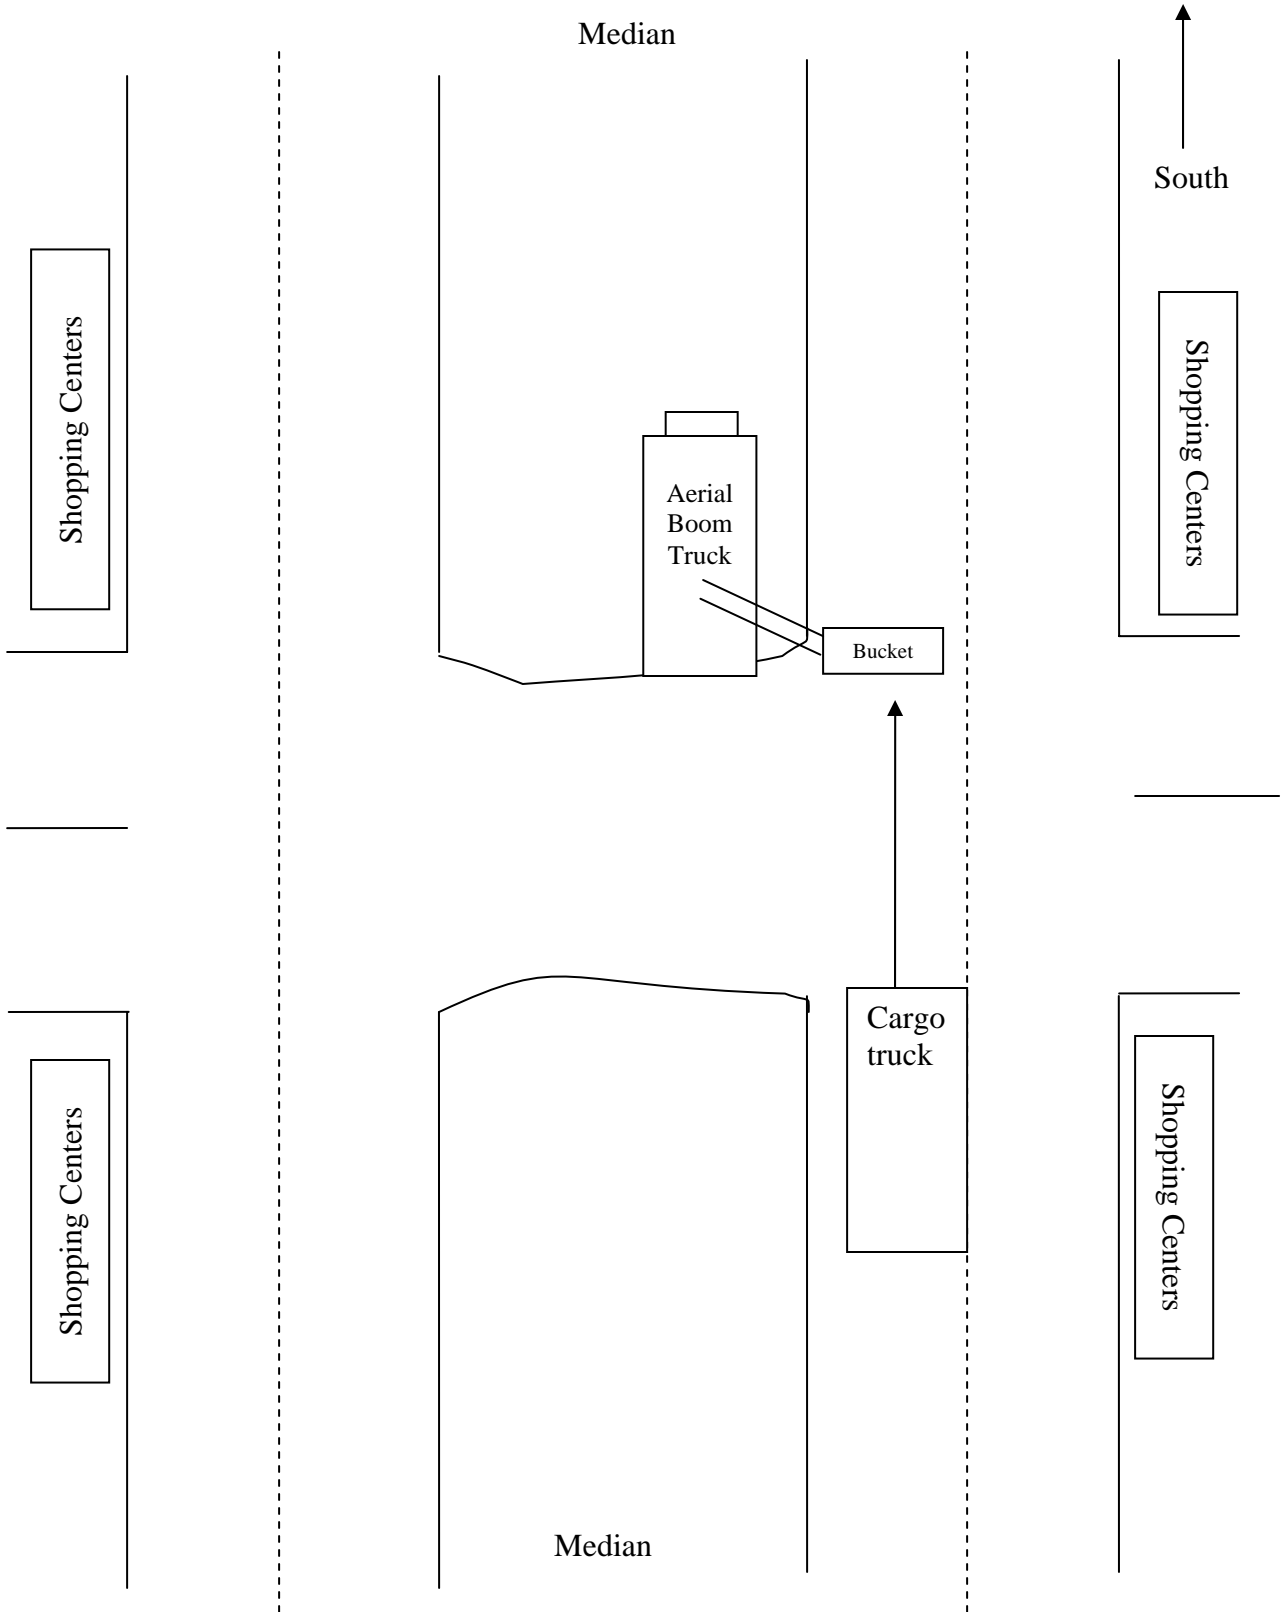
Photograph depicts the attachment of the boom to the bucket and the eye hook for harness attachment

Employers have a responsibility to provide a safe working environment for all their employees. Employees have a responsibility to themselves, their fellow employees and to their employer to use all applicable safety training and personal fall protection equipment provided by the employer. The safety harness was not worn at the time of the incident. There were two other harnesses in the truck provided by the truck manufacturer which had not been used and only needed adjustment to fit the user. A safety harness should have been worn and tied off to the eyehook on the boom.
