Master Plumber Dies When Trench Collapses

Incident Number: 03KY072

Kentucky Fatality Assessment and Control Evaluation (FACE) Program

Release Date: May 27, 2004

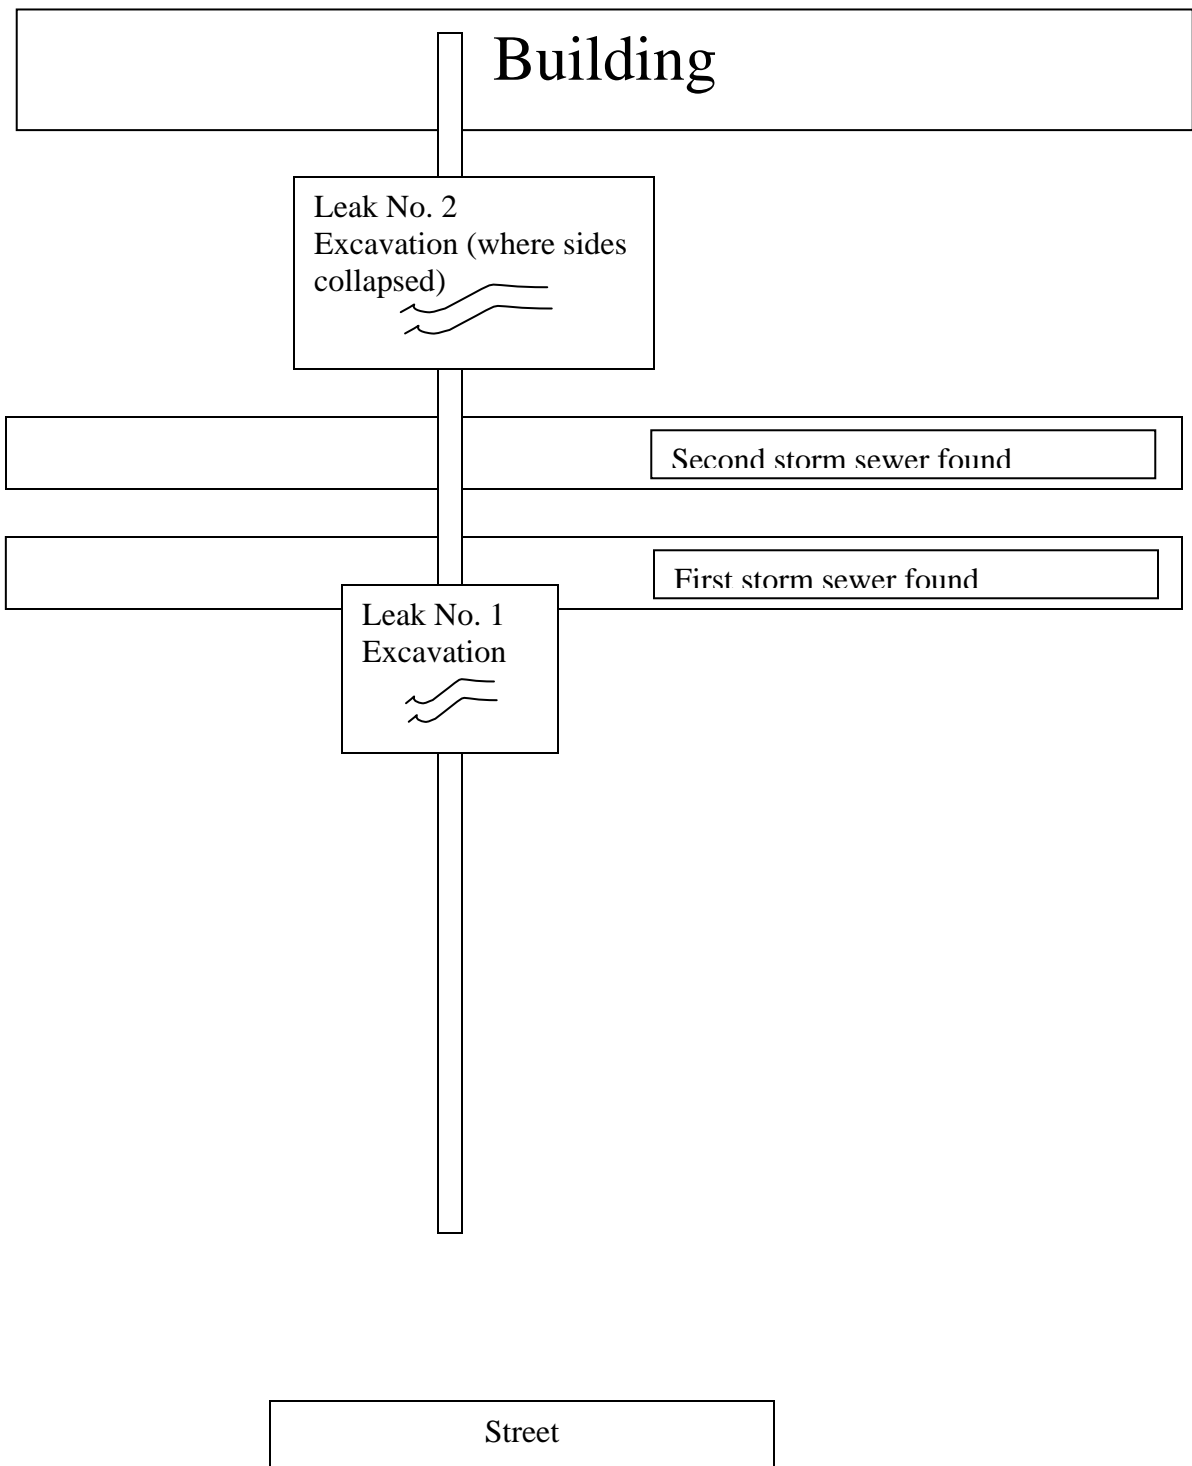
Photograph of Leak No. 1 excavation. Excavation for Leak No. 2 where incident occurred was immediately filled in by the plumbing contractor after decedent had been removed by emergency personnel. This photo was taken the day after the incident.
