**Bulldozer Owner / Operator Drowns While  
Trying to Repair a Pond  
Incident Number: 03KY073**

## **Kentucky Fatality Assessment and Control Evaluation (FACE) Program**

**Incident Number: 03KY073**

**Subject: Bulldozer Owner / Operator Drowns While  
Trying to Repair a Pond**

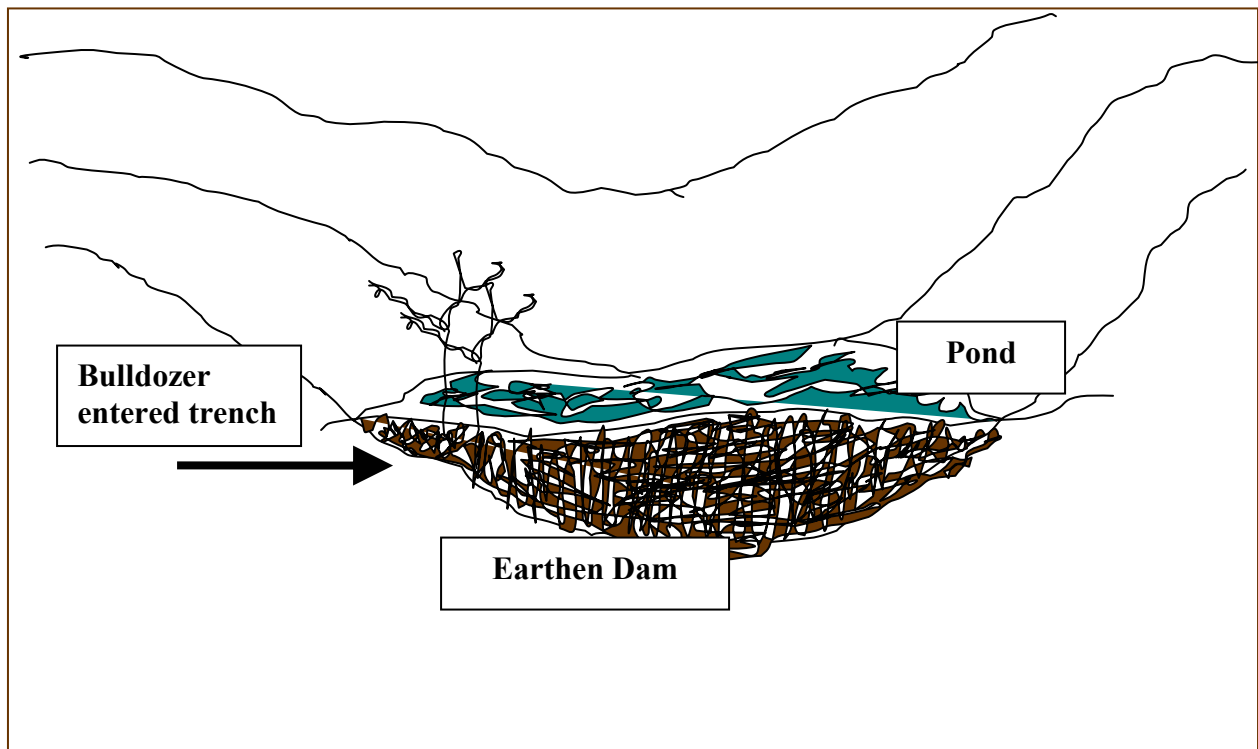
Rendering of view of pond site from earthen dam end

The pond on the farm had been made by creating an earthen dam between two hills. This captured rain run-off from the hills and spring water entered from the side of the pond opposite the earthen dam.
