Production Supervisor Falls 19.5 feet through a Metal Roof and Dies

Incident Number: 14KY048

Kentucky Fatality Assessment and Control Evaluation (FACE) Program

Release Date: August 24, 2015

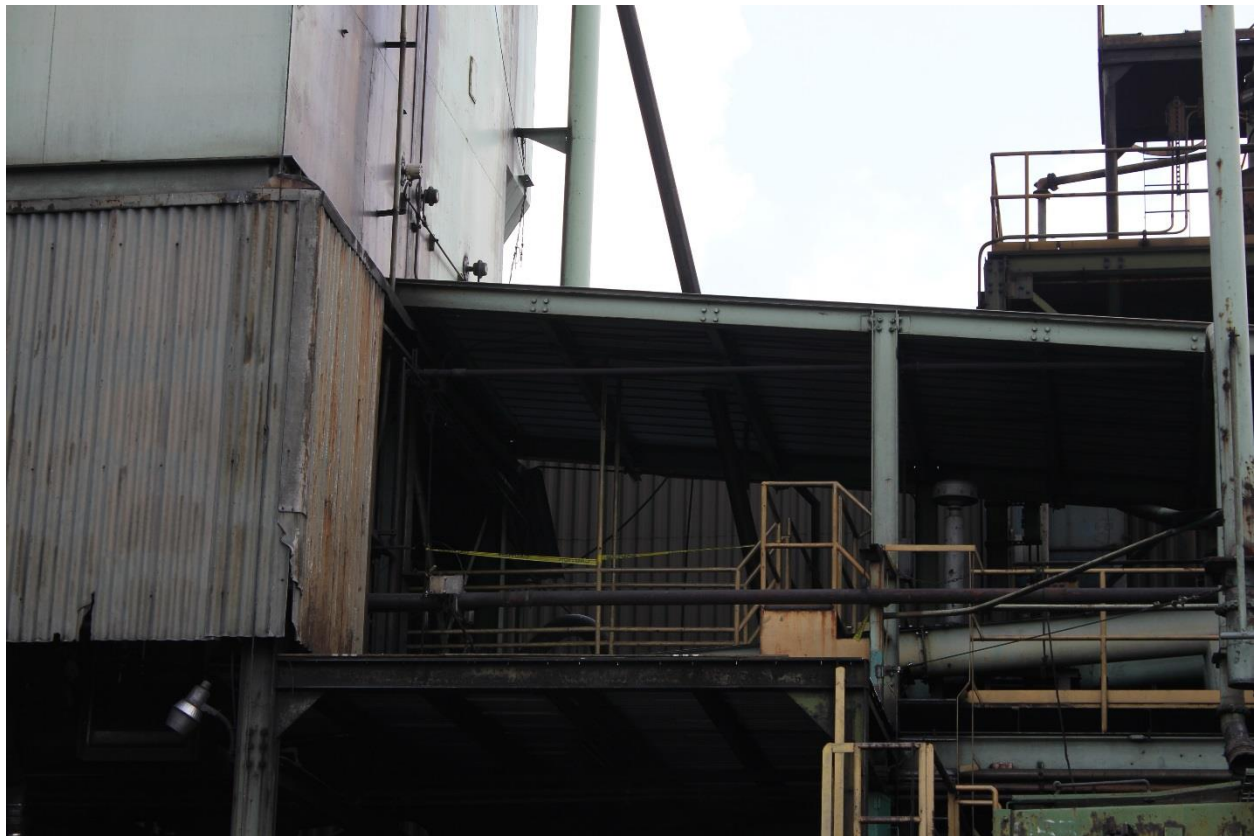
The scene was a metal roof covering a loading dock with a hardened earth surface. The roof area was flat and had a catwalk that ran over for access to the top of the roof. The edge of the roof area did not have any railings present and was 19 feet 6 inches above the ground. The area was slightly more than 13 feet wide. The metal roof had visible signs of rust and deterioration (see photo 3). Plywood was used to cover holes in the metal.

for him and found him lying on the ground. The supervisor had stepped onto a rotten area of the metal roof and had fallen through the roof 19 feet 6 inches to the hard dirt surface below.

The metal roof was in poor condition as evidenced by the plywood sections covering holes and that there had been at least two other employees who stepped through the roof but had not fallen. The roof was not in suitable condition to support human body weight. Routine assessment of the structural integrity of the roof and regular maintenance of the roof would have prevented this fatality.

Recommendation No. 1 Employer worksites should be regularly assessed for structural integrity.
