Apprentice Distiller Fatally Burned by Overpressurized Pot Still

Incident Number: 15KY019

Kentucky Fatality Assessment and Control Evaluation (FACE) Program
Incident Number: 15KY019
Release Date: December 15, 2015
Subject: Apprentice Distiller Fatally Burned by Overpressurized Pot Still

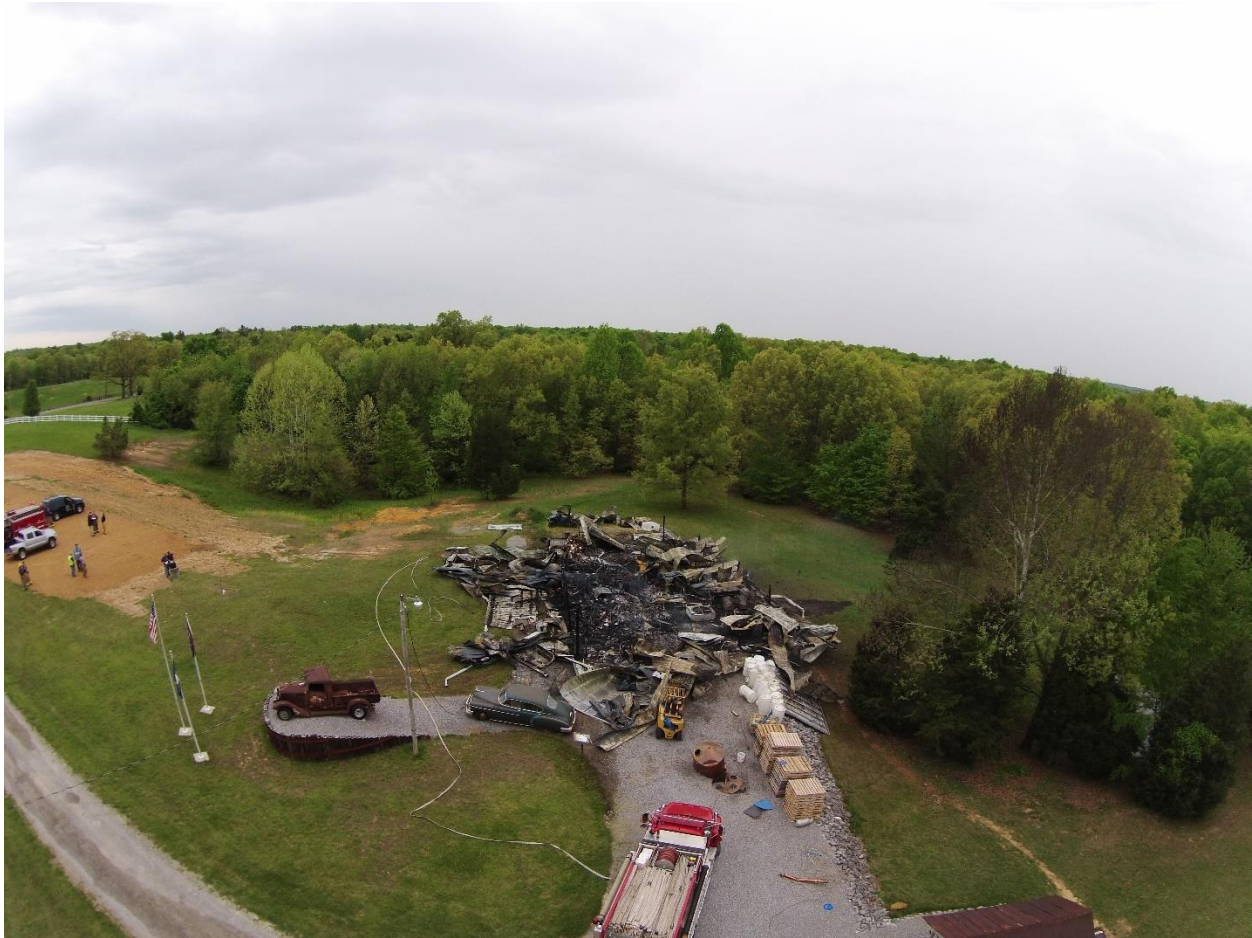
Photo courtesy of Marshall County Daily Newspaper

As they exited the building covered in hot mash, the second master distiller found the 300 gallon still and some of its components outside the building in the driveway, next to the distillery, and 90 feet from where the still had been mounted in the building.
