## Tree Trimmer Electrocuted and Dies While Trimming Tree Away from Power Lines

### CASE SUMMARY

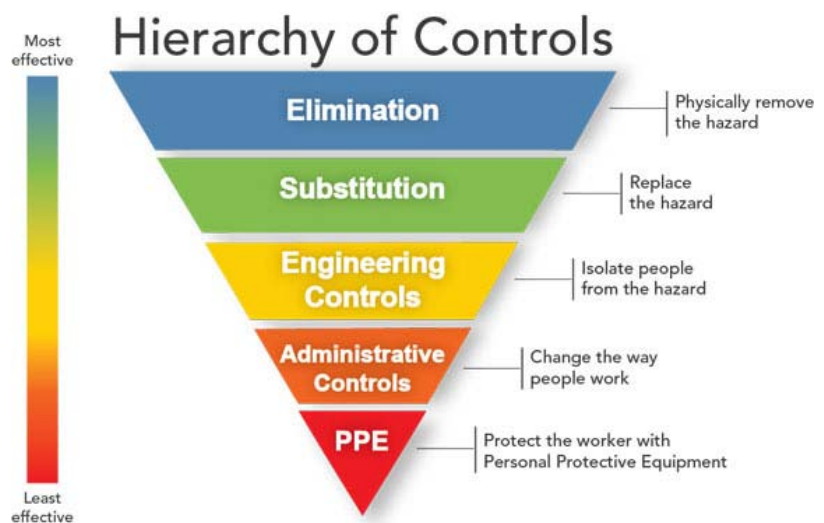
The tree trimmer working alongside the victim stated that the victim was a safety-conscious individual and performed a pre-shift risk assessment prior to beginning the job, as usual. However, sufficient protections were not put in place to prevent contact with the exposed, energized power line. When risk assessments are conducted and hazards are identified, proper follow up action should be initiated in accordance with the hierarchy of controls to prevent injury. For example, if we were to apply Hierarchy of Controls to a case like this, the energized power line could not be eliminated or substituted. Engineering controls would most likely involve permanent insulation of the overhead power lines by the line manufacturers, but this solution is unlikely due to the high associated cost. The next step in the hierarchy of controls is to provide administrative controls, followed by protecting the workers through

**Figure 8.** Hierarchy of Controls. Source: NIOSH.

use of personal protective equipment. OSHA standards require both administrative controls and personal protective equipment for line-clearance tree trimmers working within the MAD, or handling conductive objects within the MAD of exposed power lines.

**Recommendation No. 3: Safety hazards identified in risk assessments should be properly abated prior to beginning work.**
