REPORT#: 17KY034

REPORT DATE: 6-29-2018

Dump Truck Driver Loses Control and Flips Truck Resulting in Fire

State **FACE** Program

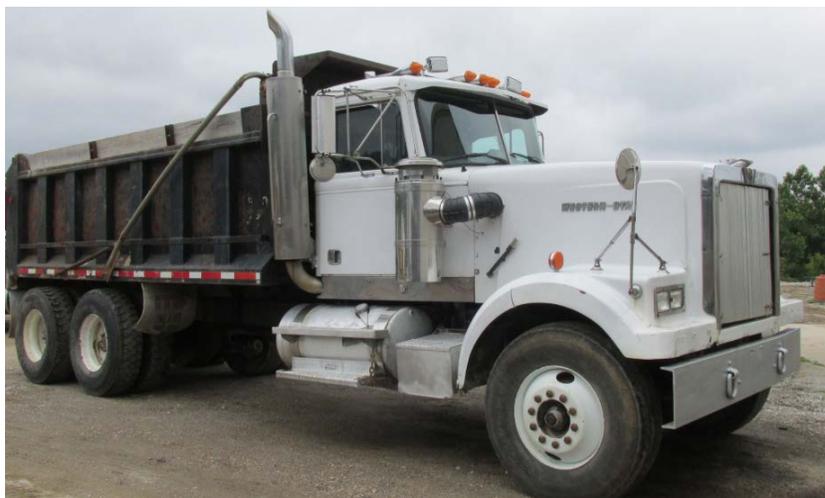
The truck left the roadway on the passenger side and flipped onto its right side into the culvert eight feet below the highway. As the truck flipped, the fuel tank struck a piece of rebar that was protruding from the concrete retaining wall leading to a water drainage tunnel under the highway. The fuel tank ruptured, causing a small fire in the engine that rapidly began to spread as fuel leaked from the tank.

Photo 4: 1987 Western Star 4900 series dump truck (Stock photo)

Recommendation #4: Large truck manufacturers should consider re-design and placement of fuel tanks.

Discussion: Large truck manufacturers should consider an engineering redesign and new placement of fuel tanks within all trucks. With the high number of truck crashes that result in fire, this redesign could save lives as well as equipment. According to the Bunn et al. (2012), large truck vehicle fire rates in Kentucky were significantly increased when compared to light trucks and passenger cars.⁶ The study recommended the fuel tanks would be better protected within the truck body and not exposed.
