REPORT#: 25KY028 REPORT DATE: 02/02/2026

Concrete Finisher Crushed by Collapsing Dump Bed

SUMMARY

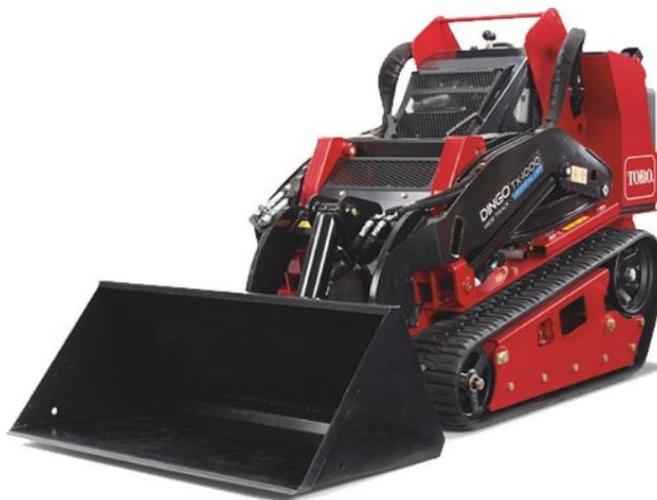
Photo 7: Photo showing a Toro Dingo, similar to the type of equipment utilized by the involved company to unload the gravel. Stock photo obtained via Google image search.
