### Metal Fabrication Shop Owner Dies When Crushed By Falling Steel Plate Incident Number: 03KY124

<b>Kentucky Fatality</b>	Assessment and Control Evaluation (FACE) Program
<b>Incident Number:</b>	03KY124
<b>Incident Date:</b>	December 13, 2003
<b>Release Date:</b>	December 1, 2004
Subject:	Metal Fabrication Shop Owner Dies When
-	Crushed by Falling Steel Plate

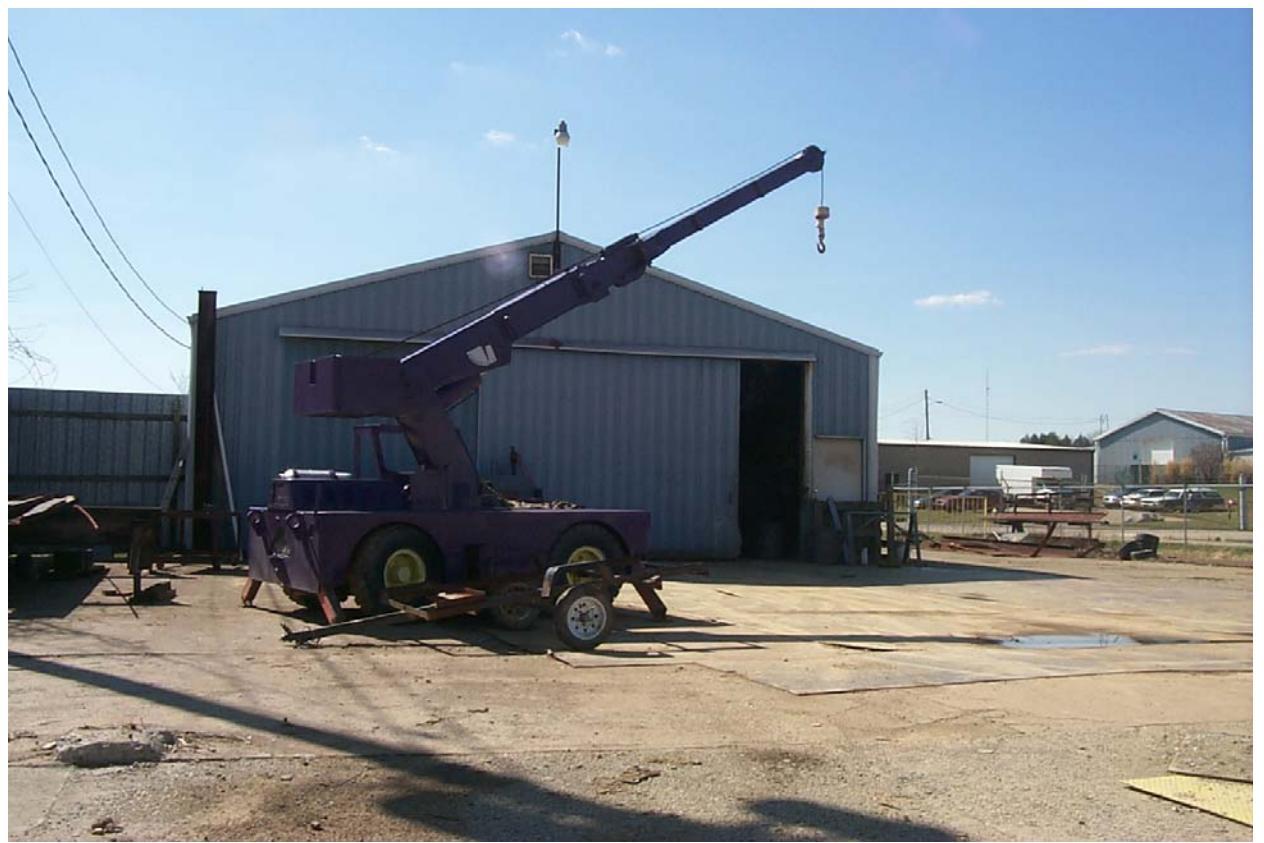
Back of shop where steel plate fell on business owner. The crane was used to load and unload materials.

An adequate beam and hoist mechanism for flipping over large plates and heavy pieces of metal should have been installed. By using a series of clamps and cables attached to an appropriate beam in the ceiling, the cables could be clamped on to the plates and by using tension on the cables, plates could be turned over or moved in a more controlled manner. Another alternative method for turning over cumbersome material would be to use an overhead crane. Either of these methods would allow for a safer way of handling and moving large pieces of steel and turning them over. Metal plates could be hoisted and turned over without positioning blocks underneath the 4,000 pound plate.

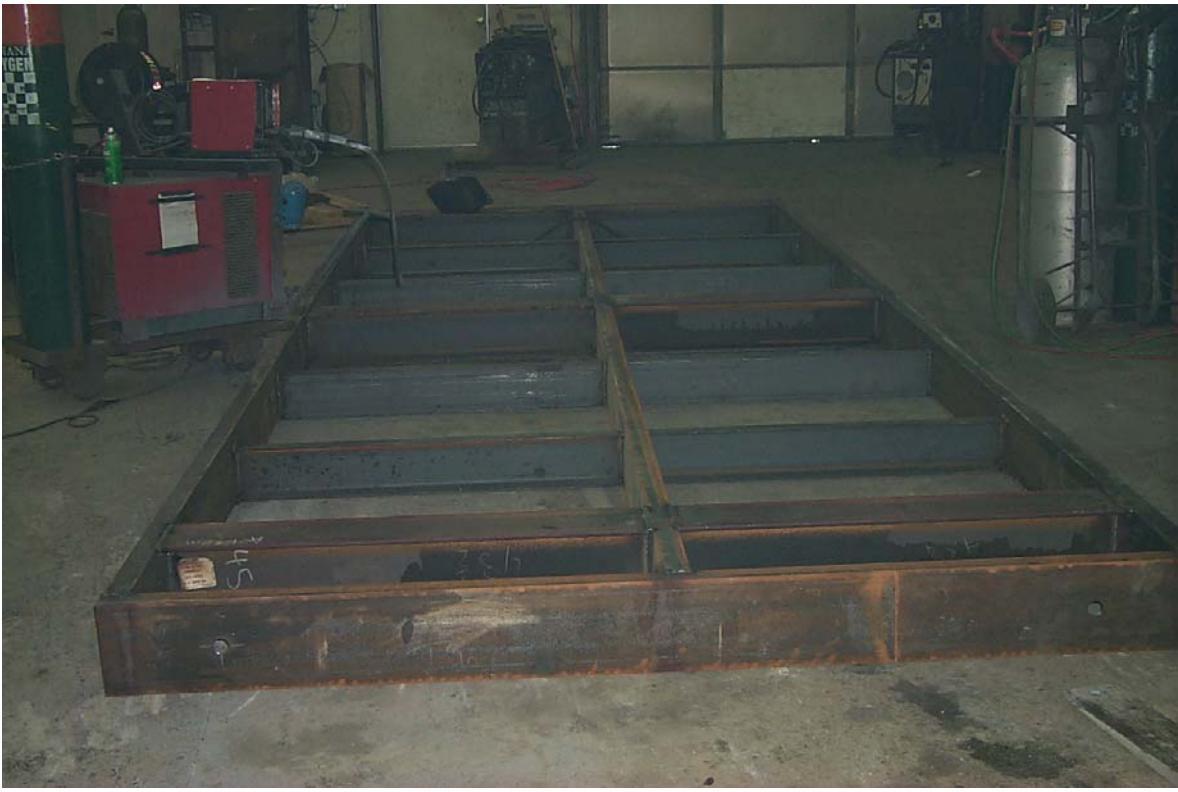
The victim in this incident owned a metal fabrication business that produced steel plate bases for large motors and pumps. Bases were made of steel and channel iron. Due to space limitations inside the facility, it was common practice to push the large plates outside with a fork truck, flip them over, then push the plates back inside so the other side could be worked on. This procedure was used when pieces required welding or painting.

Base plate inside shop before being pushed outside to be turned over. This plate is very similar in configuration to the one which fell on business owner.

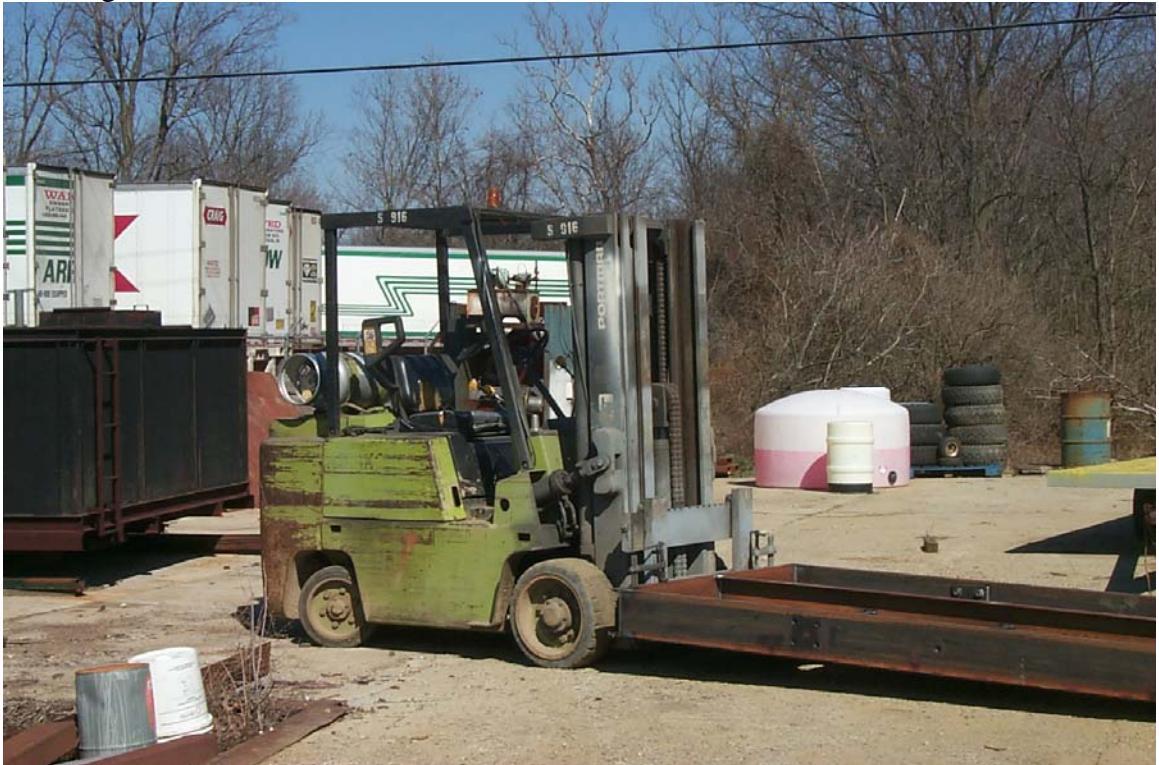
On the day of the incident, the decedent and 2 laborers were fabricating a <sup>1</sup>/<sub>2</sub>" x 10' x 20' steel metal plate weighing approximately 4,000 pounds. One side of the plate base had been completed with channel iron beams and connectors. One of the laborers operated the forktruck and pushed the plate outside the shop so it could be flipped over and pushed back inside to continue work on the other side of the plate. After pushing the plate outside, the forktruck operator slipped the forks under one side of the plate and tilted the plate with the other side on the ground. The owner then crawled headfirst under the plate to place blocks underneath. As he was positioning the blocks under the plate, the plate slipped off the forks and fell on the victim. One of the laborers immediately called emergency services. The incident occurred at approximately 2:52 pm. Emergency services arrived at the scene within minutes of receiving the

An example of how the fork truck was used to lift the metal plate. This plate is similar to the one that fell on the business owner.

KY OSH 1910.178(m)(2) states that "No person shall be allowed to stand or pass under the elevated portion of any truck, whether loaded or empty". This type of injury could be prevented by adhering to this standard.

KY OSH 1910.178(o)(1) states, "only stable or safely arranged loads shall be handled. Caution shall be exercised when handling off-center loads which cannot be centered". Lifting the edge of a 10' x 20' metal plate with forks of a forktruck is a dangerous undertaking. This type of task, if necessary to perform, should be performed by an individual trained in the mechanics of picking up a typical heavy load such as this with a forktruck.

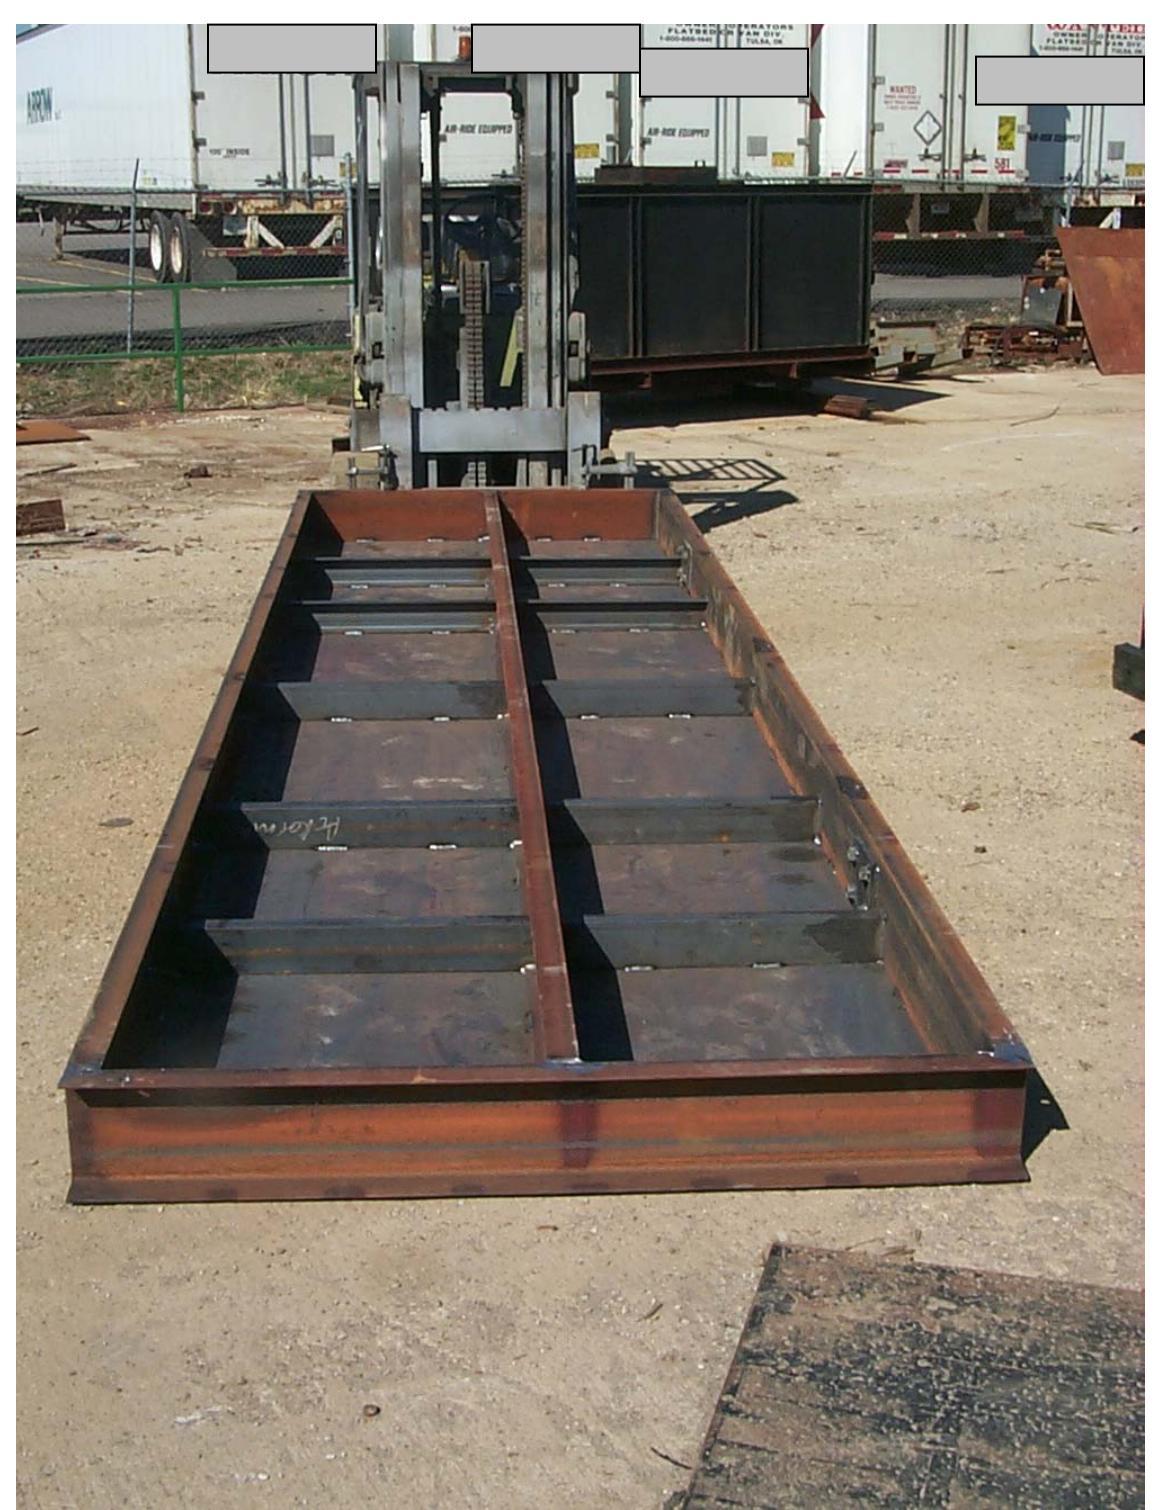
A small steel fabrication business was contracted to build a base plate for a water pump that would pump tens of thousands of gallons of water per day. When completed, the 10' x 20' steel plate would weigh approximately 4,000 pounds.

An example of the metal base plate which fell on business owner.
