Municipal Solid Waste Collector Dies after Falling from Solid Waste Vehicle Hopper Area Incident Number: 10KY006

Kentucky Fatality As	ssessment and Control Evaluation (FACE) Program
Incident Number:	10KY006
Release Date:	January 11, 2011
Subject:	Municipal Solid Waste Collector Dies after Falling
-	from Solid Waste Vehicle Hopper Area

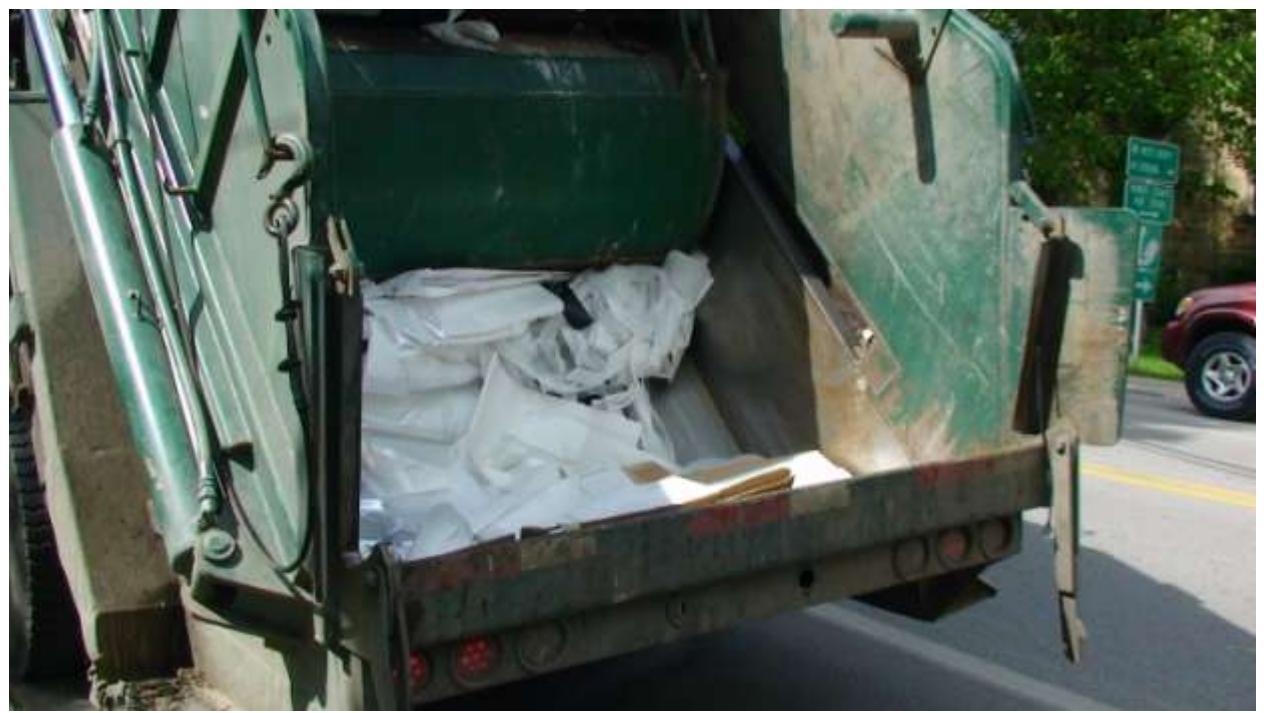
Photograph of hopper from which Collector fell. Photograph courtesy of KY Labor Cabinet.

Between stops, Collector 1 rode on the rear step on the passenger side of the solid waste truck. The rear step on the driver side of the truck was broken and it would not support Collector 2's weight. Without a step to ride on, Collector 2 rode on the driver side in the hopper area located in the back of the truck where the solid waste was collected from the trash receptacles. As he sat in the hopper area between stops, Collector 2 separated cans from the trash.

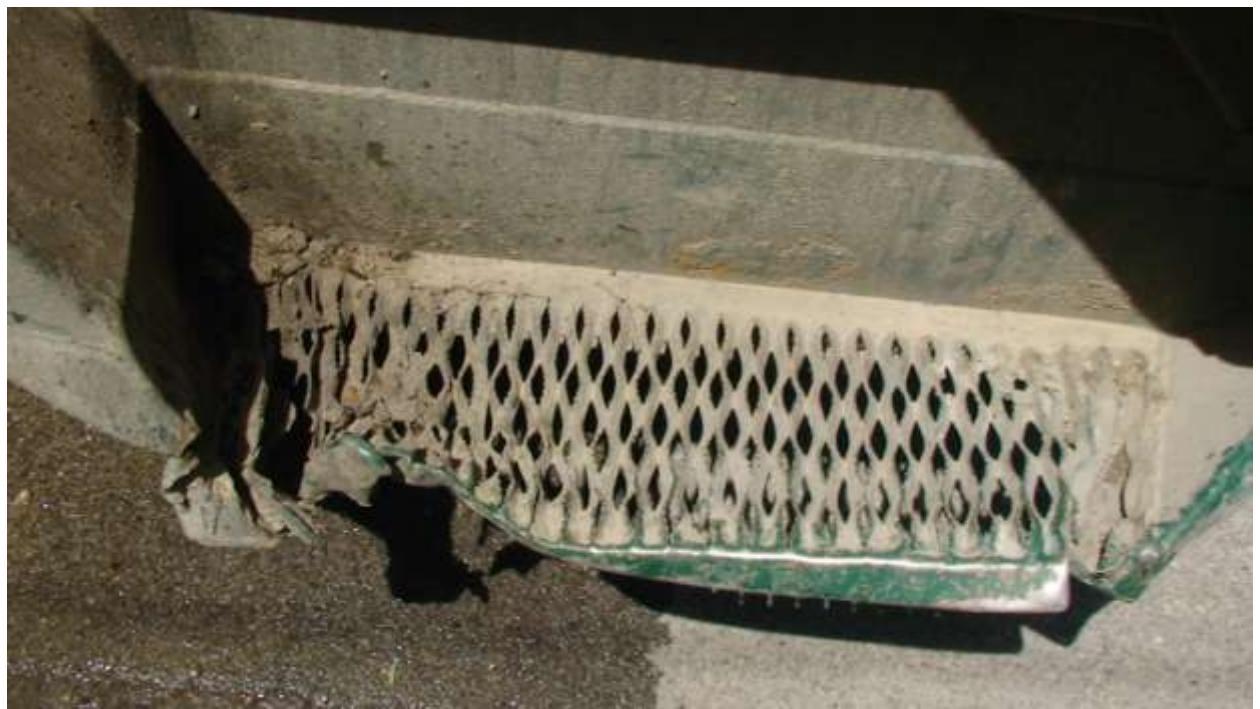
Each time the DVIR is completed, a supervisor should be notified so that needed repairs can be promptly completed. CFR 396.11 also requires that repairs affecting safety be completed prior to the vehicle being operated. According to a municipal official, the broken step had been reported as needing repair for six months prior to the incident. At the time this incident occurred, supervisors were notified verbally that repairs were needed on the solid waste trucks. After this incident, repair requests are now documented in writing.

Photograph of broken step.. Photograph courtesy of KY Labor Cabinet.

Recommendation No. 1: Municipal solid waste divisions should require drivers to perform daily post-trip safety checks on solid waste collection vehicles and timely repairs should be performed.

Municipal solid waste divisions should follow the United States Department of Transportation, Federal Motor Carrier Safety Administration, CFR 396.11 Driver vehicle inspection report(s), regulation that requires the driver of a commercial vehicle to perform a post-trip vehicle inspection at the end of the workday. A written report on the condition of the vehicle is also required. A Department of Transportation Driver's Vehicle Inspection Report, DVIR, (Attachment) should be used to note any defects that need to be corrected before the vehicle is operated. The report lists important aspects of the vehicle such as the air compressor, air lines, battery, body, brakes, clutches, wheels and rims, windshield wipers, etc., which the driver should be required to inspect each time the solid waste truck is operated. There is a section on the form for the driver to make notes of items not listed on the DVIR that may need to be addressed immediately or in the future. The DVIR does not contain an item on operation of the hopper. Municipal solid waste divisions should customize the DVIR to include specific items such as proper hopper functioning, and steps' and grab bars' condition.

At the time of this incident, the standard operating procedures pertaining to vehicle riding by collectors were verbal instructions to not ride in the back of the solid waste truck, and to work safely. After this incident occurred, the steps on the solid waste trucks were removed and workers were required to ride in the cab of the truck. Standard operating procedures for solid waste collectors riding in/ on a solid waste truck should include, at a minimum, the following: 1) collectors should either ride on the steps installed by the truck manufacturer or ride in the cab of the truck; 2) collectors should not attempt to disembark from a moving truck; 3) visible signage should be applied to the vehicle instructing collectors where to ride. When collectors are required to ride in the cab, there should be enough legal seating for each collector. Most solid waste trucks have legal seating for two. When more than two collectors are working the route, a follow vehicle with enough legal seating should be used to transport the collectors.

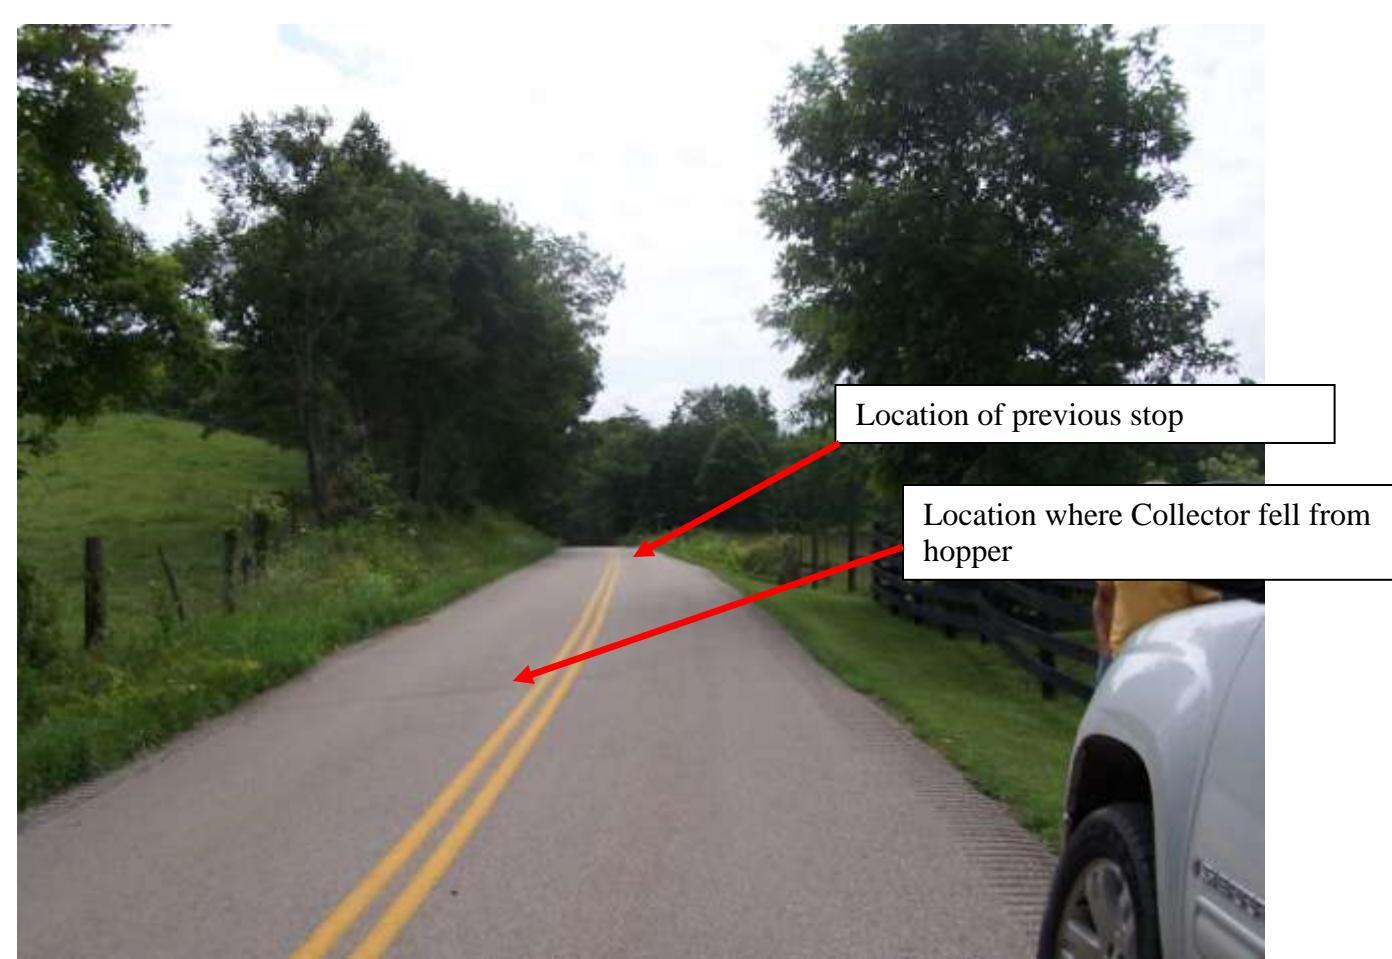
The crew took a lunch break then restarted the route. At approximately 11:40 AM, the crew collected trash from the end of a driveway then proceeded up the road 280 feet toward the next stop. The pavement surface was asphalt, and was smooth, flat and dry; the weather was clear. The posted speed limit was 55 miles per hour. According to the police report, the truck was going between 5 - 10 mph when Collector 2 attempted to jump out of the hopper area, falling onto the pavement striking his head. The vehicle was 50 feet from the next stop. The driver looked out the rearview mirror, saw Collector 2 on the pavement and stopped the truck. The driver and Collector 1 ran to Collector 2; Collector 1 administered first aid. There was no cell phone service at the scene, so the driver drove the solid waste truck several miles to a nearby store, and at 11:50 AM called emergency medical services and his supervisor. Emergency

Roadway where Collector fell out of hopper of solid waste truck. Photograph by KY FACE
